November 4, 2014

Re: Horse Farm, Livestock Office, and Horticulture Shed Cost Evaluation Report,  
Revised to address comments

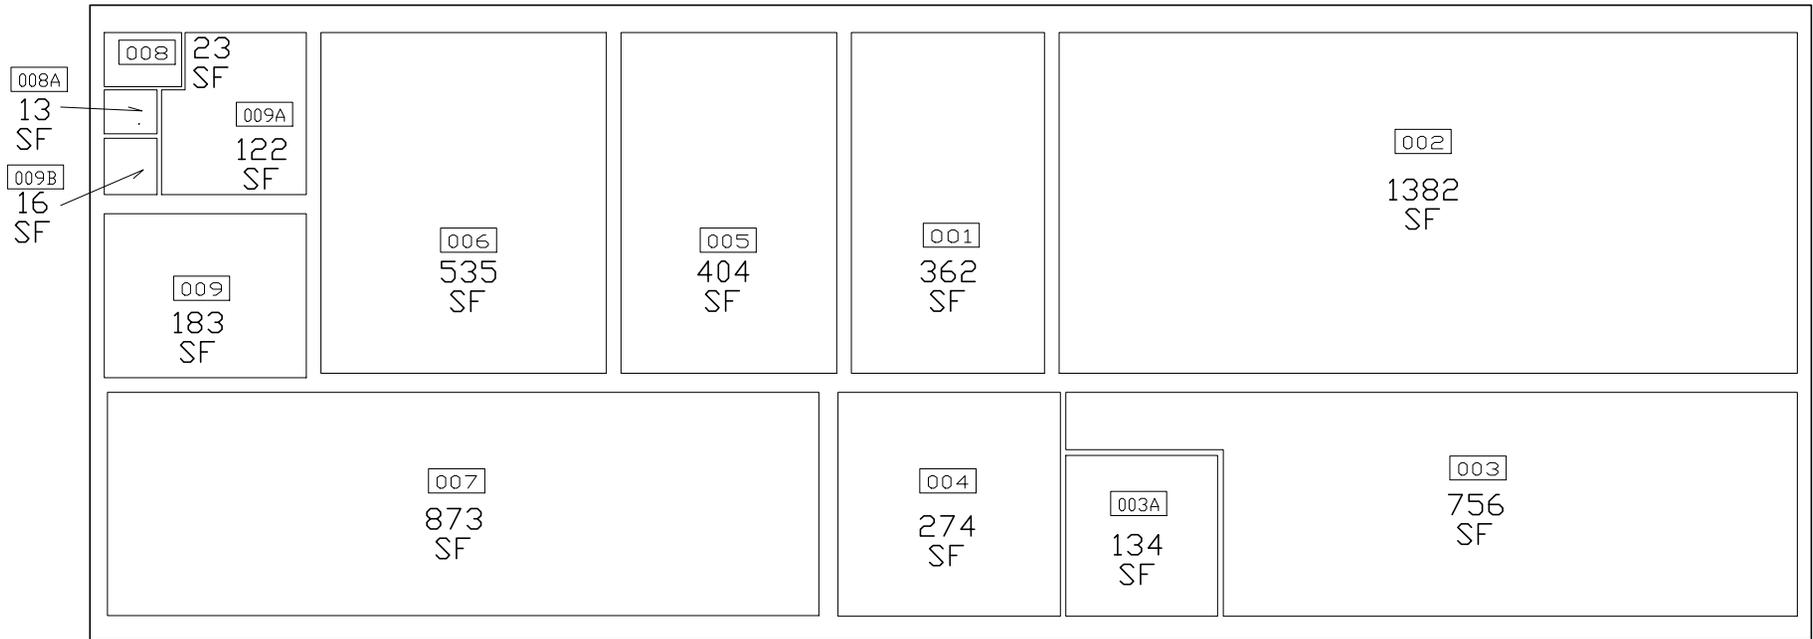
FIGURE 1

The Horse Farm Office was built in at least two phases around 1935, but is not considered to have any historical significance by NMSU's architecture department. However, the Horse Farm Office is an unusually large size for an adobe structure. It is currently unused, with the exception of the tack room which houses saddles and other tack equipment for the Horse Farm. The building covers 6,011 square feet and the exterior and interior walls of the Horse Farm Office are constructed of adobe. The exterior of the building is covered with stucco, which has cracked and fallen away in some areas as a result of moisture infiltration into the exterior. The roof is uninsulated and constructed of timber framing with corrugated metal sheeting. The

metal sheeting is not water tight and rain damage is visible on the interior timber framing and by erosion on the unfinished adobe interior walls.

The interior adobe walls are exhibiting damage at their bases where concrete facing was installed at the wall bases at a previous attempt to repair water damage. Concrete speeds up deterioration of adobe and is not recommended to be used in contact with adobe walls. The concrete facing has prevented the adobe walls from “breathing” when they absorb moisture and so moisture has to travel farther up the wall to evaporate into the atmosphere which damages the adobe. The damage is exacerbated where water pools on the building interior because of the leaking roof. Site drainage around the building is very poor and allows water to pool near the exterior walls in several locations which is then absorbed by the adobe walls which causes damage to the structure. The concrete floor of the building is in relatively good shape with some minor cracking.

The farm office has an interior office, restroom, kitchen/laboratory, and storage area with plastered or drywall interior walls. With the exception of the kitchen/laboratory which has its own separate roof structure within the larger building, all of the finished rooms show significant rain damage also. **Figure 1** shows a floor plan of the Horse Farm Office.

The Horse Farm Office is unusually large for an adobe structure and fits well with the cultural heritage of the College of Agriculture and the surrounding area. BHI consulted an adobe renovations expert who believed the building, while in need of extensive repair, is not beyond saving. Most of the deteriorated adobe is less than 4 inches deep in the walls and is repairable. The majority of the problems with the existing building are caused by poor site drainage which allows water to pool next to the adobe exterior walls and the leaking roof. Repairs to the walls have been attempted in the past by pouring a concrete facing at the base of the building's interior walls as an attempt to shore up the wall bases. However, the concrete has only exasperated these problems since moisture in the walls has to travel higher up the walls before it can escape to the atmosphere.

If NMSU chooses to renovate the Horse Farm Office, it is necessary that only traditional adobe construction methods and a qualified contractor be used to perform the work to ensure a long life for the structure. Using traditional materials will allow moisture that gets into the walls from the building foundation to escape to the atmosphere before it can travel up the walls and cause damage to the structure. Use of non-compatible building materials with adobe will speed up deterioration of the building. It will also be necessary to survey the site, locate an appropriate off-site storm water discharge location or retention ponding area, and construct swales around the site to allow for proper removal of storm water. These tasks would need to be done if the building is replaced with a new structure also.

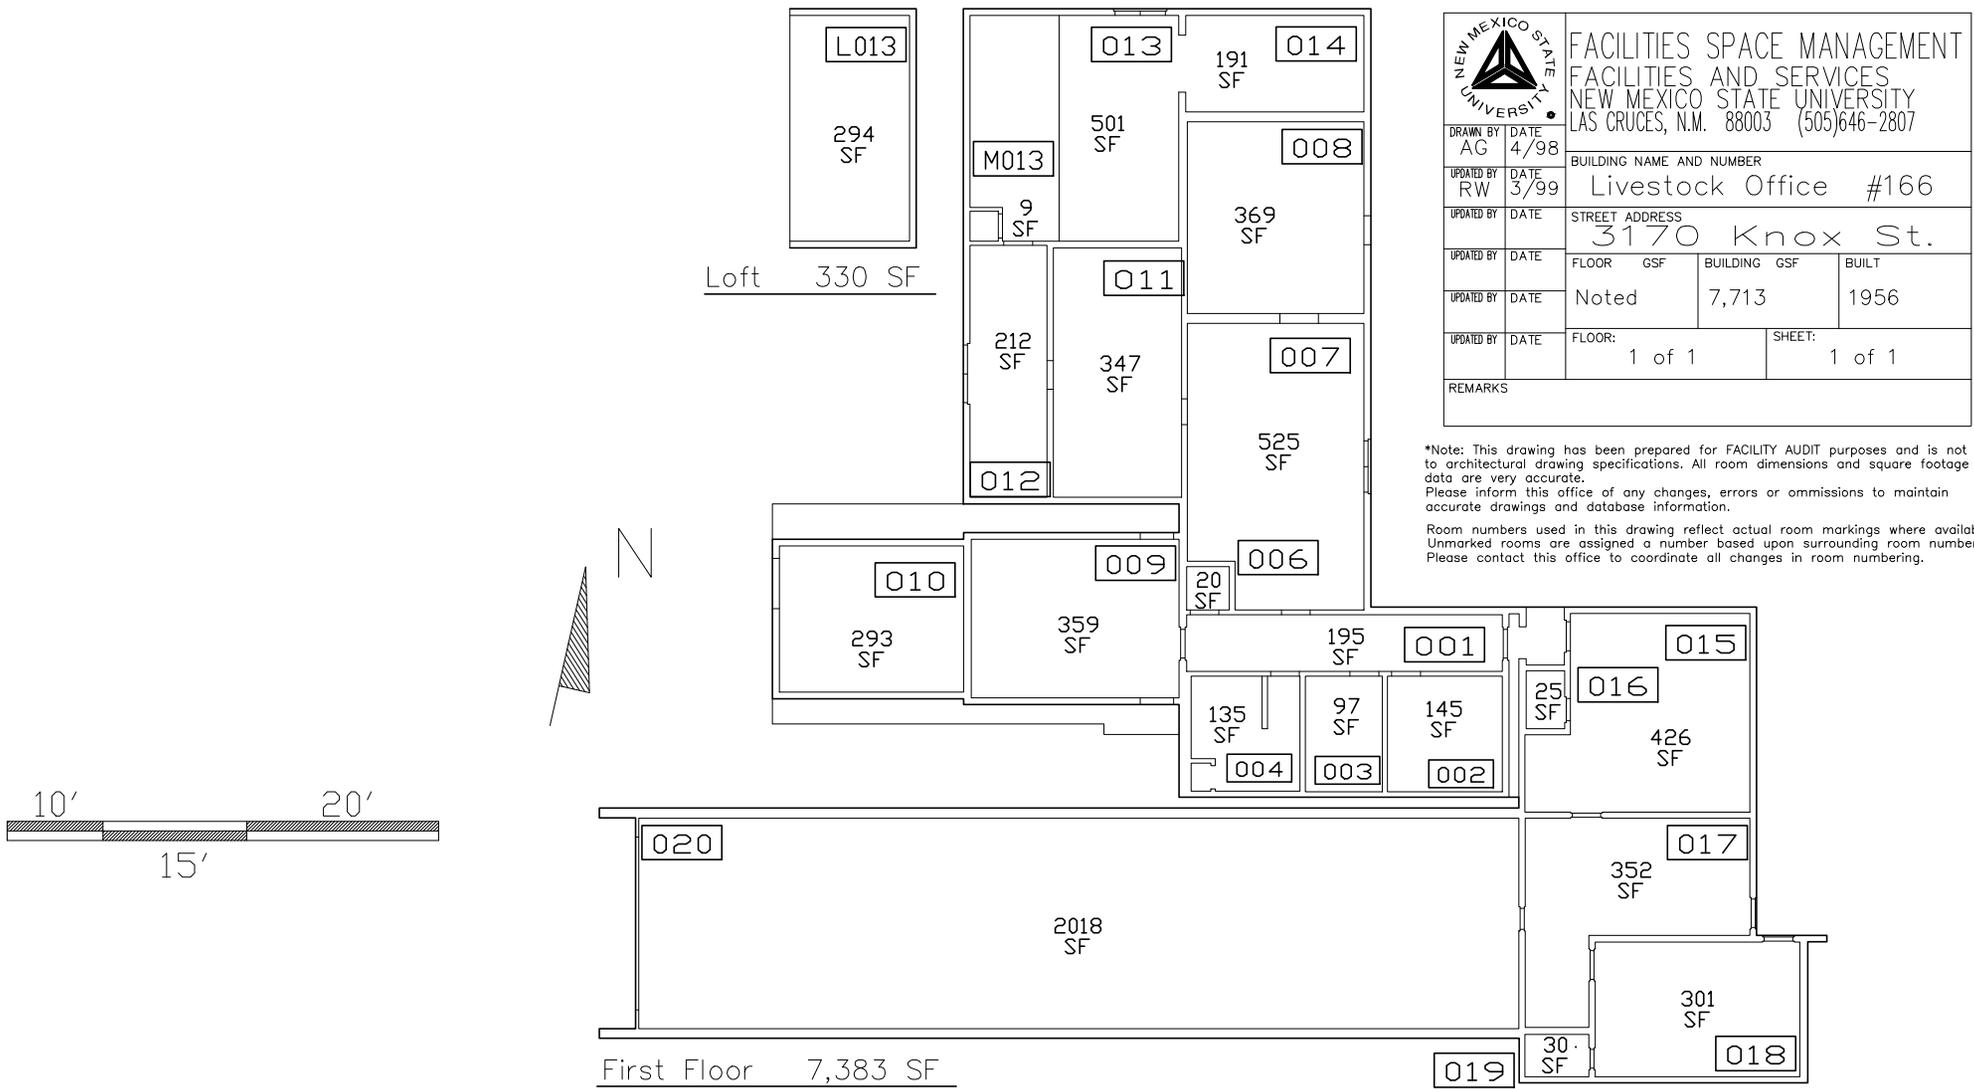
FIGURE 2

The Livestock Office was built in 1956, and is not considered to have any historical significance by NMSU’s architecture department. The Livestock Office covers 7,383 square feet and is actually two separate structures built adjacent to each other. The interior and exterior walls are constructed of CMU. The exterior is finished with stucco, and most of the interior walls are painted or plastered. The exterior stucco is in very poor shape and is peeling away.

There is evidence of settlement cracking throughout the building in both the interior and exterior walls. The roof of the 2,018 square foot dairy milking room is exhibiting large deflections due to water damage caused by a severely deteriorated roof. Water damage was observed throughout the remainder of the building, indicating that the entire roof is likely in similar shape. The building is known to have asbestos in some of the wall and ceiling materials and it is possible that there may be mold contamination in the building due to the prolonged water leaks in the roof. There was a fire at some point in the north part of the building, but the roof supporting members have since been reinforced with new lumber and appear structurally sound.

A custodial office and adjoining restroom were renovated within the last five years and appear watertight, though some evidence of minor settlement cracking on

interior, non-bearing walls is visible inside the renovated area. **Figure 2** shows a floor plan of the Livestock Office.

Rooms 009, 010, and 020 are a hay storage area, an unused chicken coop, and an unused dairy milking room respectively. These rooms were specifically designed and laid out for their original purposes. If the Agricultural Department doesn't intend to use them again as agricultural facilities, it is recommended that these rooms be demolished rather than renovated if NMSU decides to renovate this building rather than demolish or replace it.

The majority of the problems with the Livestock Office have arisen from the leaking roof. With a new roof, the structure could still be viable as a storage facility and office space but it is in need of extensive cleaning and updating. There is also some asbestos abatement that will need to take place before any renovations are completed.

The Livestock Office contains a hay storage room, an abandoned chicken coop and an abandoned dairy milking room (Rooms 009, 010 and 020). If NMSU chooses to renovate this building and does not intend to use those rooms for their original intended purposes, it is

recommended that these three rooms be demolished and the rest of the building renovated because they would be awkward spaces to try to re-purpose as classrooms, offices or storage spaces.

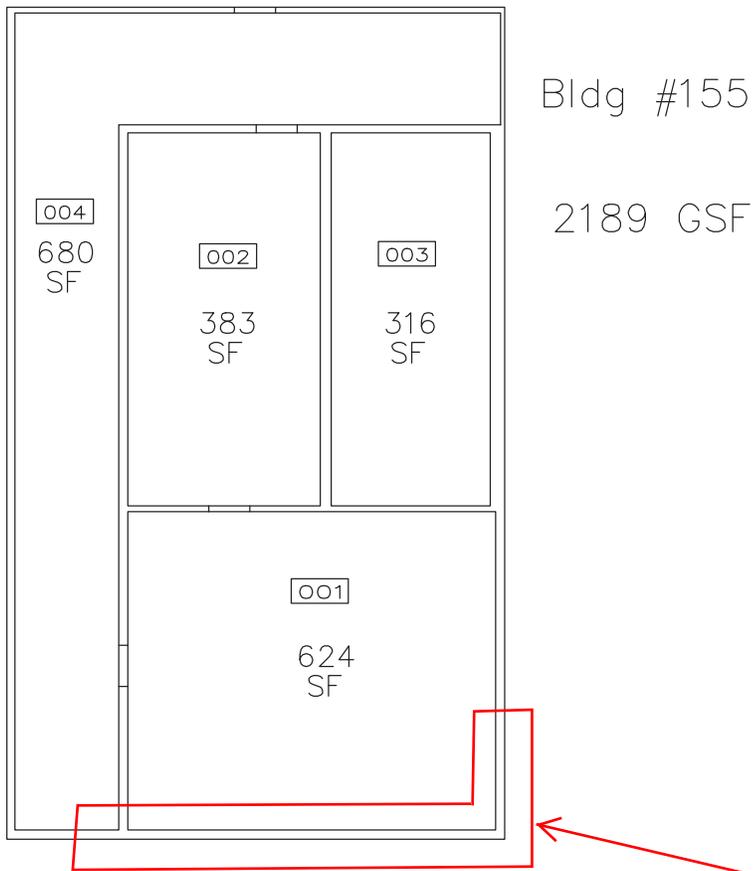
FIGURE 3

The Horticulture Shed was built in 1948 and is considered by NMSU to have historical significance to the campus. The Shed is a 2,189 square foot building with brick walls, cast-in-place concrete lintels and timber truss roof framing. The brick walls appear to be constructed on a continuous concrete stem wall foundation. The building has a raised wooden floor. The shed is uninsulated and has an unfinished interior. There is evidence of differential foundation settlement on the entire south wall, particularly pronounced in the southeast and southwest corners of the building. Although the settlement cracking is pronounced on the building exterior, there is no apparent distress to the interior building framing or floor. The settlement cracks have been visible for at least five years, but were not reported to have been widening since that time. There is also evidence of shear cracking at the corners of the four crawl space entrances spaced around the building exterior. **Figure 3** shows a floor plan of the Horticulture Shed.

The Horticulture Shed is adequate for its intended purpose. It is experiencing settlement on the south wall which should be stabilized if possible. It is likely the settlement is caused by a sublayer compacting due to a drop in the water table. BHI recommends a geotechnical investigation be completed near this wall to try to determine the cause of the settlement and an adequate bearing layer somewhere below the foundation. If an adequate bearing layer is found under the structure, helical piers can be installed along the wall experiencing settlement to transfer the bearing load from the soft layer to a deeper layer. The cracks can then be repaired to restore the aesthetic appearance of the building. The materials used to stabilize the wall will be buried and will not affect the historical appearance of the building.
