NEW MEXICO STATE UNIVERSITY
ALCALDE, NEW MEXICO

SUSTAINABLE AGRICULTURAL
SCIENCE CENTER

EXTERIOR FACILITIES CONDITION REPORT
FEBRUARY 12, 1998

MOLZEN-CORBIN & Associates

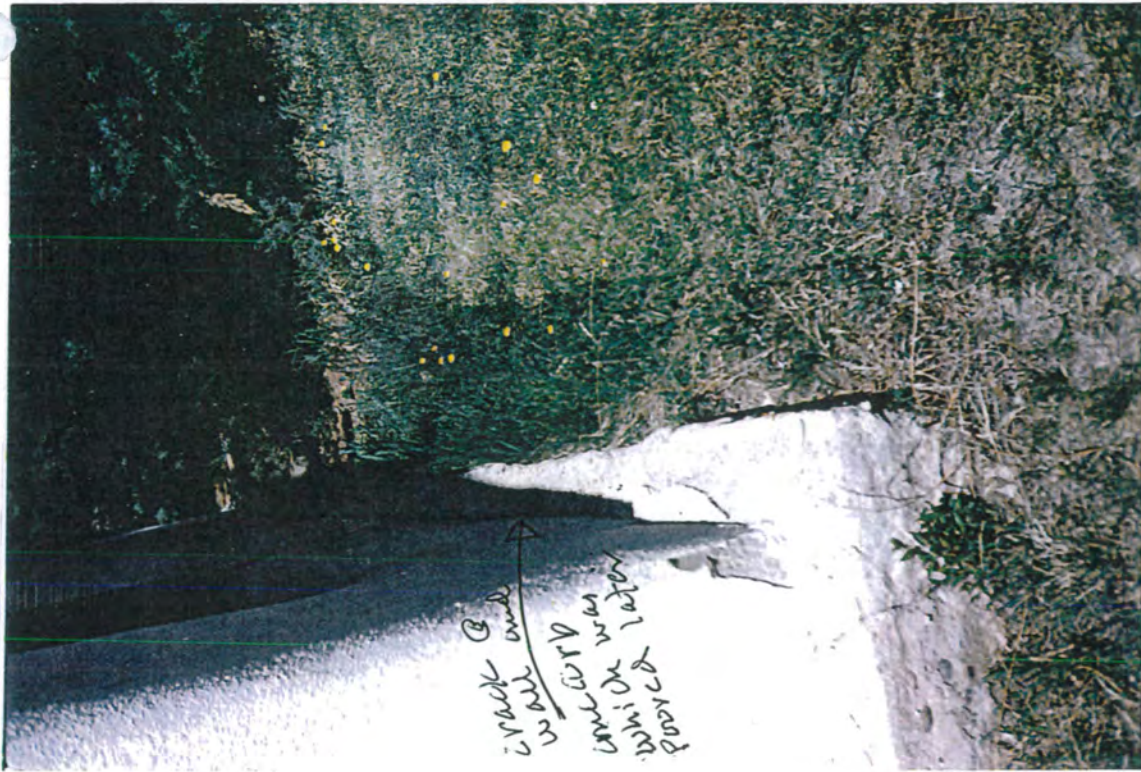
Crack and wall was built with stones & later covered with mud.

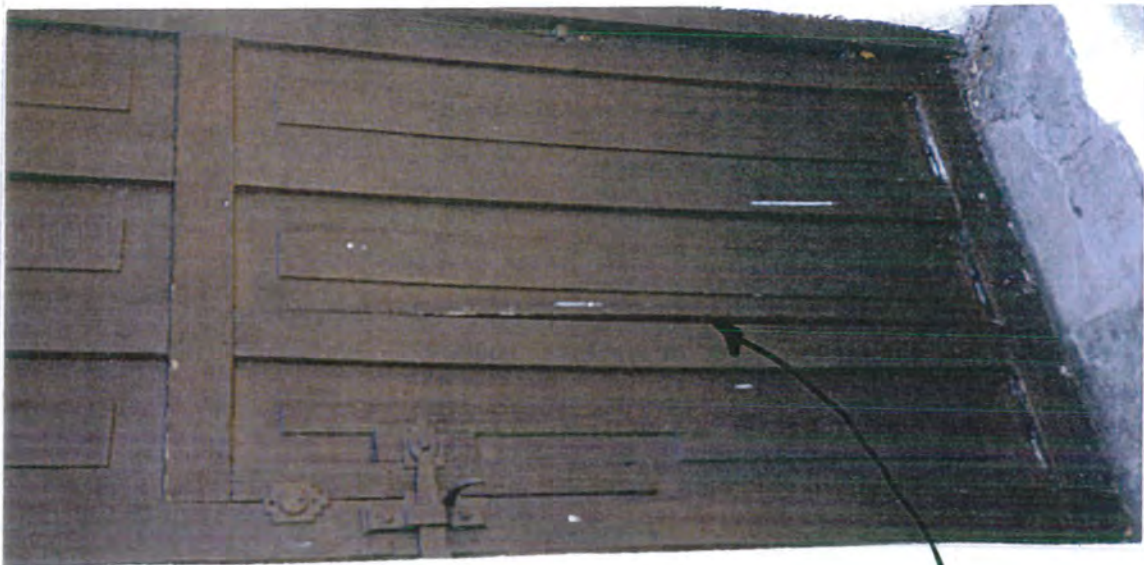
On the west side, there are two doors where the panels have warped out of the door stiles that need to be repaired or replaced in their entirety.

door panels are warping out of stiles.

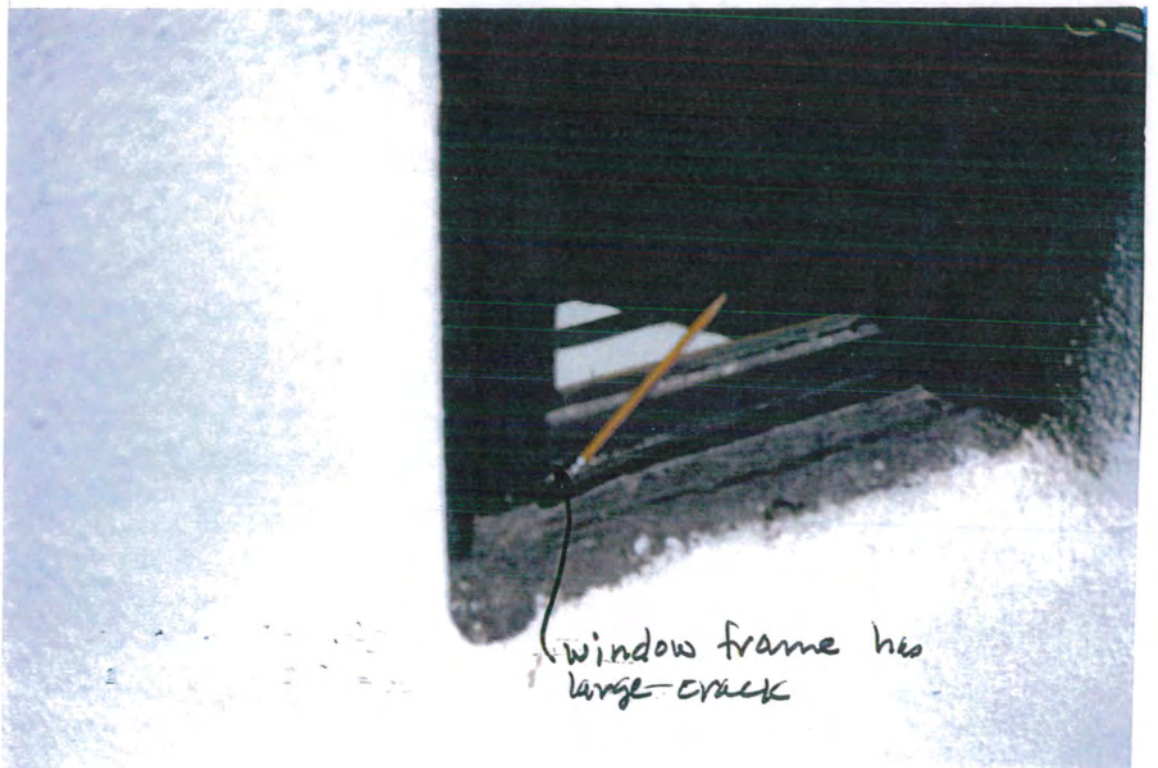
window frame has large-crack

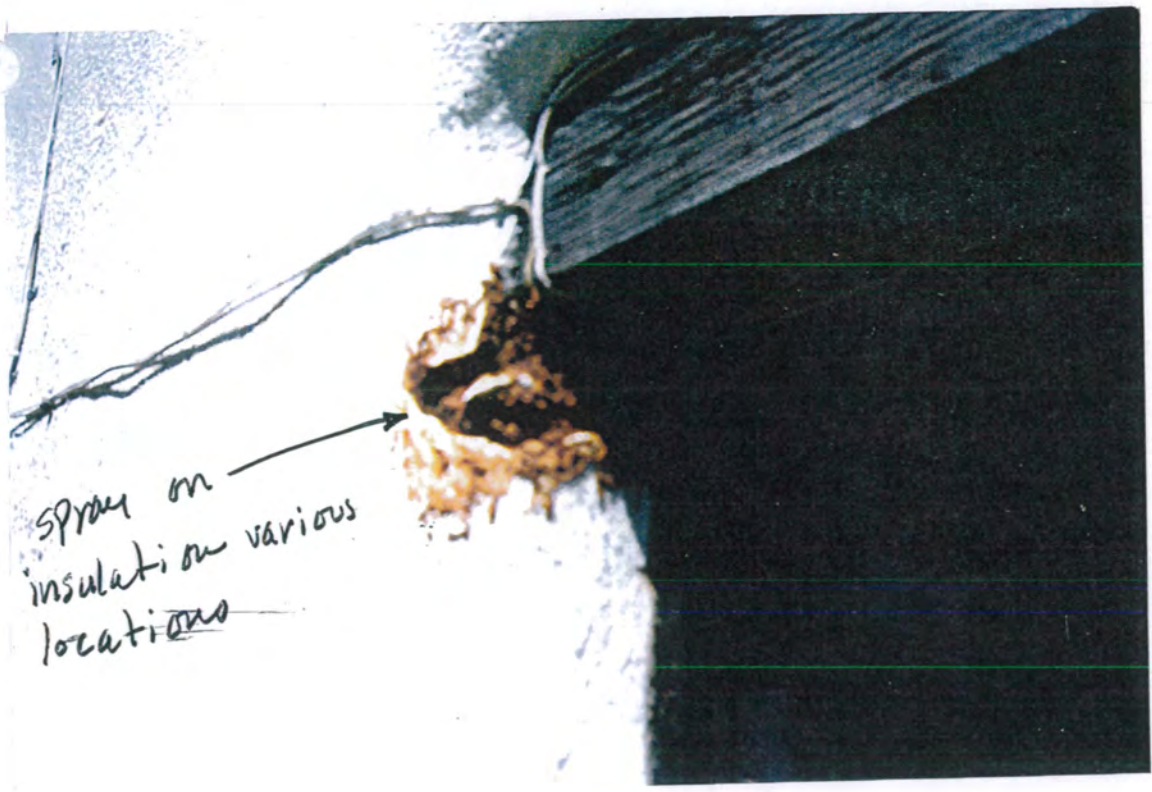
spray on
insulation various
locations
