The following is an assessment of six Agricultural Experiment Stations
April 23 – 26, 2012.

Alcalde Agriculture Science Center

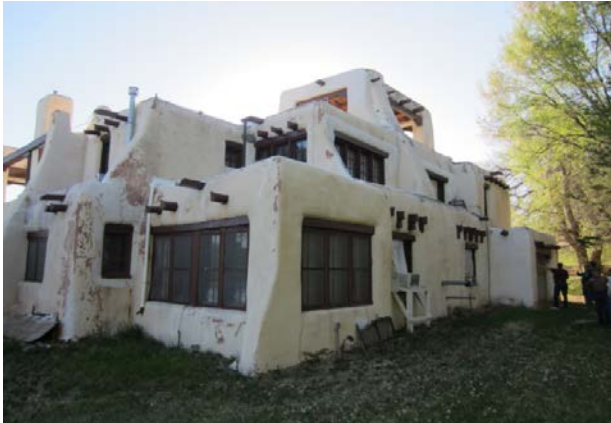
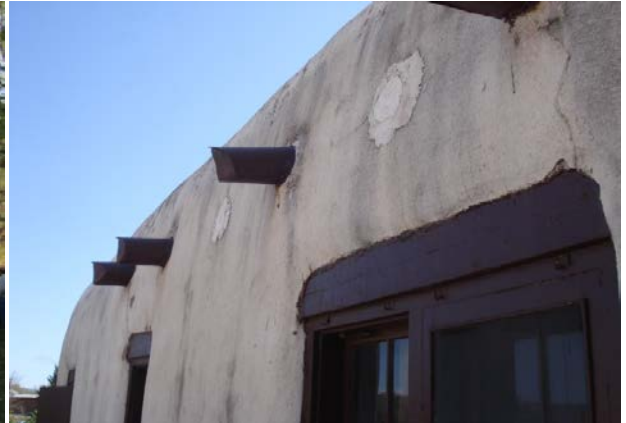
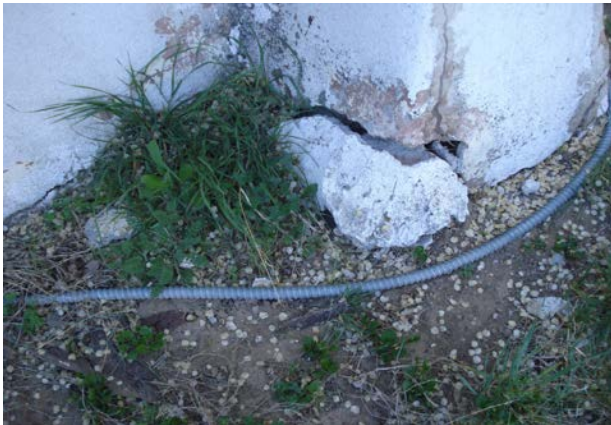
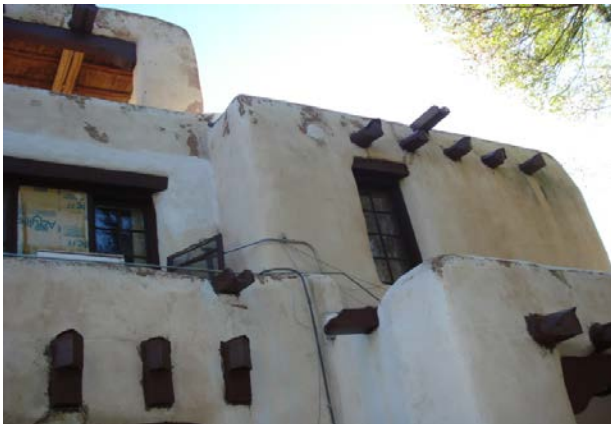
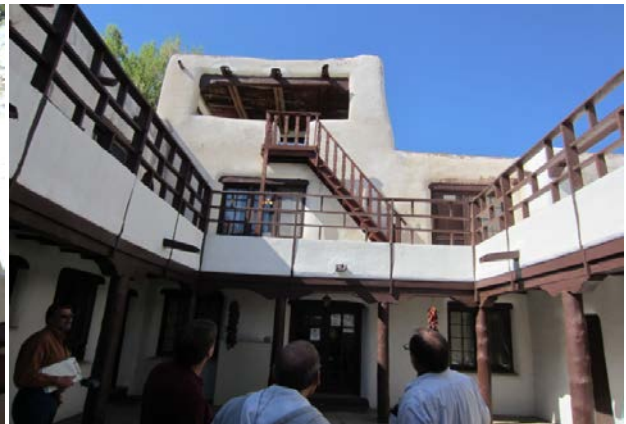
- Exterior plaster/stucco in poor condition.
- Cracking of walls close to the ground.
- Vigas on exterior is missing or rotted.
- Single pane windows; window frames rotted in areas; screens missing or torn.

- Adobe wall is deteriorated at foundation due to water.
- Interior fair condition overall.
- Rodent control on second floor desperately needed.
- Guard rail on second floor unsafe.

As shown in Figures 1- 6 above, the exterior of the main office is in need of extensive repair; stucco, vigas (possible removal), roof, railing, and surface mounted electrical and other exterior surface repairs and replacements. The building is also in need a new A/C and heating systems.

Have obtained past quotes of \$40,000 to \$100,000 respectfully to re-plaster exterior walls. Quentin Wilson estimated that it would take \$100,000 to plaster office. Need to be careful not to use stucco because it holds in moisture and this will cause further damage to the adobe walls.

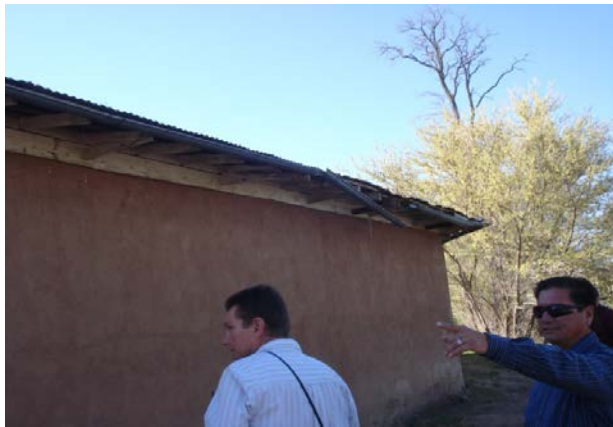
Figure 7 – Adobe Storage Buildings

As is shown in the pictures above, the historic barns, now shop storage buildings (Figures 7 & 8) are in need of significant repair or replacement. The exterior adobe walls are in poor condition, show significant signs of displacement, and the roofs and gutters need to be replaced. The superintendent' house (Figures 11 & 12) needs to be re-plastered as well as replacing the roofs. The irrigation canal (Figure 9) has eroded and the adobe fence next to it has collapsed. The exterior wall (Figure 8) surrounding the property is also deteriorating due to poor drainage of the main street next to it.

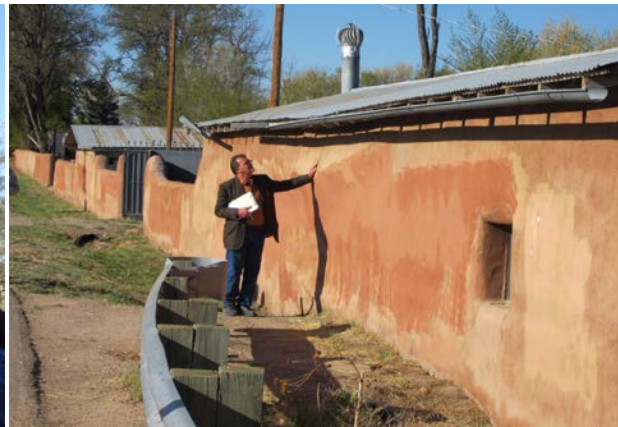
- Adobe wall on east side of property is falling over due to water draining from street.
- Graffiti problems causing wall to have different colors.
- Stucco peeling near ground due to water.
- Large cracks in some areas.
- Area north of gate is bulging out/falling over due to drainage of main roadway.
- Fence is at the end of a street (have had vehicles run into it in the past).

Figure 8 – Adobe Storage Building & Fence

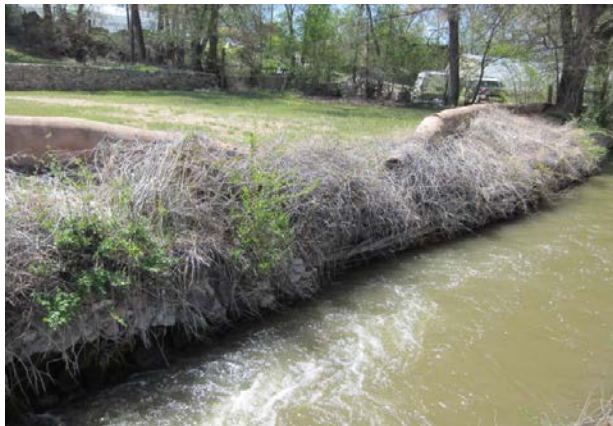
Area near office has washed out. Repairs required as water in ditch is causing erosion to property.

Figure 9 – Eroded Fence and Canal Wall

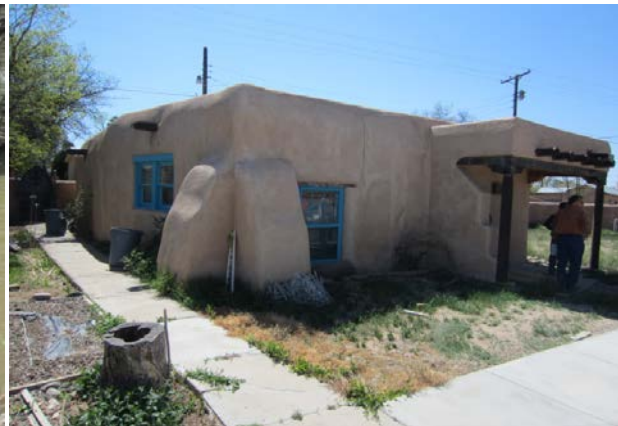
Figure 10 – Guest Home

- Built in 1800's adobe single story.
- Smaller home just recently remodeled inside—looks good but could use more work.
- Used by graduate students.
- Needs door to bathroom.
- Outside stucco cracking in areas.
- Needs new roof.
- Single pane windows.

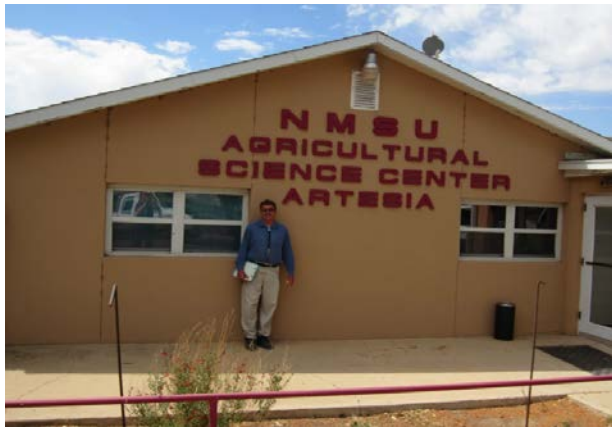
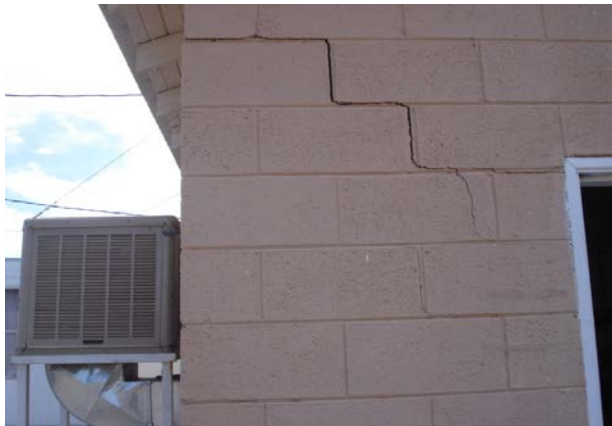
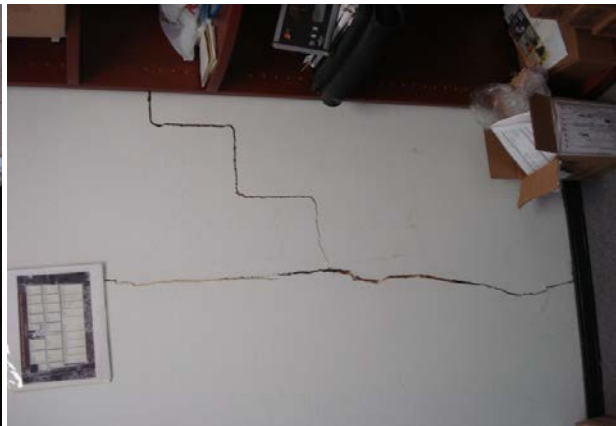
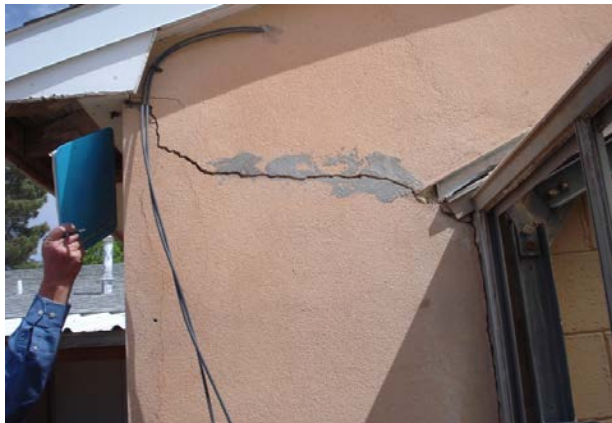
- New addition in 1977.
- Water drains from all direction towards building, especially from fields. Causing shrink and swell of soils.
- Concrete masonry unit (CMU) construction.
- Major cracks through the building interior and exterior.
- Cracks between ceiling and roof.
- Cracks in foundations – floor uneven – cracks in tile because of this.
- (Architectural drawing show 16" X 5' piers under foundation).
- Doors out of square due to settlement issues.
- Separation between old part of building and new edition.
- Both old and new have major structural cracks throughout buildings.
- Eastside roof sloping SE-E side.
- 10,000 gallon underground fuel storage tank shown on drawings. Unsure if removed.
- Ceiling popcorn treatment style - possible asbestos.
- Metal roof installed 7 years ago.
- Newer septic system.
- Eaves need paint.

The most significant concern is the drainage sloping towards the main building office on site. Saturation of the soil around and under the building has caused major movement of the original building and the 1970's addition (Figures 1-5). All have structural cracks in every corner of the building. The green house is non-functioning and is only used for storage (Figures 2 & 6)

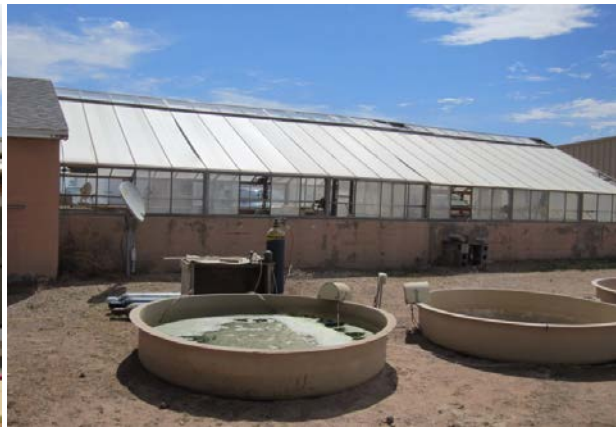
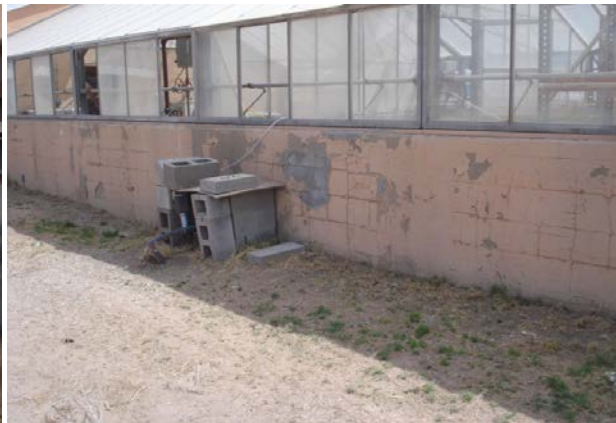
- Located at backside of office.
- Same crack damage as seen in office.
- Has not been used in 15-20 years.
- Electric no longer works.
- Water no longer works.
- Greenhouse AC system no longer works.
- Glass roof is missing in areas.

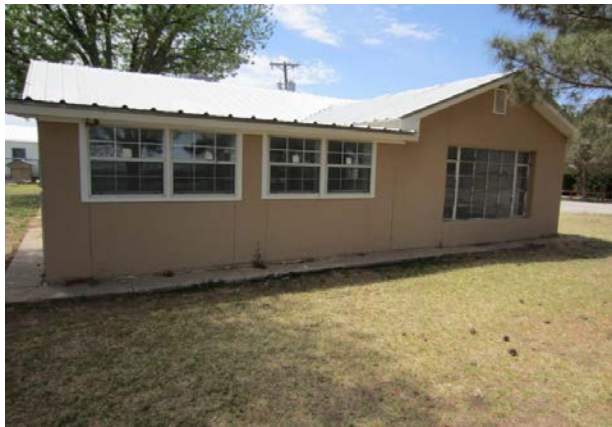
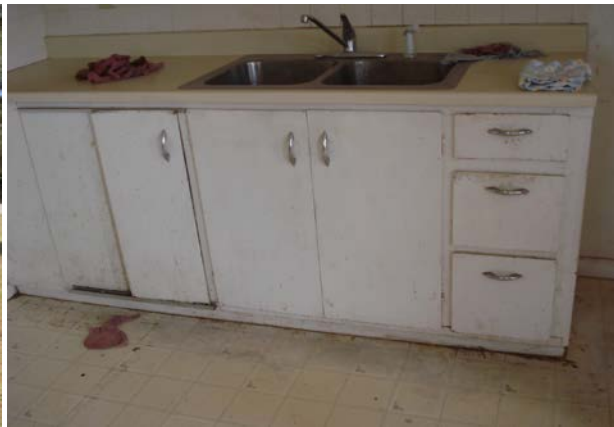
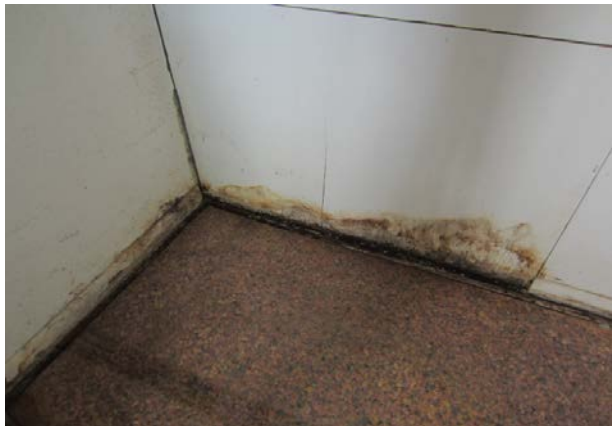
- House is in extremely poor and unclean condition.
- Cracks in and between walls and foundation.
- Needs new doors (interior and exterior) and windows.
- Stucco is falling off.
- Needs new flooring—9"x9" tiles under carpet –possible asbestos.
- Water damage on interior walls.

- Light fixtures missing throughout house.
- Needs a complete new kitchen - cabinets, floors, plumbing fixtures etc.
- Metal roof around 7 years old.
- Electric service good.

The ranch manager's house shown above in the top two photos is in need of complete refurbishment. There are concerns with vinyl asbestos tile (VAT) throughout the building, mold, kitchen upgrades and whether this building is worth saving (Figures 7- 9). The other photos include the major shop buildings on site that are in relatively good shape (Figures 11 & 12). The lack of footings and erosion under the side walls of one of the shop buildings is a concern (Figure 10).

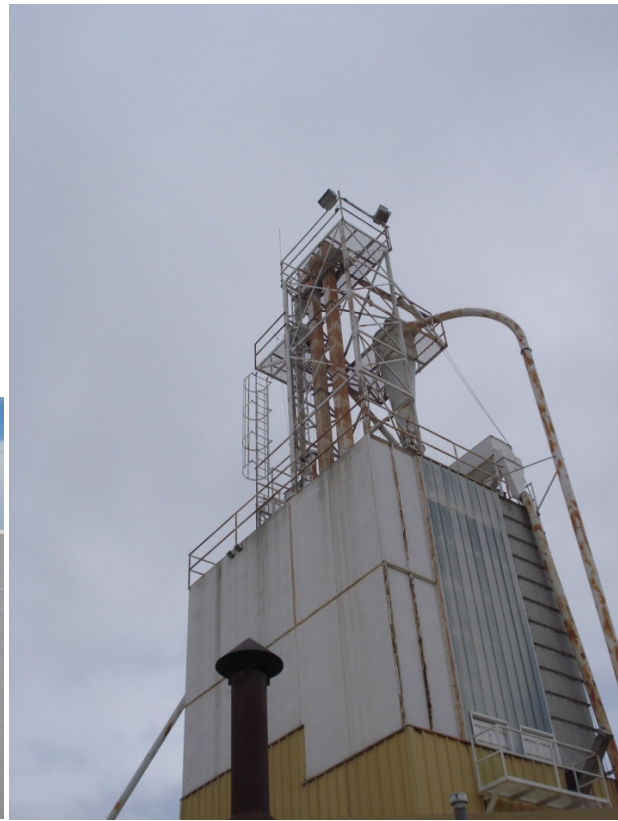
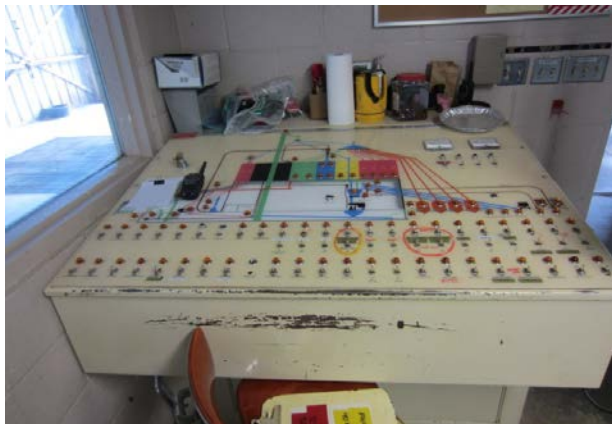
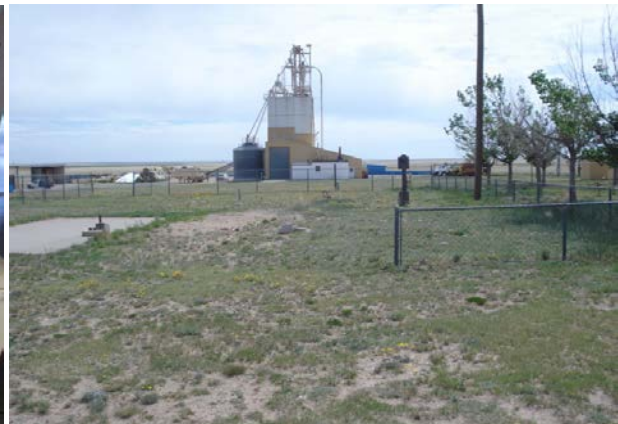
- Mill needs paint.
- Metal construction—some of metal on building significantly dented.
- Concrete Masonry Unit (CMU) building attached to back of mill has cracks.

Employees say one of the bins are flat instead of cone shape, therefore grains that are processed stay at the edges of bin and become moldy. They have to crawl into the bin to clean it out.

One of the biggest concerns is the upgrading and/or replacement of the feed mill. This may have been a “state-of-the-art” facility roughly 30 years ago. This is the single most expensive upgrade to the Livestock Research Station in Clayton

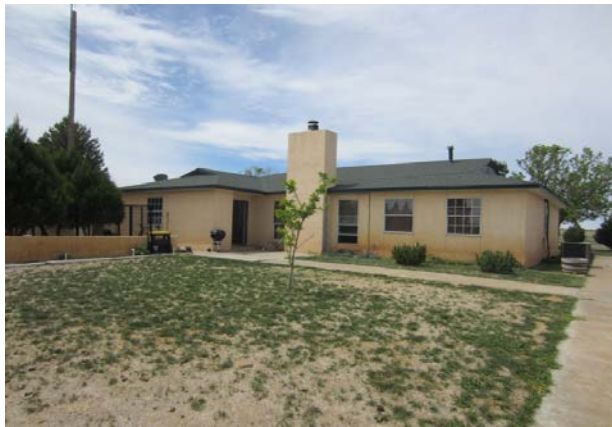
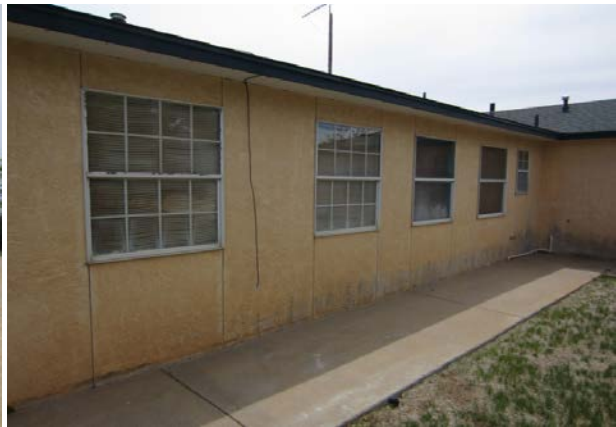
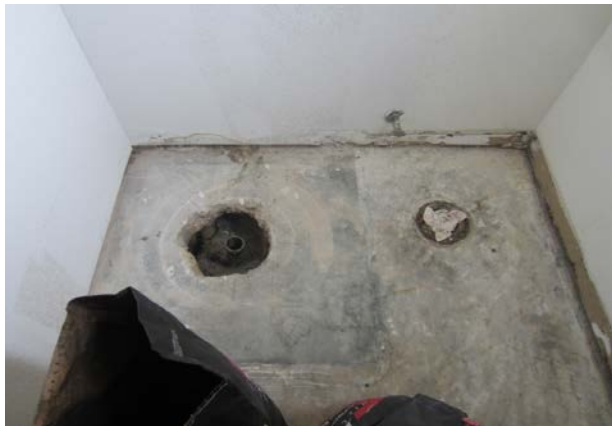
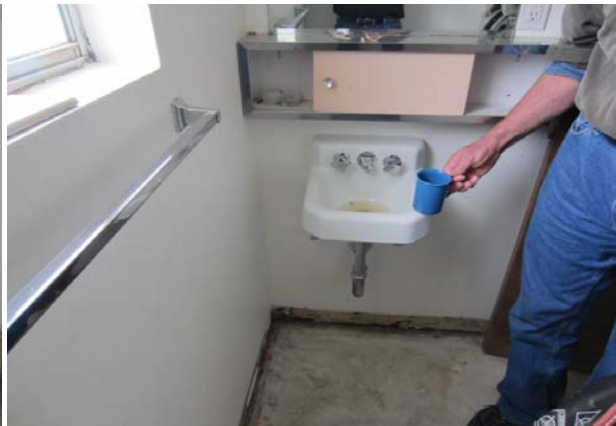
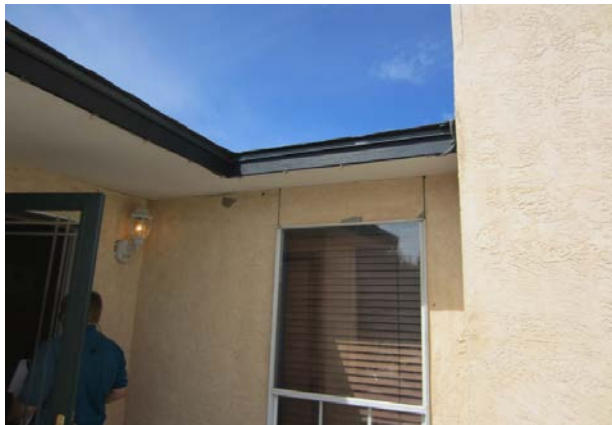
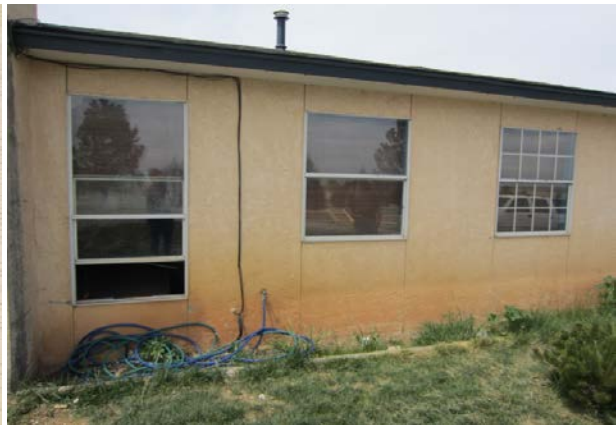
- Frame construction.
- Building needs new stucco.
- Fireplace does not vent properly.
- Needs new windows – double windows fog up between glass due to break in thermo-panes.
- Past resident gutted the 2nd bathroom. Needs new bathroom
- Fences have cracks and need new stucco

Some of the bigger concerns with the superintendent's house shown in the above pictures are the stucco repairs, window replacement and completion of bathroom renovation work. (Figures 5-9)

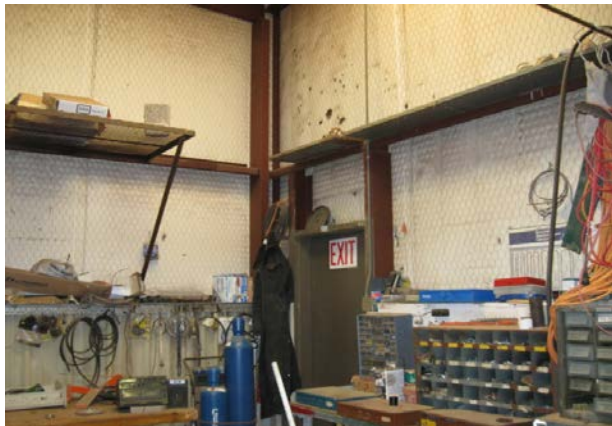
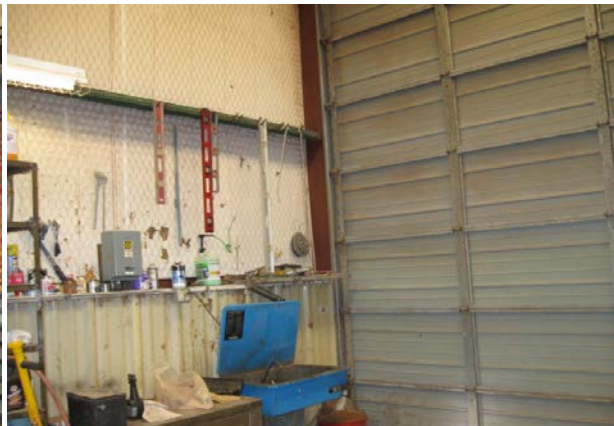
Other than the wells going dry, the facility is in pretty good shape. The shop area is far too small for the repair of ranch equipment and the shop could easily be doubled in size. (Figures 3 & 4)

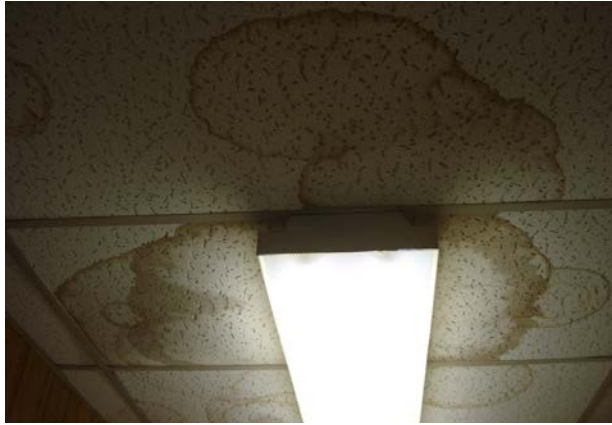
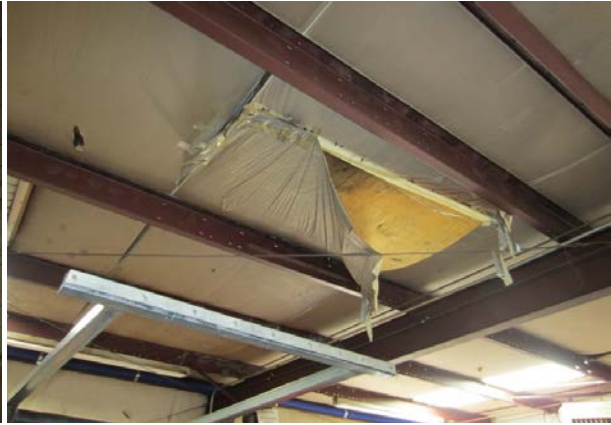
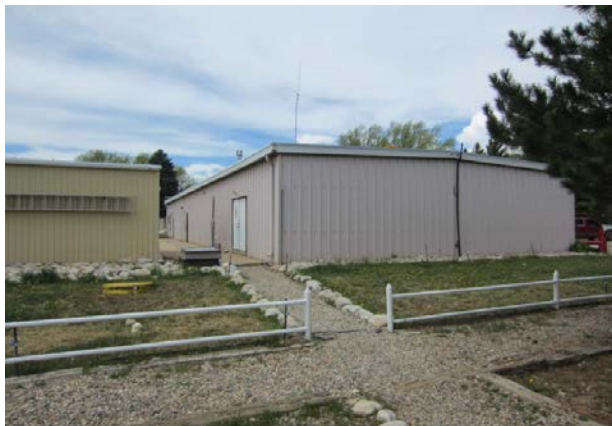
- Combination office and shop area.
- Metal construction.
- New roof required.
- Water from rain seeping into ceiling area—getting into light fixtures.
- Need new ceiling tile after roof is repaired..
- Office and two residences share same septic tank—have to pump every 3 months.
- On city water.

The primary concerns are that the roofs need to be replaced on the office/shop and the both residences (figures 1 & 2). Compressors for refrigeration and freezers need to be replaced (Figure 6). Finally, individual septic tanks for each occupied building.

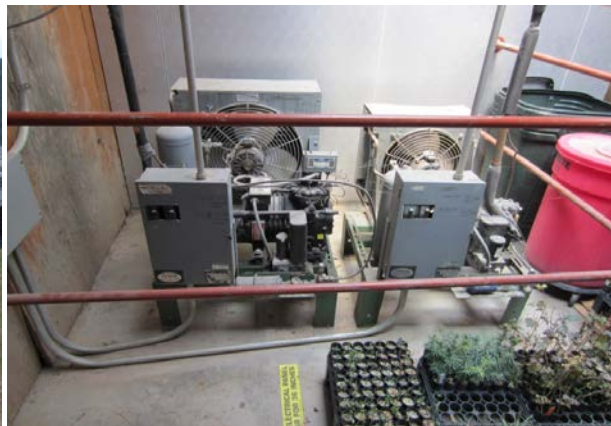
- Steel and glass/plastic covering.
- Metal building on front of greenhouse.
- In good shape.
- Walk-in freezer needs new compressor; other equipment needs work - (Figure 6)

Figure 6 - Compressors need replaced.

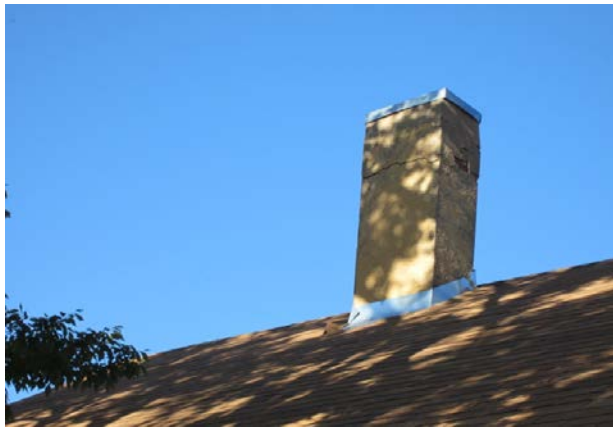
- Concrete Masonry Unit (CMU) - red brick construction.
- Front area of roof drains back against the roof. This is causing water to leak inside kitchen area and upper cabinets.
- Chimney has major cracks and cannot be used.
- Exterior stucco has major cracks.
- Outside wood needs to be painted.
- Windmill next to house needs to be grounded electrically.
- Old electrical devices (switch and receptacles) throughout the house.
- Water has leaked into basement.
- House needs new windows.
- Part of basement needs concrete on floor.
- Need more receptacles in the house.

Figure 1 - Main Home Chimney

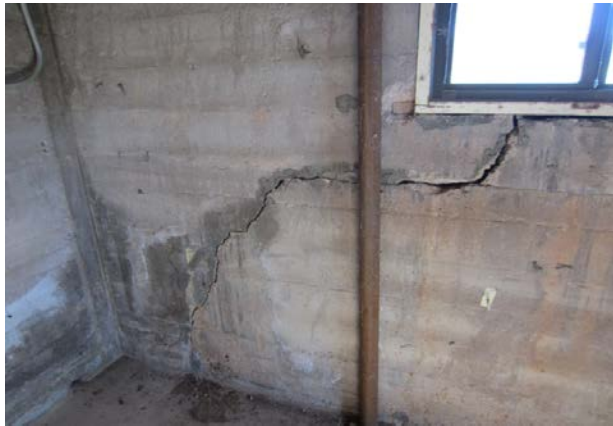
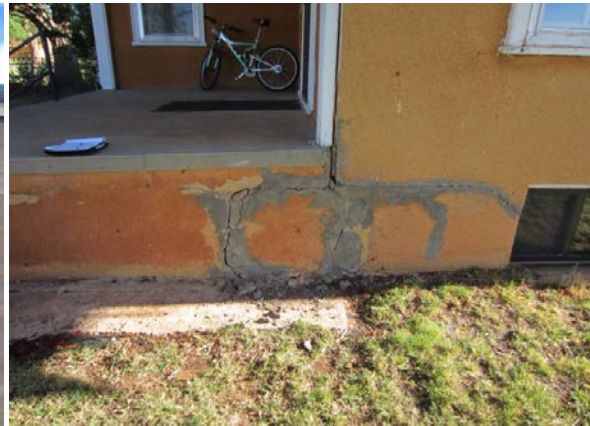
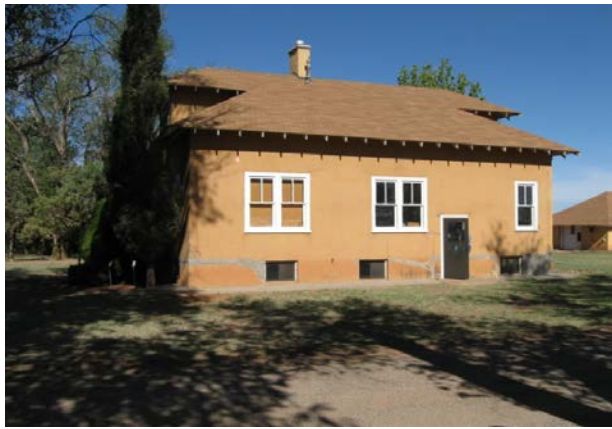
- Concrete Masonry Unit (CMU) red brick/ construction.
- Cracks throughout exterior wall, especially where foundation meets wall.
- Wall cracked at entrance step - maybe used to crawl under at one time.
- Fairly new roof.
- Single pane windows.
- Need more AC/cooling.
- Domestic well 110 feet deep; new pump 8 years ago.
- Need more receptacles throughout office.
- Drainage of water is toward building.
- Basement walls have major cracks.
- Paint is needed on window frames and eaves.
- Gutter has been removed.
- Chimney severely cracked.
- In basement, the joist are not on concrete wall and causing sagging in floor above.
- Water comes in basement windows.

As shown in figures 3, 4 & 11, the office has stucco cracking on the outside of the building and also has foundation walls that are cracking. Other repair items to the office are noted in this report. The Conference Building (figure 6) exterior painting is needed along with other items listed in the report.

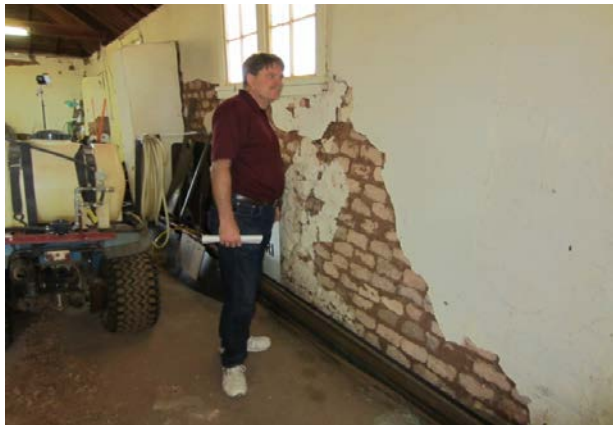
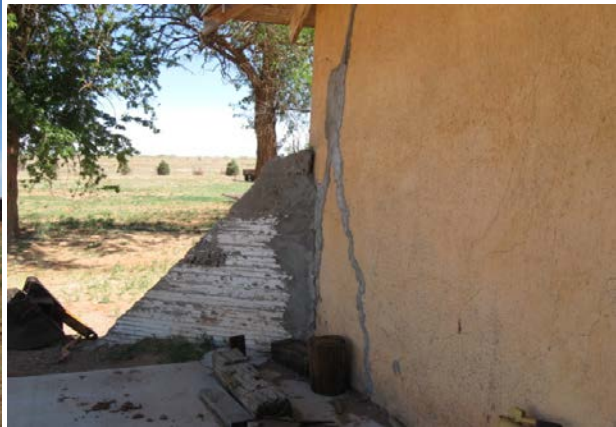
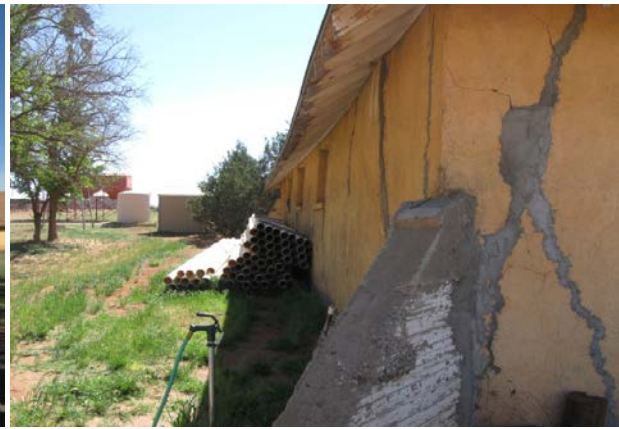
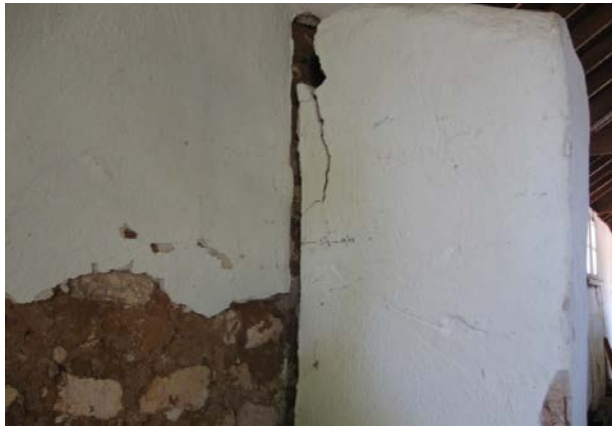
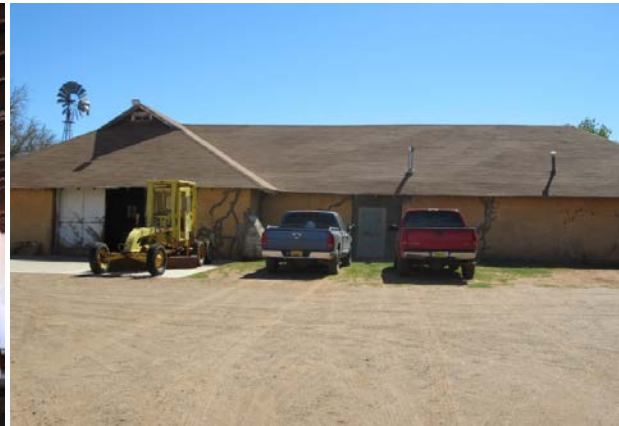
- 100 year old adobe.
- Major structural problems.
- Concrete braces on corners.
- Concrete support base inside.
- Major cracks outside stucco.
- Needs new concrete floor.
- Interior plaster coming off adobe walls.
- Roof and ceiling in good shape.

- Electrical transformer concrete pad sinking.
- Roof joist has sagging areas when looking from outside.
- Wood doors, eaves, window frames need paint.

Wall movement is being measured to show distance the wall is falling over each year. When looking at support it looks like wall is falling outward. When looking outside wall is falling inward and pushing support with it.

The Shop Building shown in figures 5, 10, 12, 13 & 14 is a 100 year old adobe building. Even though this building is a functioning shop, there are serious structural concerns with the building. This building is not in as poor of a condition as the Horse Barn, but needs a complete structural analysis and recommendations how to preserve the building to prevent further deterioration. Figures 15 & 16 show two different views of the Main Home and repairs and modifications are noted in this report.

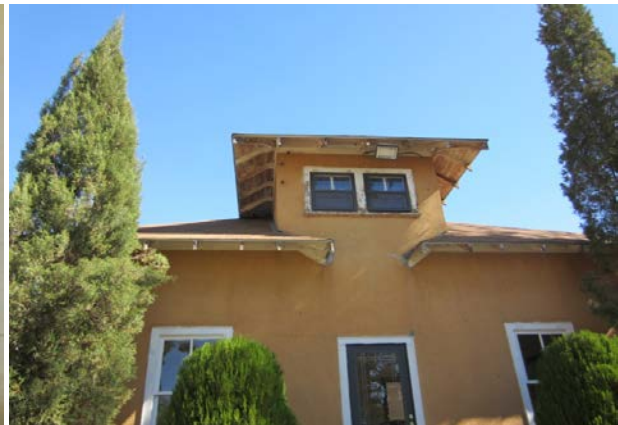
Figure 6 - Conference Building

- 100 year old adobe.
- Had flood irrigation damage in basement.
- Major cracks in stucco.
- Conference room is shifting both directions from center of room/fireplace area.
- Outside window frames and eaves need paint.
- Basement has been lifted with jacks and a steel I- beam installed where building was falling in.
- Major cracks in basement walls and floors.
- Attic is shifting both directions out from fireplace chimney.
- Windows and eaves need paint.
- Needs new windows.

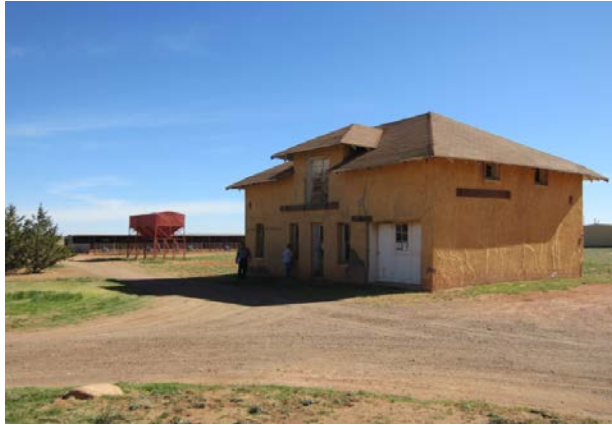
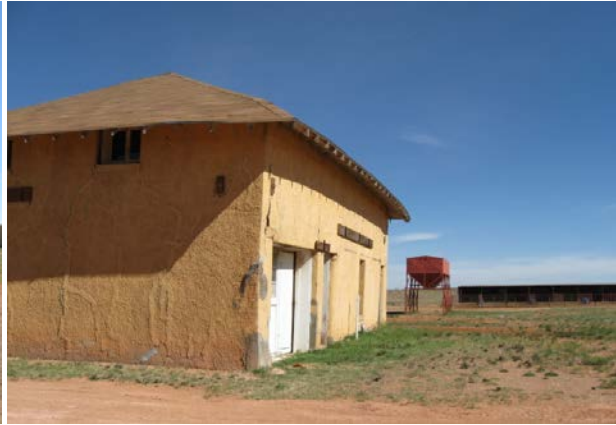
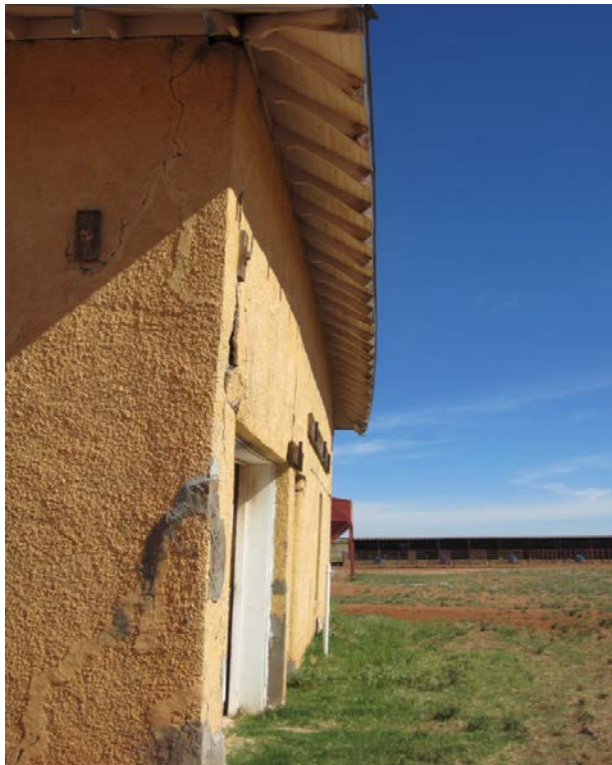
- 100 year old adobe.
- Major structural problems.
- Has been condemned.
- One side of barn is bulging out at least 2 feet.
- Someone has tried to reinforce it with cable inside to keep from falling over.
- Major cracks in stucco - stucco should not be used with adobe. Should have been re-plastered.
- Needs new windows.

The Horse Barn shown in figures 7, 8 & 9 is the most significantly deteriorated building on the property. The building is condemned and beyond repair. The building should be demolished and any current uses of the building relocated, or another facility will need to be built to accommodate current functions.
