Engineering Report

New Mexico State University
Auxiliary Services Drainage Concerns
Las Cruces, New Mexico

August 2013

PSC Project # 01891613

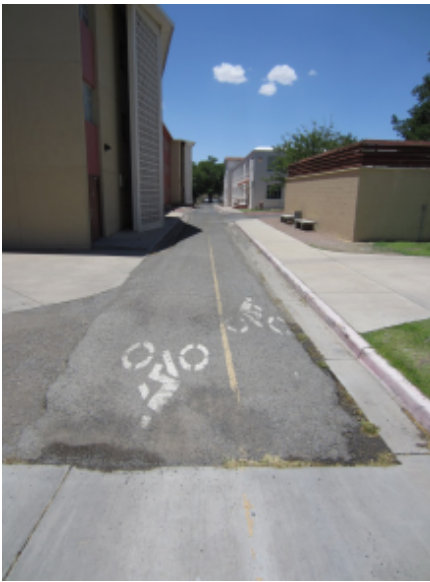
Figure 1-1

Ponding at this location occurs on the south side of the bike path near the intersection of the Lot 19 driveway. Due to repaving the path multiple times over existing pavement, the pavement section has been built up where the gutter now acts as a ponding location. The existing pavement in the area looks aged with portions breaking off. The existing curb and gutter look to be in good condition with minimal settlement, providing positive slope towards Jordan Road.

As mentioned previously, the bike path slopes from east to west but due to the buildup of pavement it cannot drain properly. The existing pavement and base course will need to be removed to allow for re-grading and repaving of the bike path. This includes the driveway which intersects with the bike path. The curb and gutter can remain in place due to its good condition. The new recommended bike path would have a reverse crown section, which would provide flow away from the adjacent buildings. This is approximately 570-square yards of new pavement. The proposed pavement section shall be 2-inches of HMAC, 6-inches of flexible base course, 6-inches of sub-grade. The new pavement section will transition to match with existing at Jordan Road. In addition, new curb and gutter shall be placed on the last 155-feet of pavement section to prevent further erosion from occurring and prevent the new pavement from prematurely deteriorating. A layout of project location is shown in Figure 1-2.

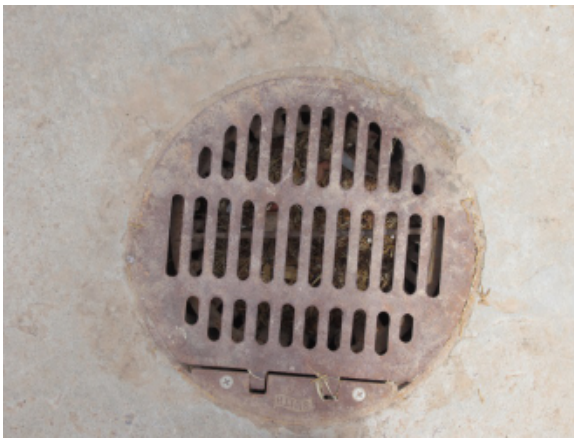
Figure 2-1

Memorial Stadium Field House is located north of Aggie Memorial Stadium and west of the Weight Training Center. The building has entrances on both the north and west side. These two entrances are 6-feet below the adjacent ground elevations. As seen in Figure 2-1, each entrance has a 1-foot diameter inlet grate with a sediment catch basin, connected to a 6-inch drainage pipe. Due to their locations the inlets are subject to a larger inflow of sediment. Upon opening each inlet, the catch basin was full of grass, leaves and sediment, as seen in Figure 2-2. We were unable to determine discharge point of the pipes, although it appeared both pipes were pointed in a northwest direction.

The existing inlet sizes can be increased to a 15-inch Neenah Foundry model 4370-4 floor grate or approved equal. This will increase the inflow capacity but in turn would increase the sediment inflow. We were unable to determine if the drainage pipes were clogged downstream, which could be a contributing factor. It is more economical to perform regular maintenance to the inlets to ensure the highest capacity is available during different storm events. If flooding occurs with maintenance of the inlets, additional study in the area is needed to determine.

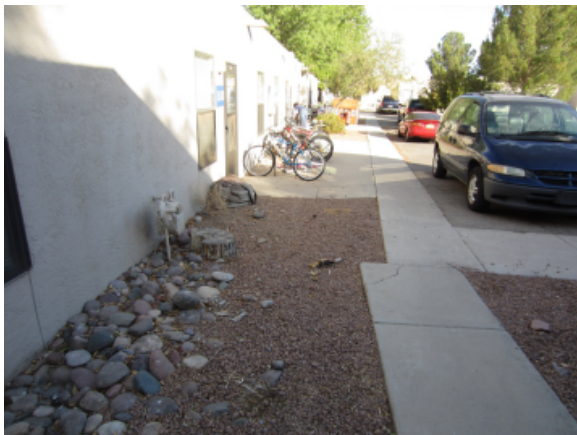
Figure 3-1

Ponding at Cervantes Village occurs near the entrances of apartment B-13 and B-14. The entrances to apartments B-13 and B-14 are at the same elevation of the adjacent parking lot if not slightly lower. To comply with building code, the sidewalk which connects to the apartment entrances slopes away from the door in turn creating a low spot between the building and parking lot. This is illustrated in Figures 3-1 and 3-2. Each entrance has a drainage area of approximately 4,000 square-feet or 0.09 acres. Based on the City of Las Cruces Runoff Analysis, each entrance currently receives 0.30-cfs of runoff. Due to the existing higher grades surrounding the building, the drainage area will not drain the water to the designated landscape area/ponding area via surface flow in the neighboring parking lot.

To alleviate the ponding created at each location would require the addition of an inlet with a minimum capacity of 1-cfs at each low spot, which would allow for a 50% clogging factor and still have the capacity to drain the 0.30-cfs flow in these areas. The inlets would be connected to a 6-inch pipe which would run 10-feet straight to the parking lot and make a 90-degree turn and run 60-feet to the existing landscaped area. The pipe would run at a ½-percent slope to minimize depth of pipe. The inlets will have the capability to drain to a proposed 16'L x 8'W x 8'D French drain system located in the adjacent landscaped area. The landscape area will provide enough distance from the buildings to avoid any potential effect on the building foundations. A layout of inlet and pipe system can be seen in Figure 3-3.

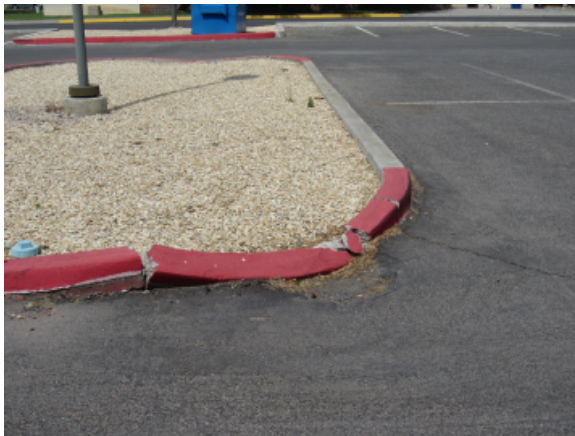
Figure 4-1

During our site investigation, we were able to identify three ponding locations within Lot 79W. Location No. 1 is near the center of the lot where the pavement and curb for the island have settled, which can be seen in Figure 4-1. Water that has ponded at this location has caused the curb to settle allowing for a larger ponding area along the curb section. Location no. 2 is a curb section that has broken and started to settle surrounding the northern most center islands, which can be seen in Figure 4-2. The settling curb creates multiple locations for water to pond preventing it to flow downstream. Location No. 3, is the corner of the first parking stall, just south of the north entrance, off Williams Street, which is seen in Figure 4-3. The lot was graded to push the water towards the corner of the parking stall which has nowhere for it to exit.

All three areas mentioned above can be easily repaired. Lot 79W provides plenty of east to west slope to provide positive drainage to Williams Avenue. Location No. 1 requires the replacement of approximately 12-feet of curb and a 12x3 foot section of pavement. When the pavement and curb are removed, the contractor will be required to re-grade and re-compact the base course layer to ensure positive slopes along the curb and to prevent settlement from occurring. When this is complete the new curb and pavement can be placed.

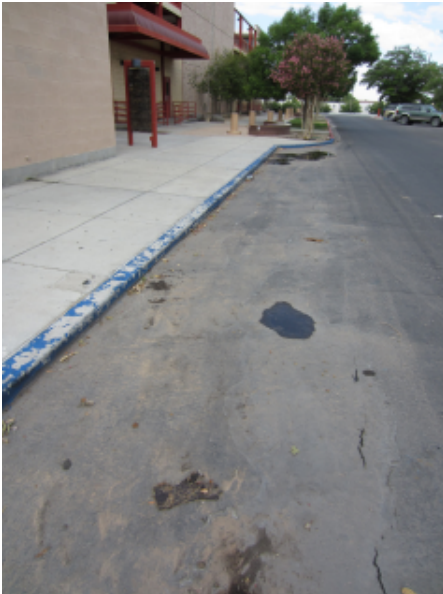
Figure 5-1

Ponding occurs on the lot near the drop-off area/handicap entrance on the south side of the lot, as shown in Figure 5-1. The existing pavement section has little to no slope on it. The portion of pavement which has minor slope, heads towards the existing curb. Few corrective adjustments can be made in this area due to its connection to an accessible ramp.

To provide positive drainage in this area, we recommend a connection between the two existing gutters with a lay down curb and gutter. The lay down curb and gutter will collect water and transport it west to the existing curb and gutter. In addition the 8'x65' drop off pavement section will need to be removed and replaced. The proposed pavement section shall be 2-inches of HMAC, 6-inches of flexible base course, 6-inches of sub-grade. In total there will be 65-feet of lay down curb and gutter and 58-square yards of pavement replaced.

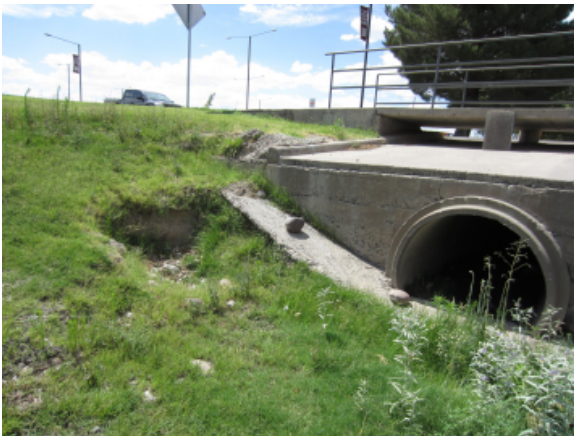
Inspection of the channel shows no significant erosion along the channel. The main erosion concern is located at the outlet of the culvert structure just south of Stewart Street. In Figure 6-1 and 6-2, although it is hard to see through all the vegetative growth, 0.5 to 3-feet of erosion has occurred at the discharge location. The erosion is being assisted from runoff of sprinkler water draining off the side slopes from adjacent grassed areas.

To prevent future erosion it is recommended that first the outlet be re-graded to 1-foot below the existing culvert outlet elevations. The area to be graded is approximately 25'x35'. When grading is completed a 35-foot long, 9-foot wide and 1-foot deep gabion mattress shall be placed as a preventative measure for future erosion. A layout for the gabion mattress is shown in Figure 6-3.

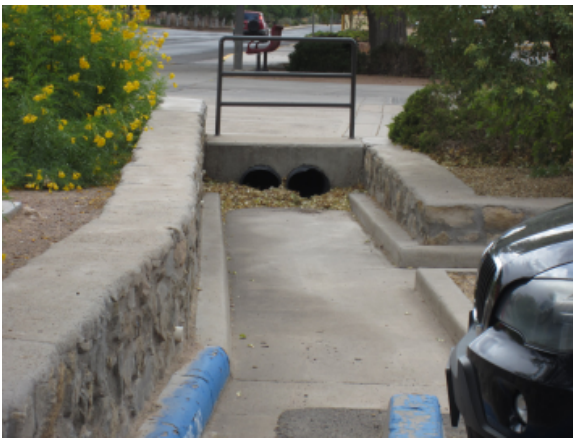
Figure 7-1

Lot 59 is adjacent to the Central Heating Plant and runs along Sweet Avenue and Stewart Street. The lot drains from northeast to southwest, where it is collected by a concrete flume which transports it to dual 12-inch HDPE pipes, as seen in Figure 7-1. Based on site observations, we were unable to determine where the water drained to once it entered the pipes. Inspection of the pipes showed no sediment buildup.

To prevent future ponding in this area, it is recommended that a 25'x20' segregated pavement section be removed and replaced. A schematic of the proposed improvements can be seen in Figure 7-3. The section will be located 10-feet east of the concrete flume entrance. In addition, existing gutters will need to be maintained and cleared out on a regular basis. Although the gutters have sufficient slope, sediment buildup will still occur in this area and needs to be maintained.

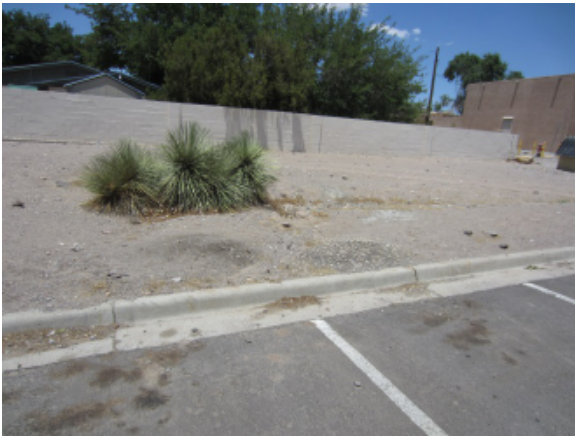
Figure 8-1

Lot 20 drains through a dirt field west of the lot before it discharges into Lot 19. As it goes through the dirt lot, runoff causes a lot of erosion and forces sediment into Lot 20. This can be seen in Figure 8-1. Rock riprap had previously been placed where the pavement and dirt lot intersect, all of which now has been eroded and pushed downstream or has been covered in sediment. In addition multiple wheel stops have been pushed down stream to the dirt lot. The erosion effects can be seen in Figure 8-2.

In order to prevent further erosion from occurring, PSC recommends that a curb and gutter that connects to a concrete flume be placed on the west border of Lot 20. Water which normally drains through the lot will collect along the curb and gutter, and be directed south through the concrete flume into Lot 19, without collecting sediment from the dirt lot. Once the water hits Lot 19 it will continue to drain downstream through the curb and gutter in Lot 19. To capture all the water, 50-feet of curb and gutter would be required. The concrete flume would measure 7-feet long, 2 feet wide and have a depth of .5-feet. A layout of improvements can be seen in Figure 8-3.

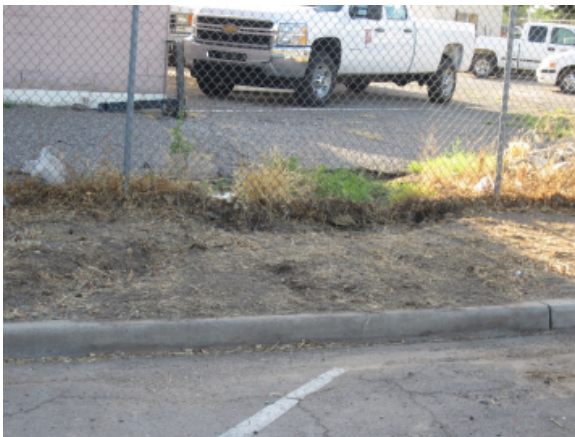
Figure 9-1

Lot 72 is located south of the Clinton P. Anderson Physical Science Lab (PSL) and west of Physical Science Laboratory Fabrication Shop. Lot 72 collects runoff from the western portion of the PSL complex and from its own lot. Due to security reasons, we were unable to examine the PSL complex to determine the extent of the drainage area. Runoff from PSL that drains to Lot 72 has caused vegetative overgrowth and erosion. This occurs at four locations throughout the lot. During our recent site visits, maintenance department had recently removed the majority of vegetative growth but erosion flow paths can still be seen as in Figure 9-1.

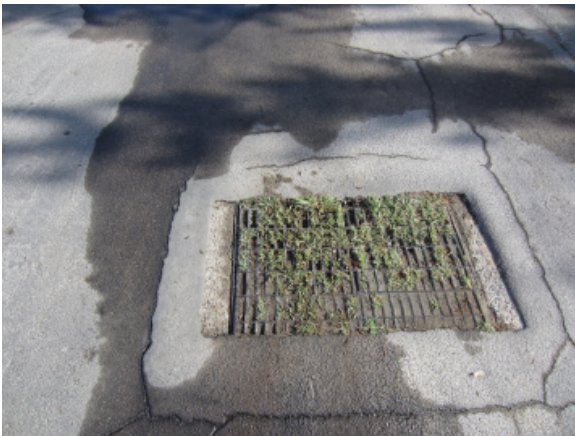
Figure 10-1

Based on observations made during our site visits, existing ponding is caused by two factors. First, is the minimal or no maintenance at the drainage inlet. It seems that since its original installation, the inlet grate has collected soil and has started to produce vegetative growth. As shown in Figure 10-1, the inlet does not perform at its full capacity and runoff passes by and continues down the parking lot. Secondly, when runoff flows to the northwest portion of the parking lot it ponds in multiple locations. These smaller ponding areas are caused by low spots formed from repaving over the existing pavement without proper re-grading of the area to account for any settlement which might have occurred. You can see multiple ponding areas in Figure 10-2. It is difficult to determine how much water reaches the flume, but a large amount of the runoff ponds until it is high enough to be pushed down stream.

To alleviate ponding in Lot 75, two items need to be addressed. First, the existing drainage inlet needs to be cleared of all existing sediment, so it can assist in the collection of runoff. When comparing the existing inlet grate cover to grates of similar size and slot opening, a clean grate cover has a drainage capacity of 1 to 4 cfs. To collect runoff that passes the grate, a 35x70 foot pavement section will need to be removed, re-graded and replaced. The pavement section is located adjacent to the inlet grate and will run 35-feet east and 70-feet north. The replacement section will be bordered north and west of with curb and gutter. The new pavement section will provide positive slope to the existing curb and gutter, where it will drain west to the drainage flume.

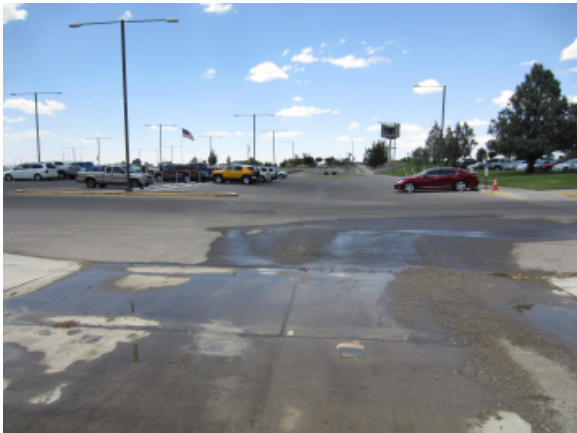
Figure 11-1

Ponding occurs just north of the entrance of the concrete culvert, as shown in Figure 11-1. Based on site observations, a 55x55 foot section of parking lot was replaced and has since experienced more deterioration due to onsite ponding. When the section was repaved, new pavement was placed over existing pavement without re-grading the affected area prior. Settlement of the existing pavement was not accounted for and low spots were created in the section. This can be seen in Figure 11-2. Figure 11-3 shows an aerial plan view of the affected area.

To relieve ponding on Lot 27, the existing 55x55 foot pavement section needs to be replaced. The replacement of the section will consist of removing the existing pavement, re-grading the base course and repaving. Due to the positive slope in the neighboring pavement sections, only minor regrading will need to occur to ensure low spots are not created.

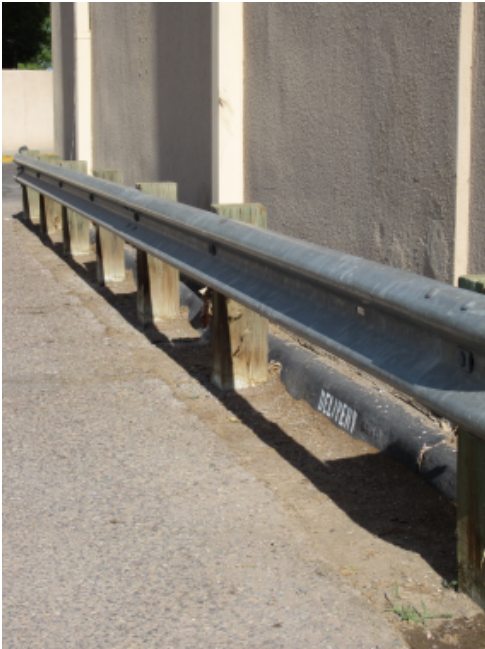
Figure 12-1

The entire lot is cracked and deteriorating with visible areas of where multiple repair patches have occurred. Based on our site visit, water ponds at two locations on the lot. The first ponding area is located near the accessible parking space adjacent to Wooton Hall. This ponding area is caused by a pavement repair patch which was placed at a higher elevation than the surrounding pavement, preventing runoff from draining towards Knox Street. The second ponding location is at the southern intersection of Gerald Thomas Hall and Lot 64. This can be seen in Figure 12-1. A wood/steel impact barrier was placed within the gutter to prevent vehicle impact from oncoming traffic. The wooden post placed in the gutter prevents runoff from flowing through unabated. In addition, PSC noticed that multiple layers of pavement have been placed throughout time to where the top of pavement is at a higher elevation than the gutter. To alleviate ponding in Lot 64, three construction options can be completed.

Option 1 consists of removing the existing pavement and re-grading, compacting the existing base course, and repaving the entire lot. Based on the existing physical condition of the existing pavement in the lot, the pavement will need to be replaced in the near future, if not continuous cracking and settlement of the pavement will continue to cause many future ponding issues. Due to the positive natural slope in the lot, repaving the area would allow water to drain to Knox St. The total amount of repaving would be 3,800-square yards.

Option 2 consists of removing the existing pavement repair patch and re-grading the area so it matches up with existing pavement. This is a minor fix that will prevent water from ponding behind the accessible parking spots. The proposed pavement patch would measure 20’x9’ or 20-square yards of pavement. This can be done in conjunction with Option 3.

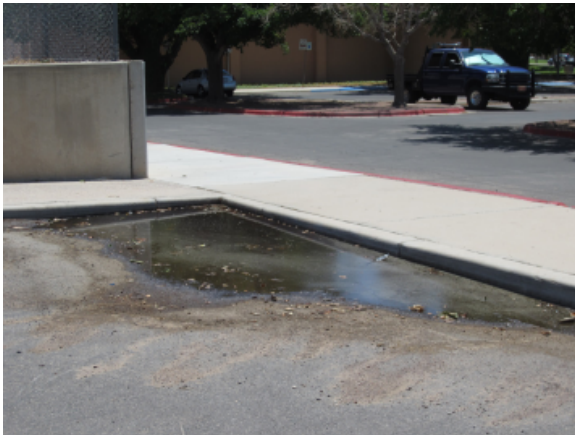
Figure 13-1

We were only able to identify ponding at one location of the lot near the intersection with Lot 100. As shown in Figure 13-1, settlement of the pavement and gutter is preventing water from draining north out of the parking stalls. Due to being inundated with water, we are unable to report on the condition of the pavement. The settlement of the curb is shown by adjacent settlement of the pedestrian sidewalk.

To alleviate the creation of the ponding area would require re-grading the subgrade beneath the pavement and curb and gutter. A 10'x18' section of pavement and 18-feet of curb and gutter (9-feet on each side of the corner section) would need to be removed and replaced. This can be seen in Figure 13-2.

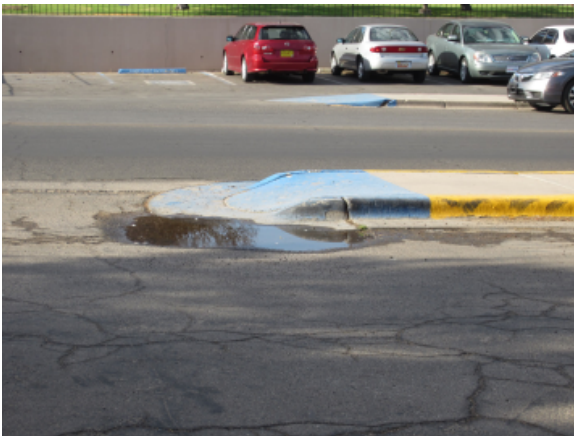
Figure 14-1

The existing pavement in the lot however looks old with many cracks and some settlement occurring in a few locations. This can be seen in Figure 14-1, where settlement has occurred in the pavement near the curb and gutter on the west side of the lot. To alleviate ponding in Lot 74, two construction options can be completed.

Option 1 consists of removing the existing pavement, perform minor grading to remove the single low spot seen and repave the entire lot. Due to the positive natural slope in the lot, removing the lot spot would allow water to reach the curb and gutter which drains to Gregg St. Due to the excessive cracking in the existing pavement, repaving of the lot will be required in the near future. The total amount of repaving would be 750-square yards.

Option 2 consists of removing and replacing the 6'x6' pavement section, shown in Figure 14-2, and re-grading it to provide positive drainage slope. This provides an economic solution for the ponding in Lot 74, but due to the condition of the adjacent pavement, settlement may begin to occur in other locations. The opinion of probable cost for Options 1 and 2 are provided in Appendix A.

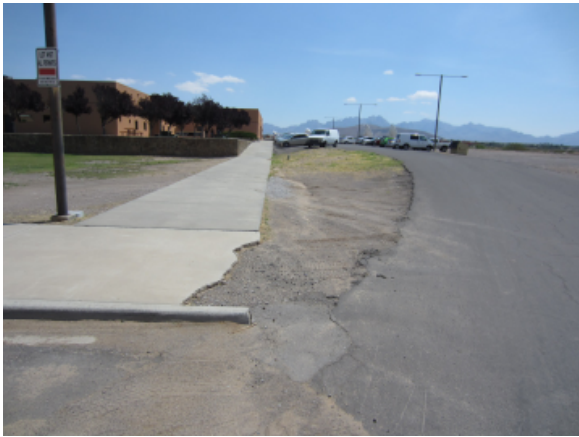
Figure 15-1

On average, Lot 97 is 2 to 4-feet higher than Lot 77A. Due to the elevation differences in the area, runoff from Lot 97 tends to cause drainage problems within Lot 77A. As seen in Figure 15-1, runoff from Lot 97 is deteriorating the edge of road pavement and concrete sidewalk located adjacent to the Academic Research building. In addition, sediment is being transported to Lot 77A, as seen in Figure 15-2. In order to prevent this from happening, two construction options can be implemented.

Option 1 consists of placing a new curb and gutter at the intersection of Lots 77A and 97, which will provide a barrier between the two lots and reduce the amount of sediment transport and pavement deterioration. In total 600-feet of curb and gutter will be added to Lot 77A. In addition, due to the excessive cracking in the pavement, re-pavement of the lot will be needed in the near future.

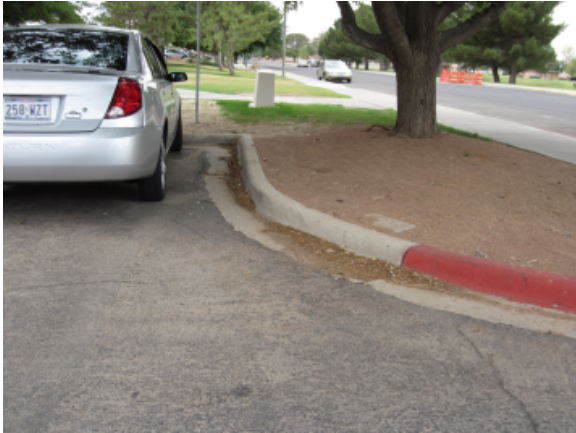
Figure 16-1

Ponding occurs in the existing parking stalls adjacent to the building. Based on site observations, the lot has been repaved multiple times without the removal of existing pavement prior to repaving. This has caused the new pavement's finished grade to be higher than the curb and gutter system. This creates a ponding area at the curb and gutter since the water cannot drain, as can be seen in Figure 16-1.

To relieve ponding on Lot 48, the pavement of existing parking stalls adjacent to Rentfrow gym need to be removed, regraded and repaved. The two parking sections measure 150'x30' and 55'x30' from west to east respectively. The new pavement sections will be graded to match existing gutter elevations. This will prevent water getting trapped within the gutter. The proposed pavement section shall be 2-inches of HMAC, 6-inches of flexible base course, 6-inches of sub-grade. In addition, a 10-foot section of curb and gutter will need to be replaced, due to uplifting of the curb. The extents of pavement and curb replacement are shown in Figure 16-2. In addition to pavement replacement, the existing gutters need to be cleared out of all existing debris.

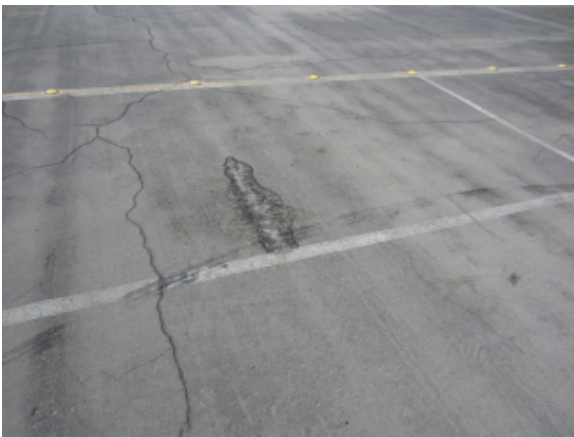
Figure 17-1

During our site visit we were able to determine the drainage flow path, and determined that ponding tends to occur in the middle of the lot. This was determined when we noticed the many areas that showed cracking and deterioration of the pavement, as seen in Figure 17-1. Preliminary elevations points were taken by PSC and they revealed that the lot has an average slope of 0.40% from north to south. Wells Street to the south and the dirt lot to the east have approximately the same elevation as the lot, so changes in the lot elevations must be done minimally to minimize decreasing the existing slope.

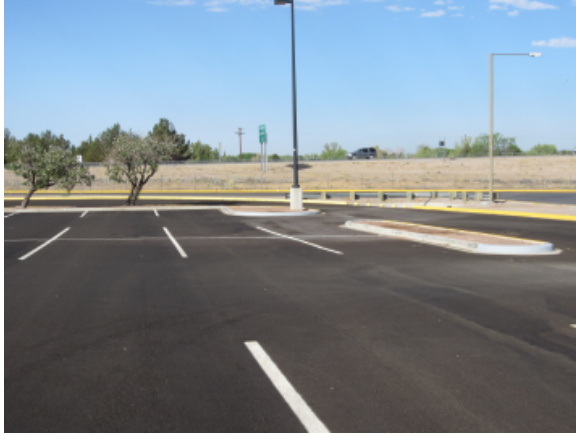
Lot 70 is located east of the Dona Ana Community College – Central Campus near the intersection of Gregg St. and Sam Steel Way. Comparing original photos to the ones taken on our site visit on July 2, 2013, we determined the parking lot had recently been repaved. In Figure 20-1 you can see water marks on the pavement which indicate existing drainage heads towards the inlet in the east corner of the lot with no problem. Based on our findings no action is required at this location.

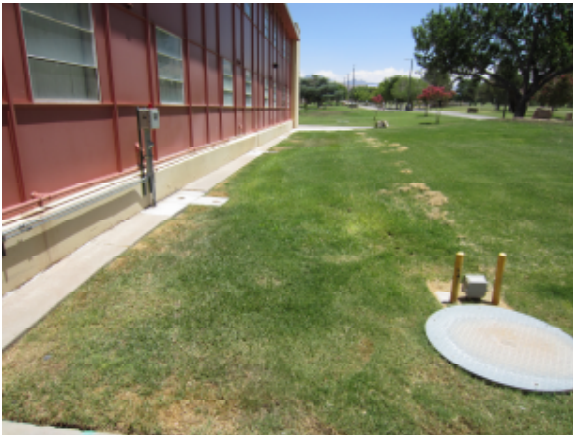
Figure 21-1

It can be seen in Figure 21-2, that concrete was recently replaced on the east end of the building and created a low spot where the landscape and sidewalk meet. Continuous ponding at this location has caused settlement of the concrete splash pads next to the building. Location and orientation of the pictures below can be seen on Figure 21-3.

To prevent ponding at this location would require the addition of a concrete valley gutter, and the removal and replacement of the sidewalk adjacent to the landscape area. The layout for the concrete valley gutter is shown in Figure 21-3. The valley gutter would run from the connection to the sidewalk 70-feet east make a 45-degree bend and continue 45-feet southwest to the existing sidewalk in front of the main entrance. The purpose of the 45-degree bend is to avoid disturbance of the existing sewer lift station. The gutter would be 3-feet wide with a depth of 4-inches. Where the proposed gutter outlets to the east, a 27'x7.5' section of sidewalk will need to be removed and replaced to match the slope of the existing valley gutter and the existing sidewalk to the east.
