WOOTON HALL COLONNADE REPAIR

CONTRACT NO:12805B23D0001

RANGE MANAGEMENT RESEARCH LAS CRUCES, NEW MEXICO

100% DESIGN SUBMITTAL

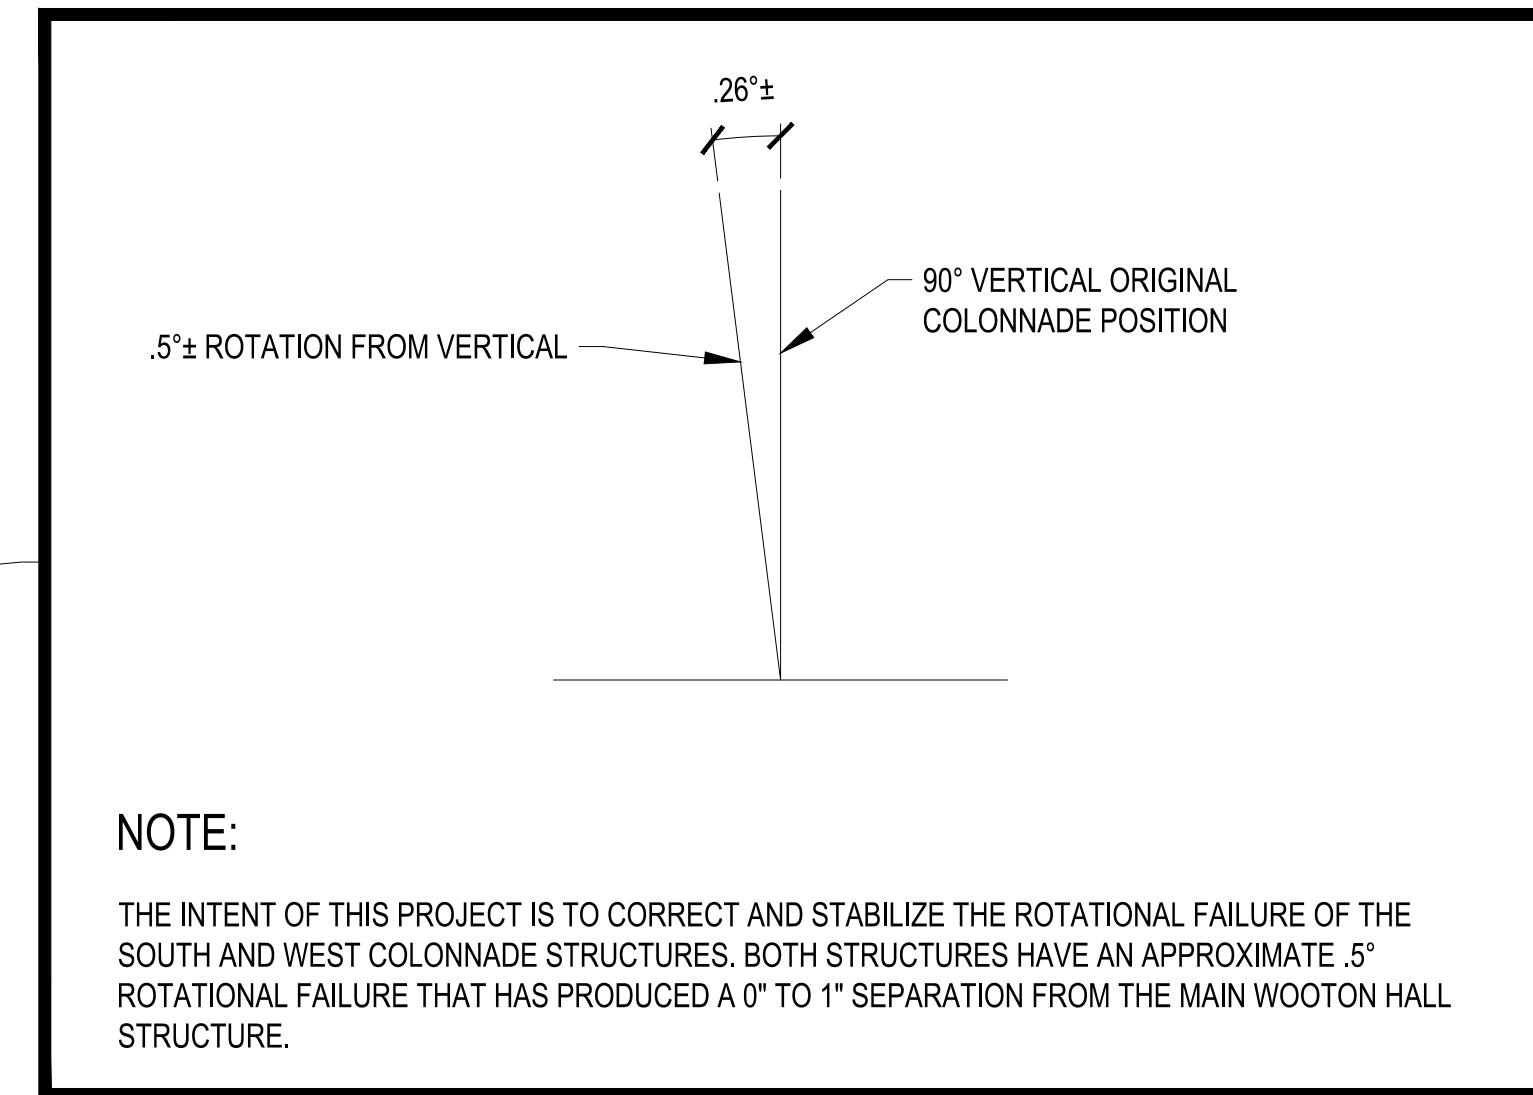
1 EXISTING COLONNADE SECTION
SCALE: 1" = 1'-0"

NOTE:
THE INTENT OF THIS PROJECT IS TO CORRECT AND STABILIZE THE ROTATIONAL FAILURE OF THE SOUTH AND WEST COLONNADE STRUCTURES. BOTH STRUCTURES HAVE AN APPROXIMATE .5° ROTATIONAL FAILURE THAT HAS PRODUCED A 0\"/>

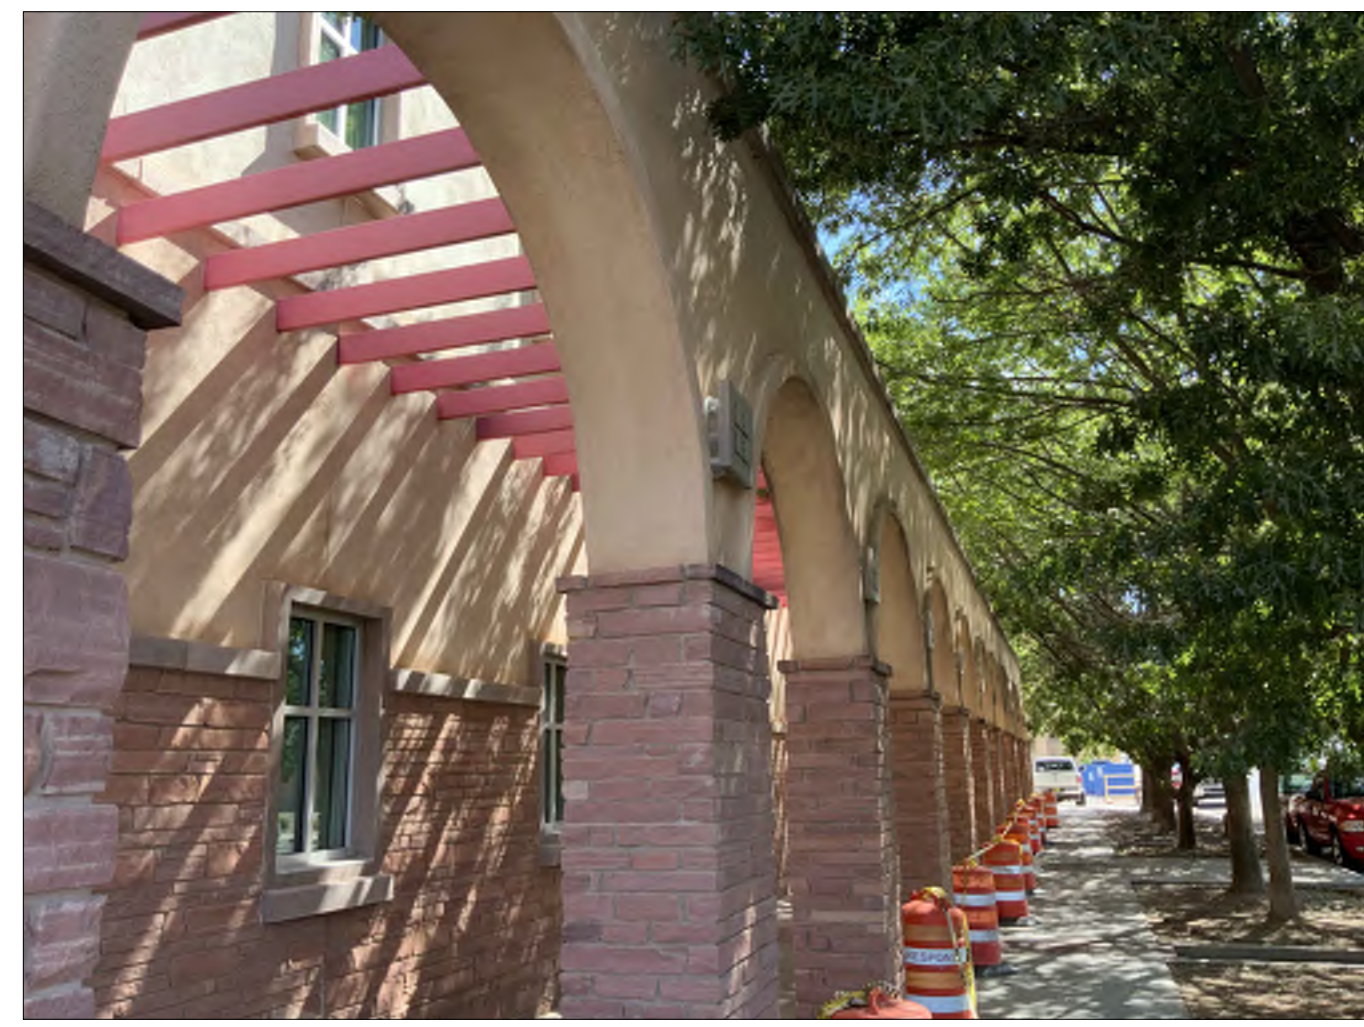
S-1 LOOKING EAST

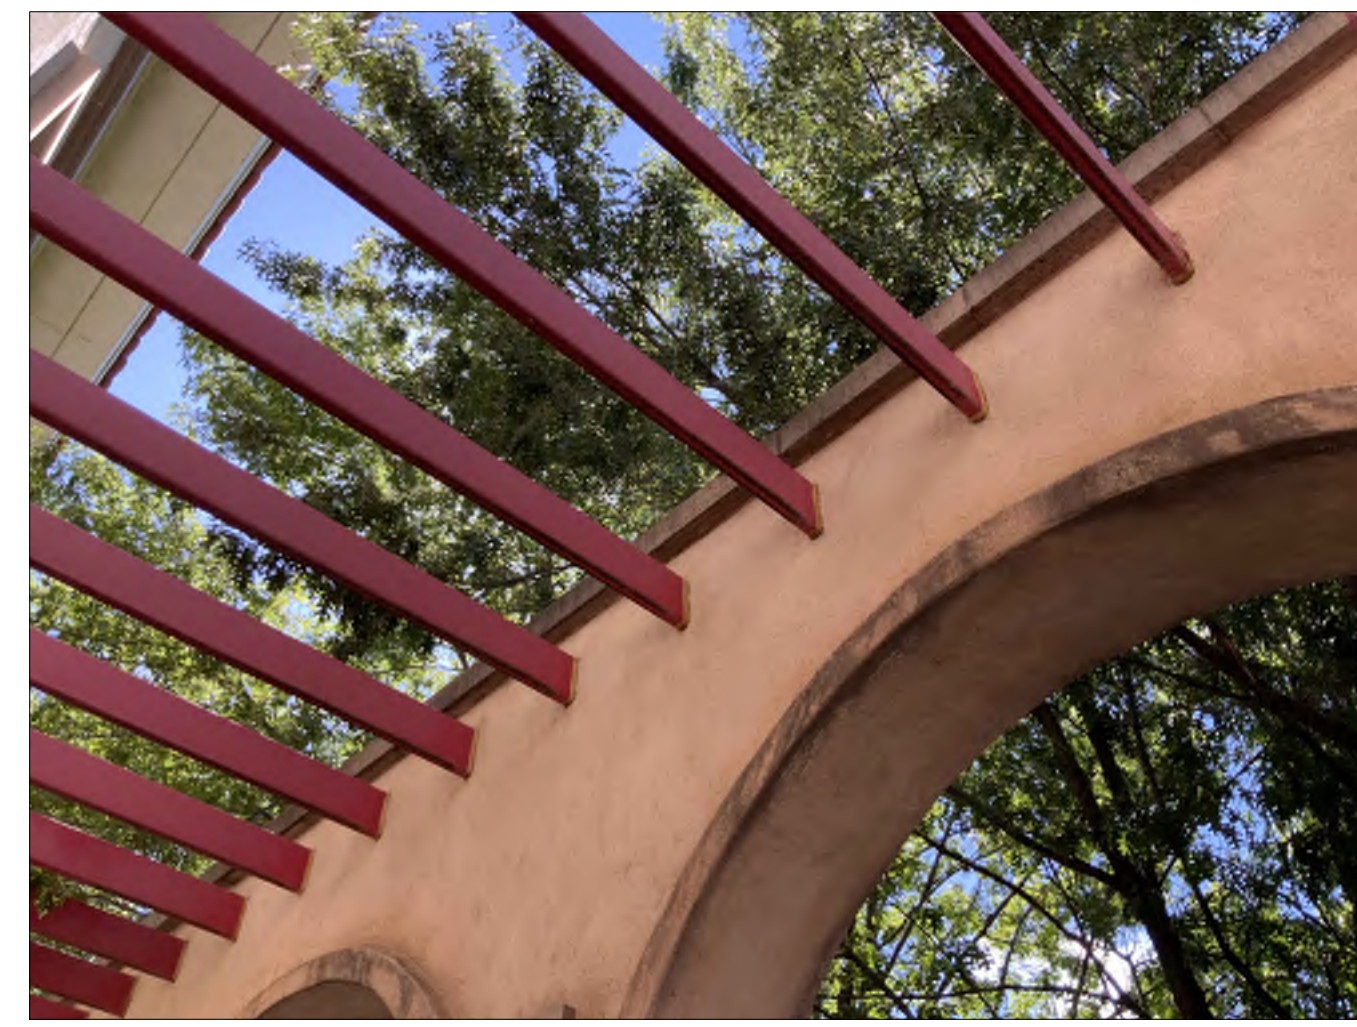
S-3 LOOKING AT TRELLIS BAR SEPARATION

NOTE:
ORIGINAL DESIGN DOCUMENTS INDICATE THAT THE TRELLIS MEMBERS ARE ANCHORED TO STEEL PLATE AS SHOWN. SITE FIELD INVESTIGATION REVEALS THAT, IF THE MEMBERS WERE INSTALLED AS DESIGNED, THE CONNECTION HAS FAILED. SEE PHOTOGRAPH S-3 ON SHEET AD201.

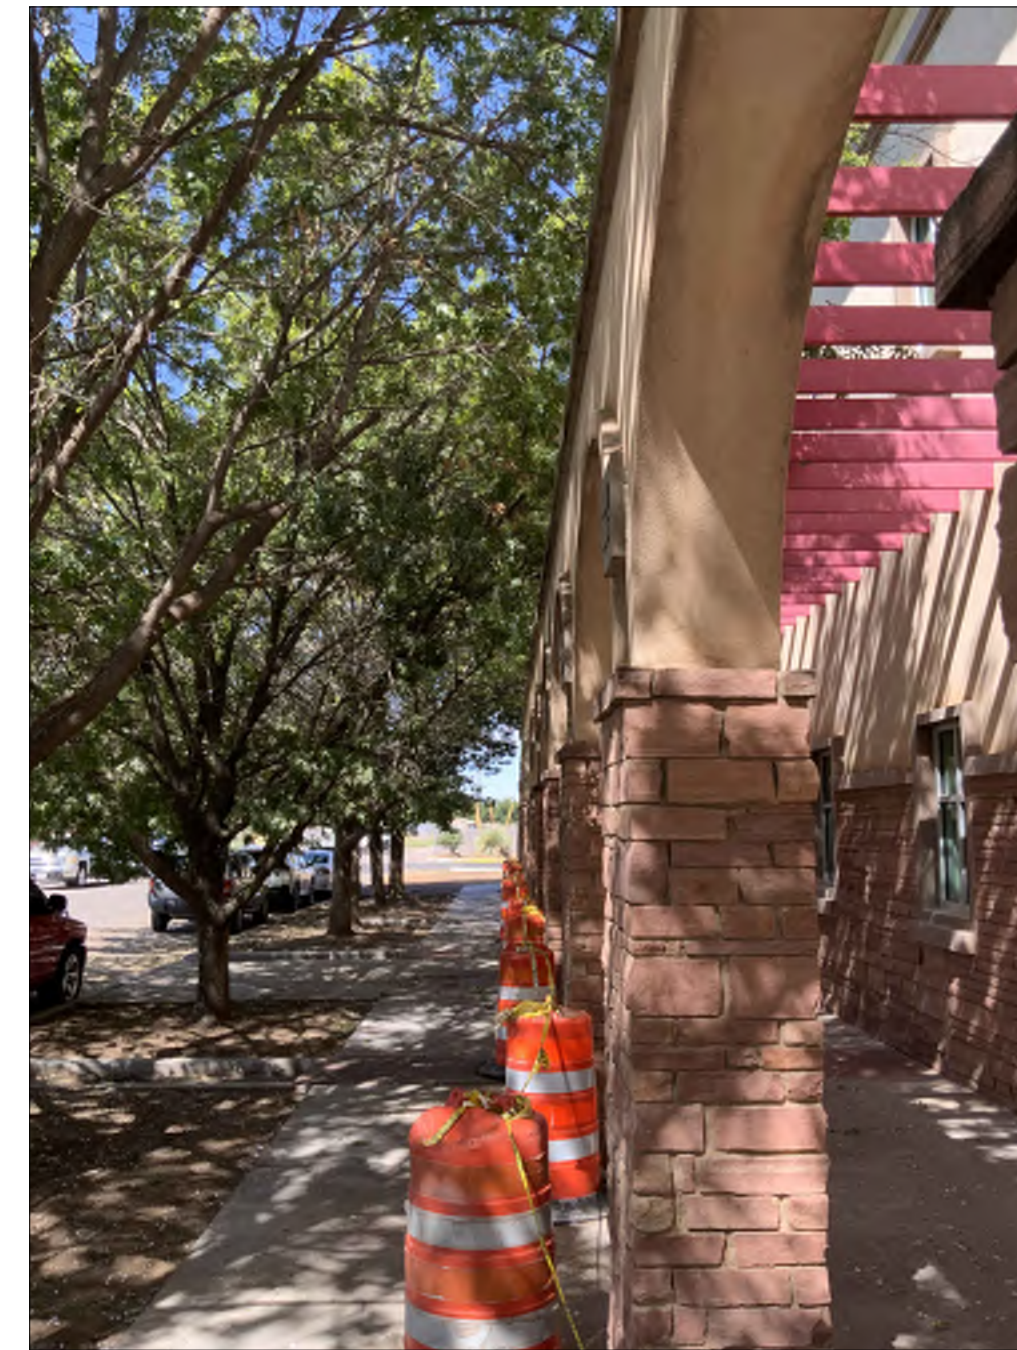
S-6 LOOKING WEST

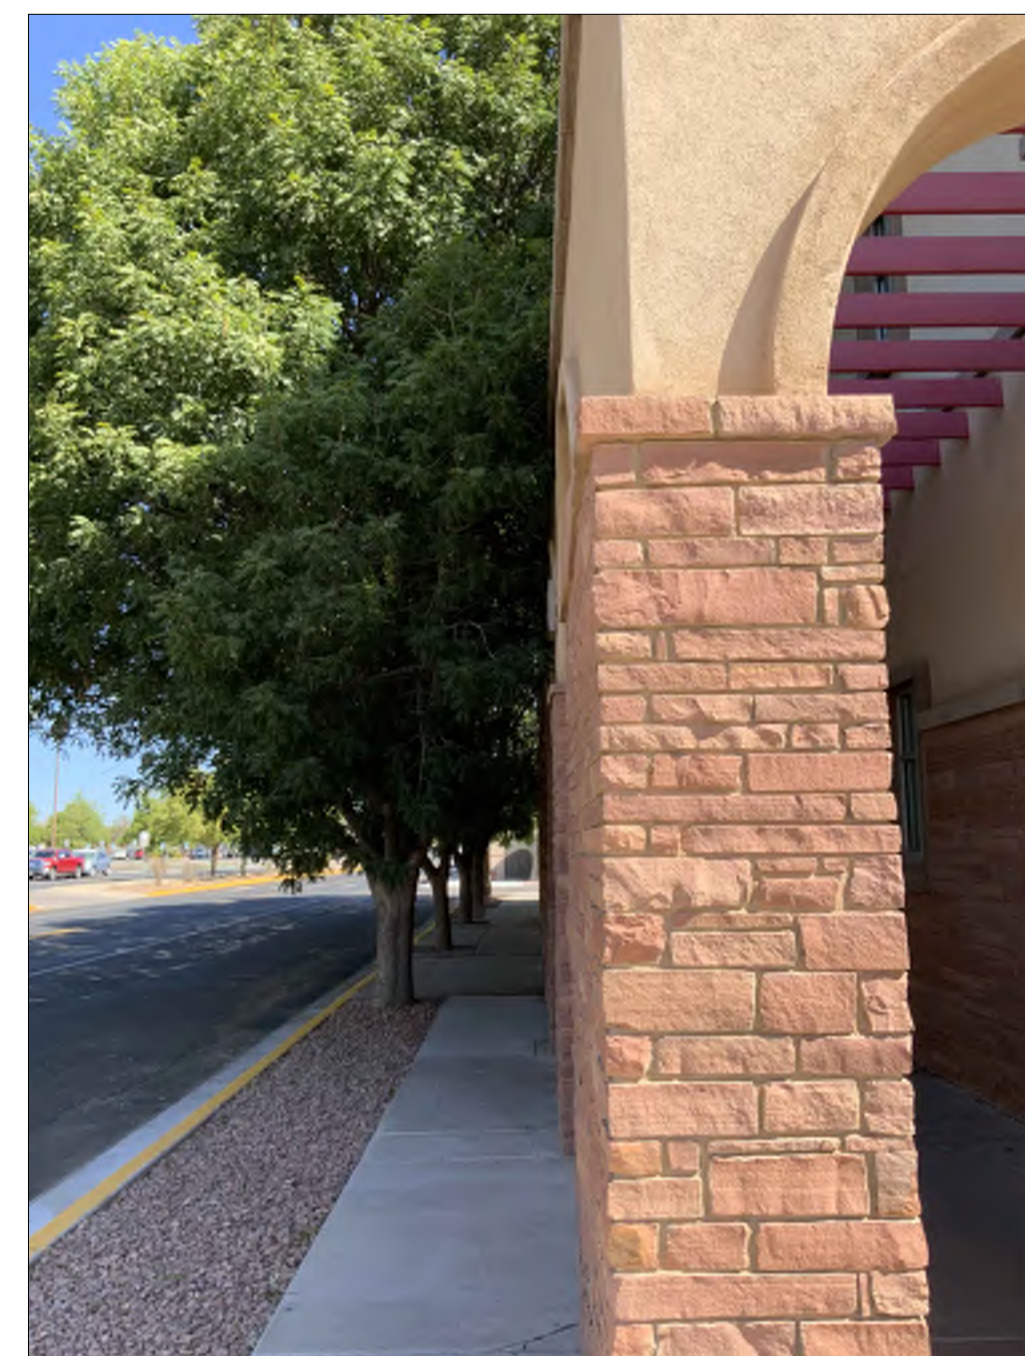
W-1 LOOKING NORTH

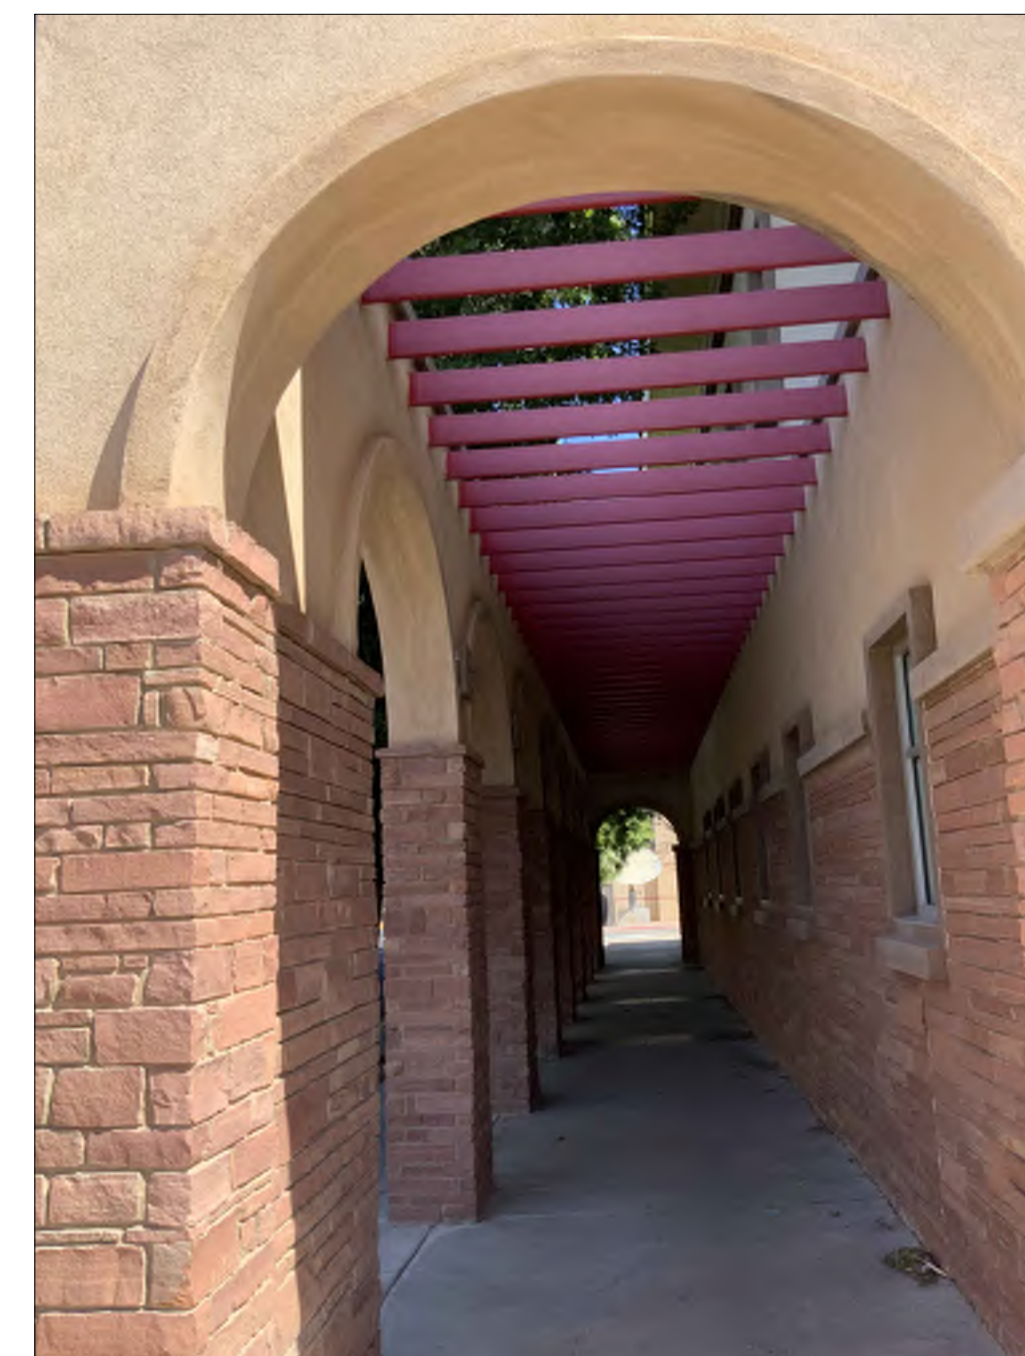
W-2 LOOKING NORTH

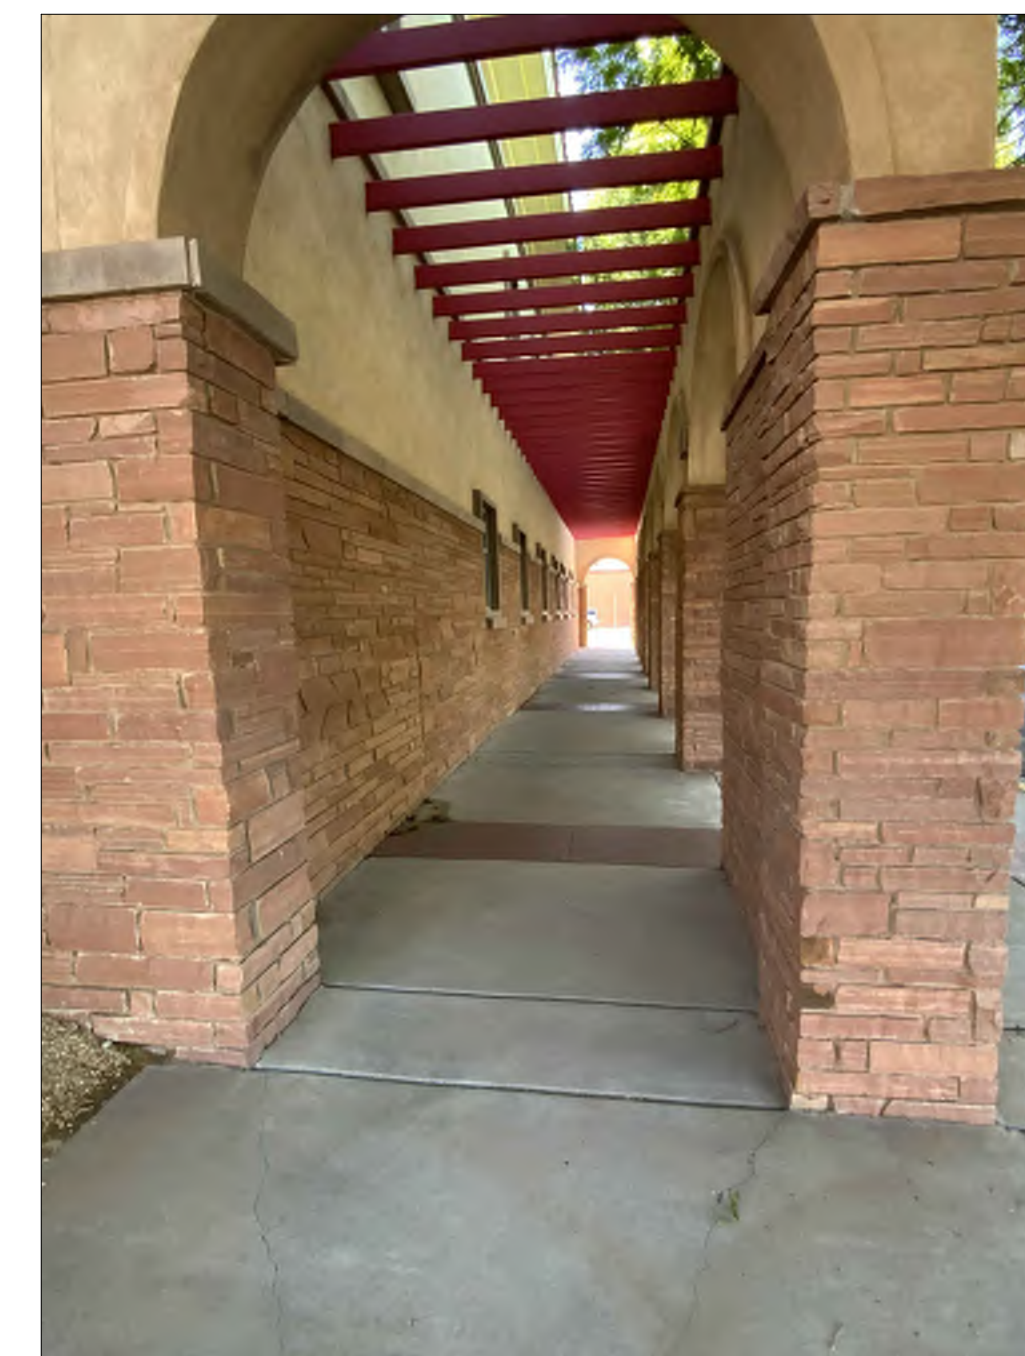
W-4 LOOKING SOUTH
