The following is an assessment of six Agricultural Experiment Stations
April 23 – 26, 2012.

Alcalde Agriculture Science Center

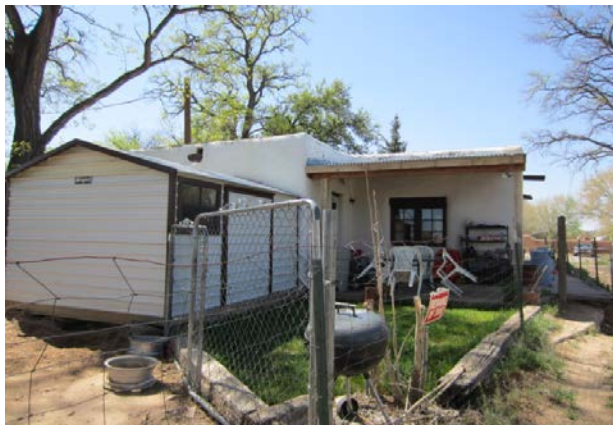
Figure 11 - Superintendents Home

As is shown in the pictures above, the historic barns, now shop storage buildings (Figures 7 & 8) are in need of significant repair or replacement. The exterior adobe walls are in poor condition, show significant signs of displacement, and the roofs and gutters need to be replaced. The superintendent' house (Figures 11 & 12) needs to be re-plastered as well as replacing the roofs. The irrigation canal (Figure 9) has eroded and the adobe fence next to it has collapsed. The exterior wall (Figure 8) surrounding the property is also deteriorating due to poor drainage of the main street next to it.

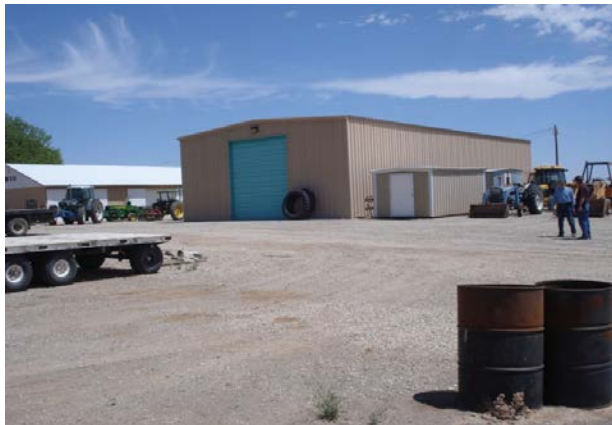
Figure 11 – Shop 2

The ranch manager's house shown above in the top two photos is in need of complete refurbishment. There are concerns with vinyl asbestos tile (VAT) throughout the building, mold, kitchen upgrades and whether this building is worth saving (Figures 7- 9). The other photos include the major shop buildings on site that are in relatively good shape (Figures 11 & 12). The lack of footings and erosion under the side walls of one of the shop buildings is a concern (Figure 10).

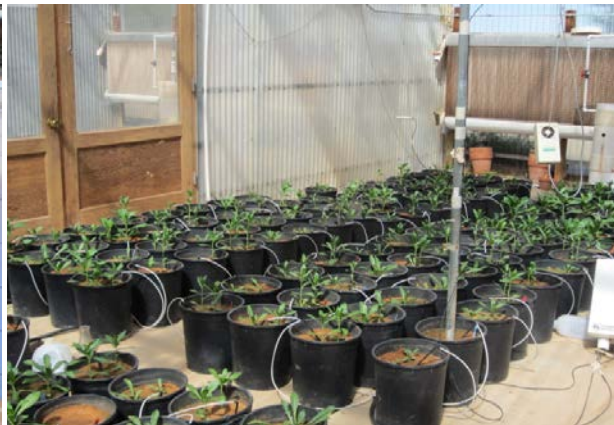
Figure 6 - Greenhouse

- **Water**-both wells domestic and irrigation are drying up.
- More receptacles in module part of office.
- Repair the greenhouse issues.
- Adding on to the Shop.

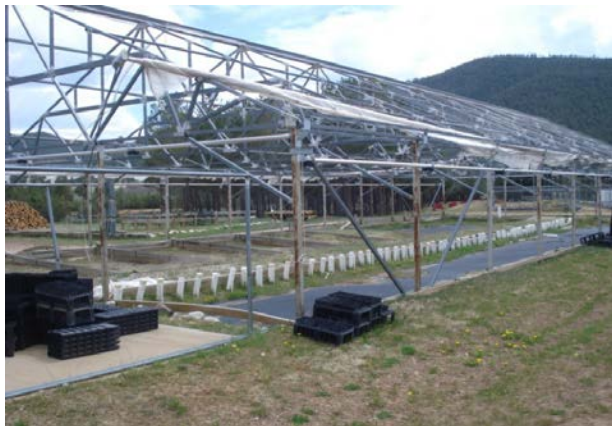
Figure 5 - 2nd Greenhouse

Greenhouses: #334B – (Figure 5)
