Engineering Report

New Mexico State University
Auxiliary Services Drainage Concerns
Las Cruces, New Mexico

August 2013

PSC Project # 01891613

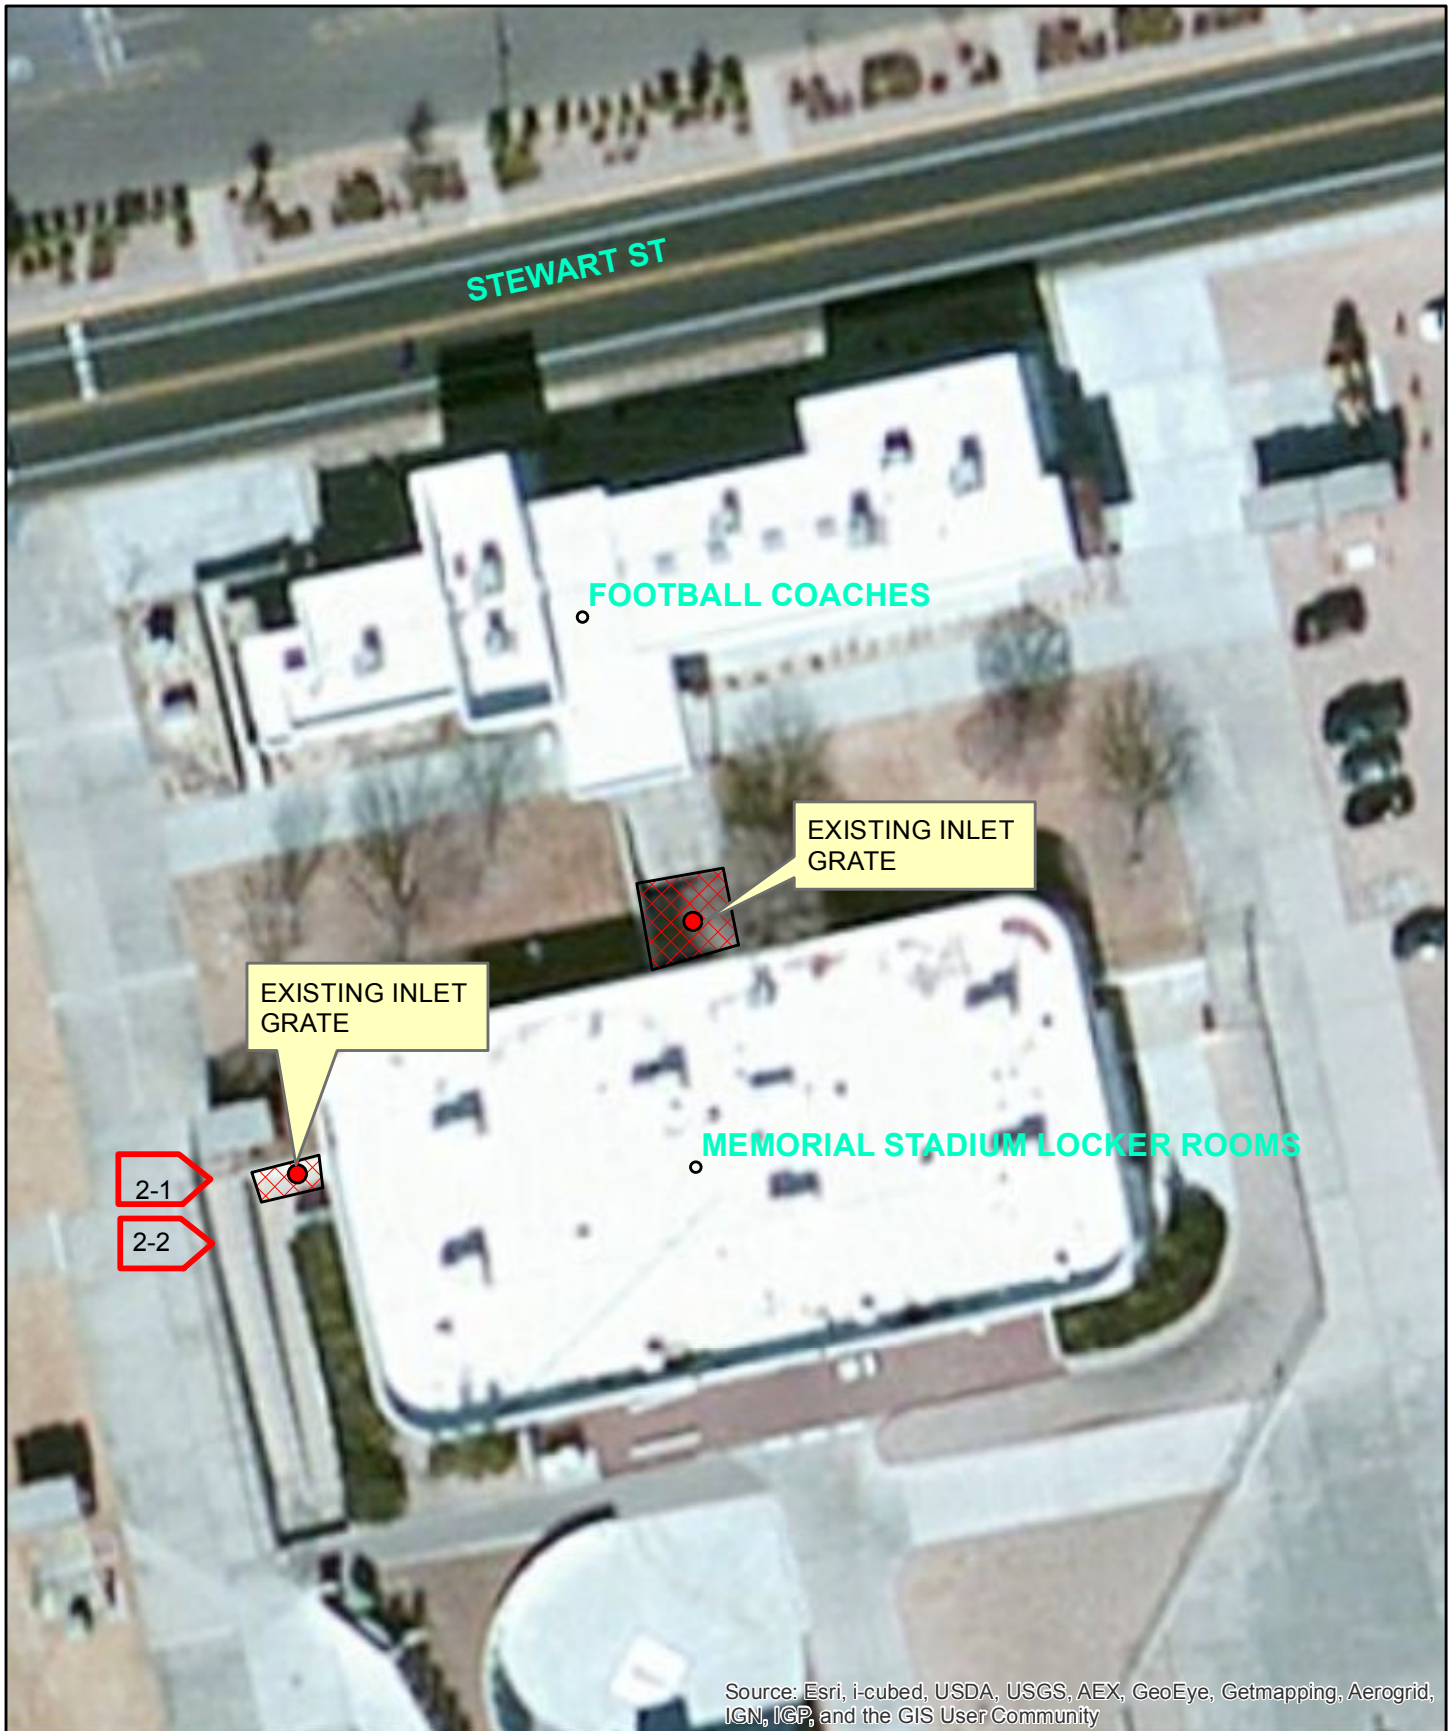
FIGURE 2-3

Based on City of Las Cruces Runoff equations, the north inlet has a drainage area of approximately 900-square feet or 0.02-acres which equals a peak flow rate 0.07-cfs. The west inlet has a drainage area of 1,733-square feet or 0.04-acres, which equals a peak flow rate of 0.13-cfs. Based on comparisons to inlets of the same size and grate opening from the Neenah Foundry website, the existing inlets should have a capacity of 0.2 to 0.3-cfs. Taking into consideration a 50% clogging factor consideration, the inlet and pipes with proper maintenance should be able to handle flows produced by these two drainage areas.

The existing inlet sizes can be increased to a 15-inch Neenah Foundry model 4370-4 floor grate or approved equal. This will increase the inflow capacity but in turn would increase the sediment inflow. We were unable to determine if the drainage pipes were clogged downstream, which could be a contributing factor. It is more economical to perform regular maintenance to the inlets to ensure the highest capacity is available during different storm events. If flooding occurs with maintenance of the inlets, additional study in the area is needed to determine.

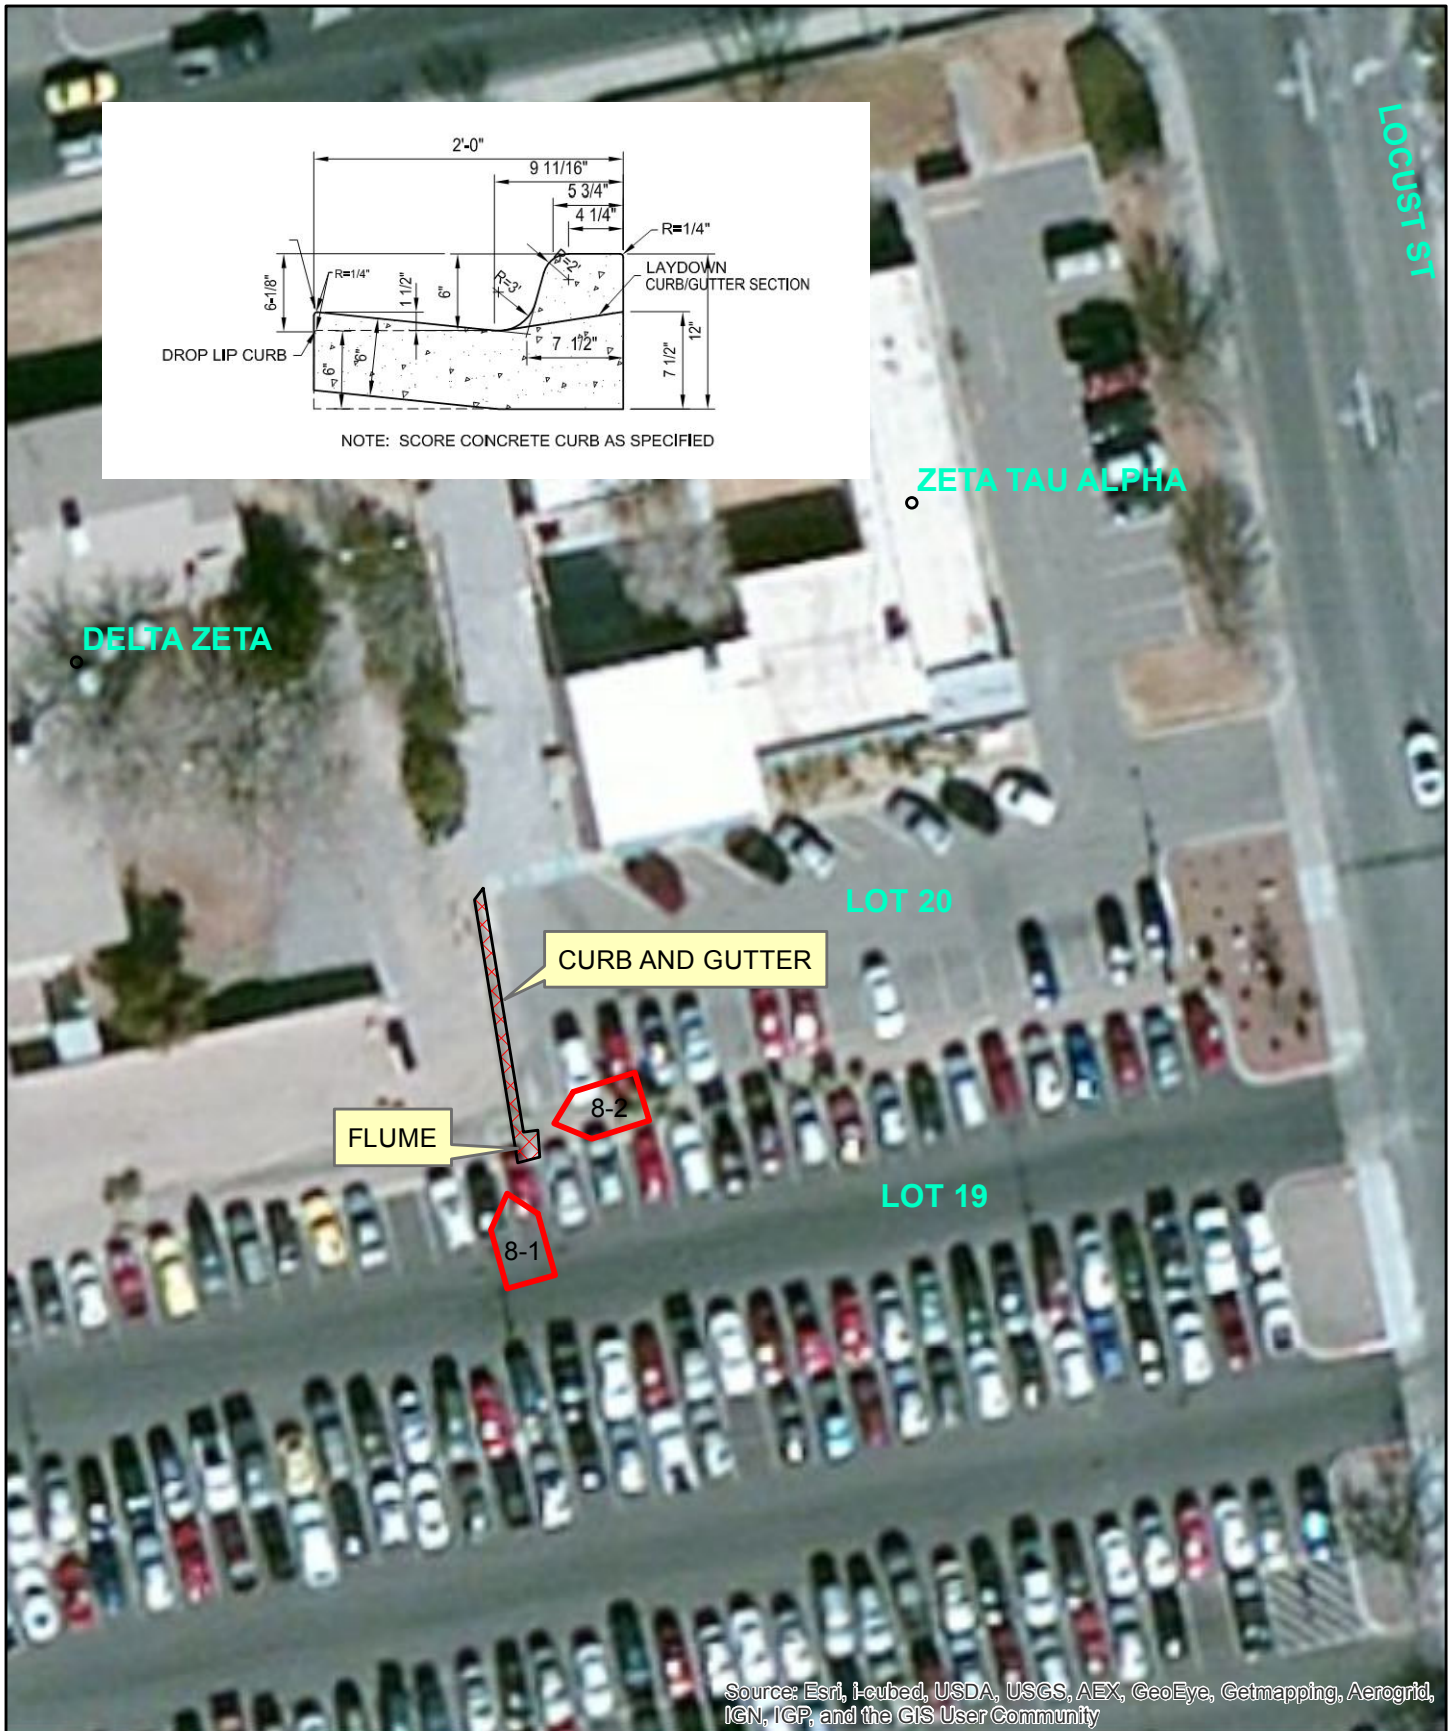
FIGURE 8-3

Lot 20 drains through a dirt field west of the lot before it discharges into Lot 19. As it goes through the dirt lot, runoff causes a lot of erosion and forces sediment into Lot 20. This can be seen in Figure 8-1. Rock riprap had previously been placed where the pavement and dirt lot intersect, all of which now has been eroded and pushed downstream or has been covered in sediment. In addition multiple wheel stops have been pushed down stream to the dirt lot. The erosion effects can be seen in Figure 8-2.

In order to prevent further erosion from occurring, PSC recommends that a curb and gutter that connects to a concrete flume be placed on the west border of Lot 20. Water which normally drains through the lot will collect along the curb and gutter, and be directed south through the concrete flume into Lot 19, without collecting sediment from the dirt lot. Once the water hits Lot 19 it will continue to drain downstream through the curb and gutter in Lot 19. To capture all the water, 50-feet of curb and gutter would be required. The concrete flume would measure 7-feet long, 2 feet wide and have a depth of .5-feet. A layout of improvements can be seen in Figure 8-3.

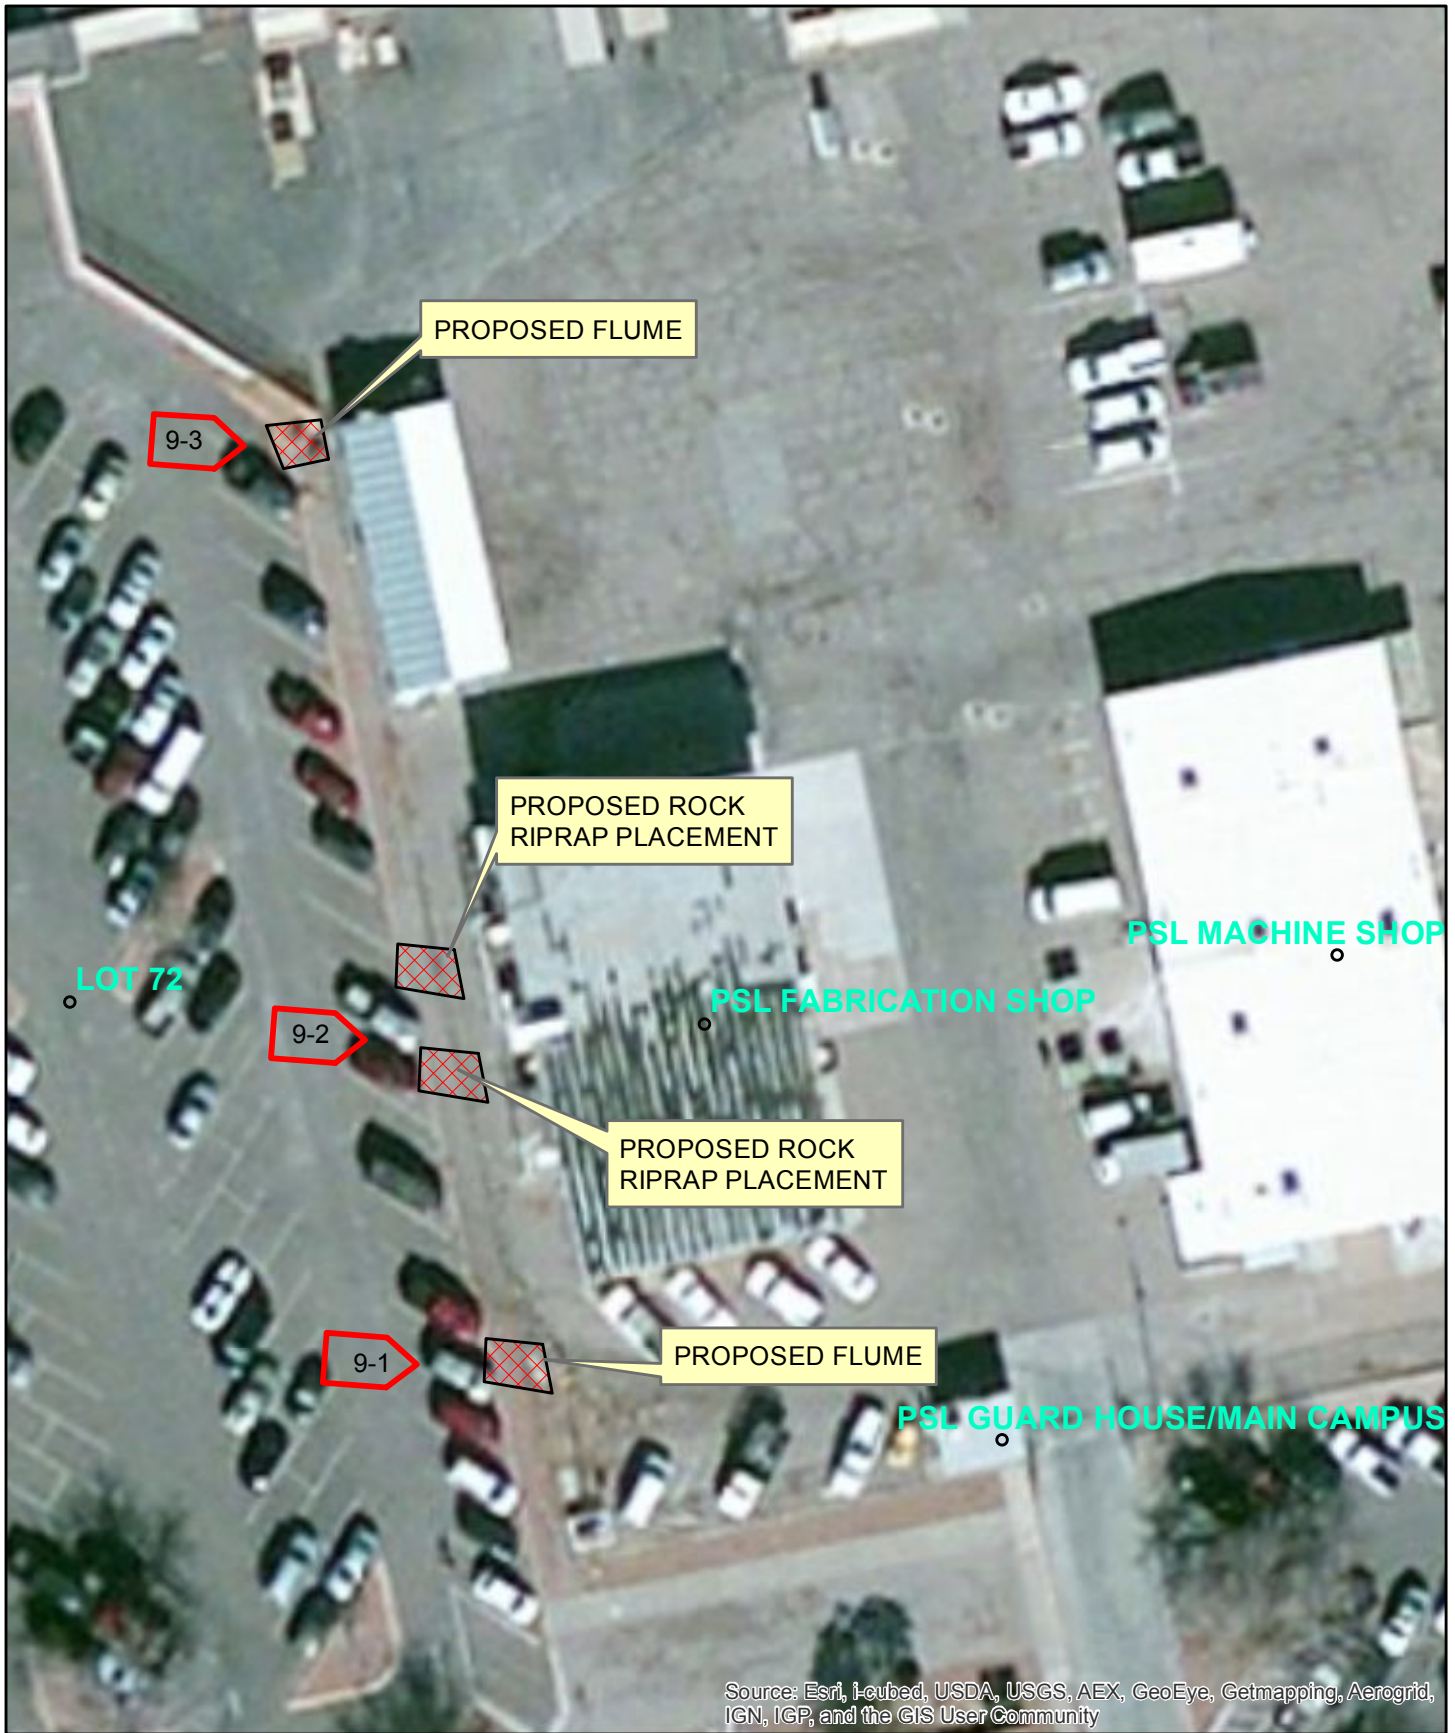
FIGURE 9-4

Lot 72 is located south of the Clinton P. Anderson Physical Science Lab (PSL) and west of Physical Science Laboratory Fabrication Shop. Lot 72 collects runoff from the western portion of the PSL complex and from its own lot. Due to security reasons, we were unable to examine the PSL complex to determine the extent of the drainage area. Runoff from PSL that drains to Lot 72 has caused vegetative overgrowth and erosion. This occurs at four locations throughout the lot. During our recent site visits, maintenance department had recently removed the majority of vegetative growth but erosion flow paths can still be seen as in Figure 9-1.

To prevent further sediment from entering the PSL complex, upstream erosion can be controlled by the placement of concrete drainage flumes at the north and south drainage locations, which will collect runoff at the fence line and transport flow. The concrete flume would measure 7-feet long, 4-feet wide and have a depth of .5-feet. At the outlet locations where condensation is released, a 7-foot long, 4-foot wide and .5-foot deep riprap mat will be added. There is minimal amount of flow in these areas so it does not constitute the addition of concrete. The width of the concrete flume and riprap mat are based on the average width of each erosion channel. Flume and riprap locations are shown in Figure 9-4.

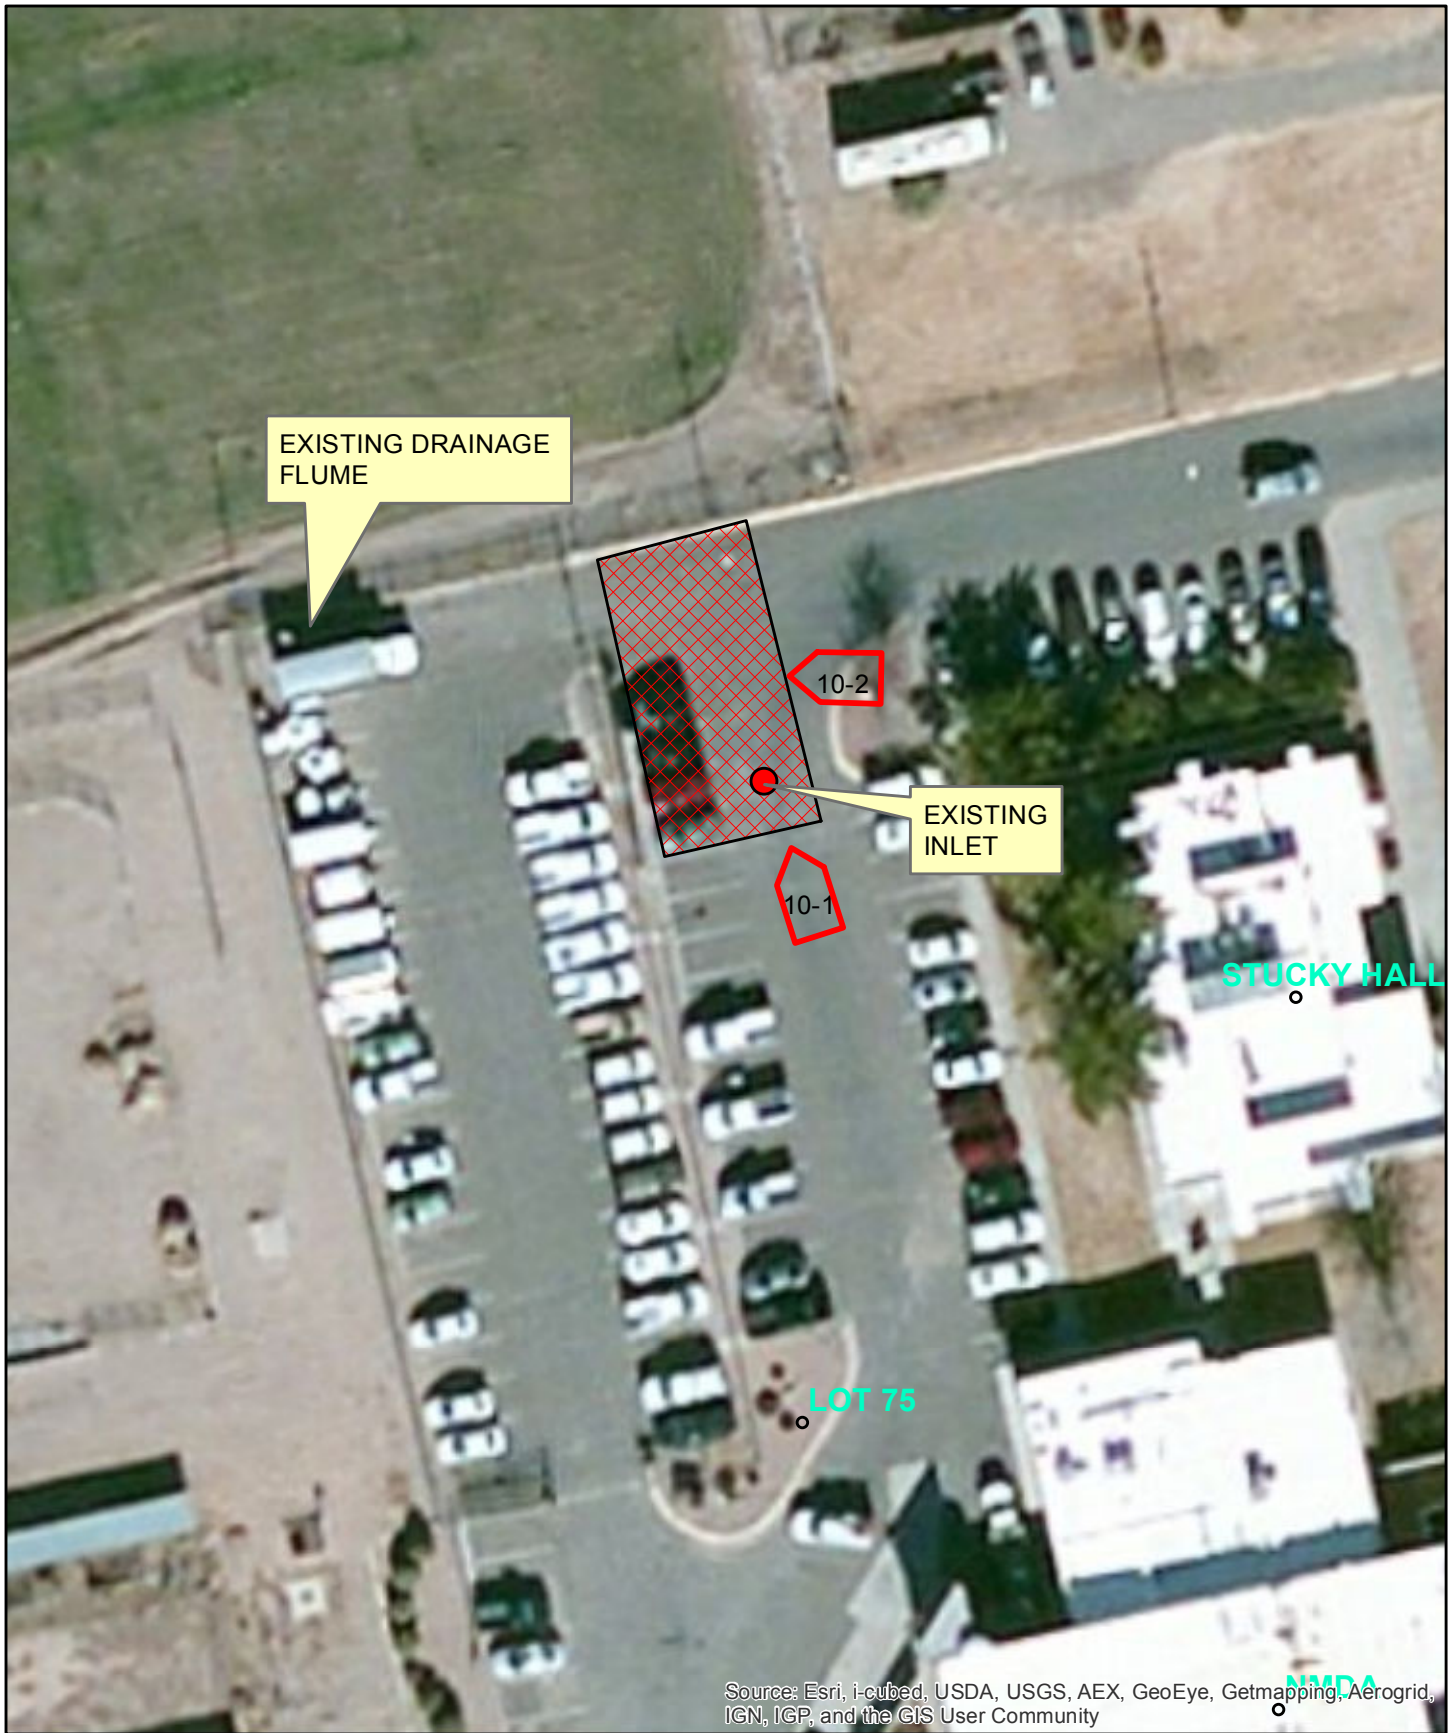
FIGURE 10-3

As seen in Figure 10-2, low spots in the landscaping have been created on the PSL complex. These low spots account for 2 of the 4 erosion locations points. The two other locations are caused by air conditioner condensation lines that terminate at the fence line, shown in Figure 10-3.

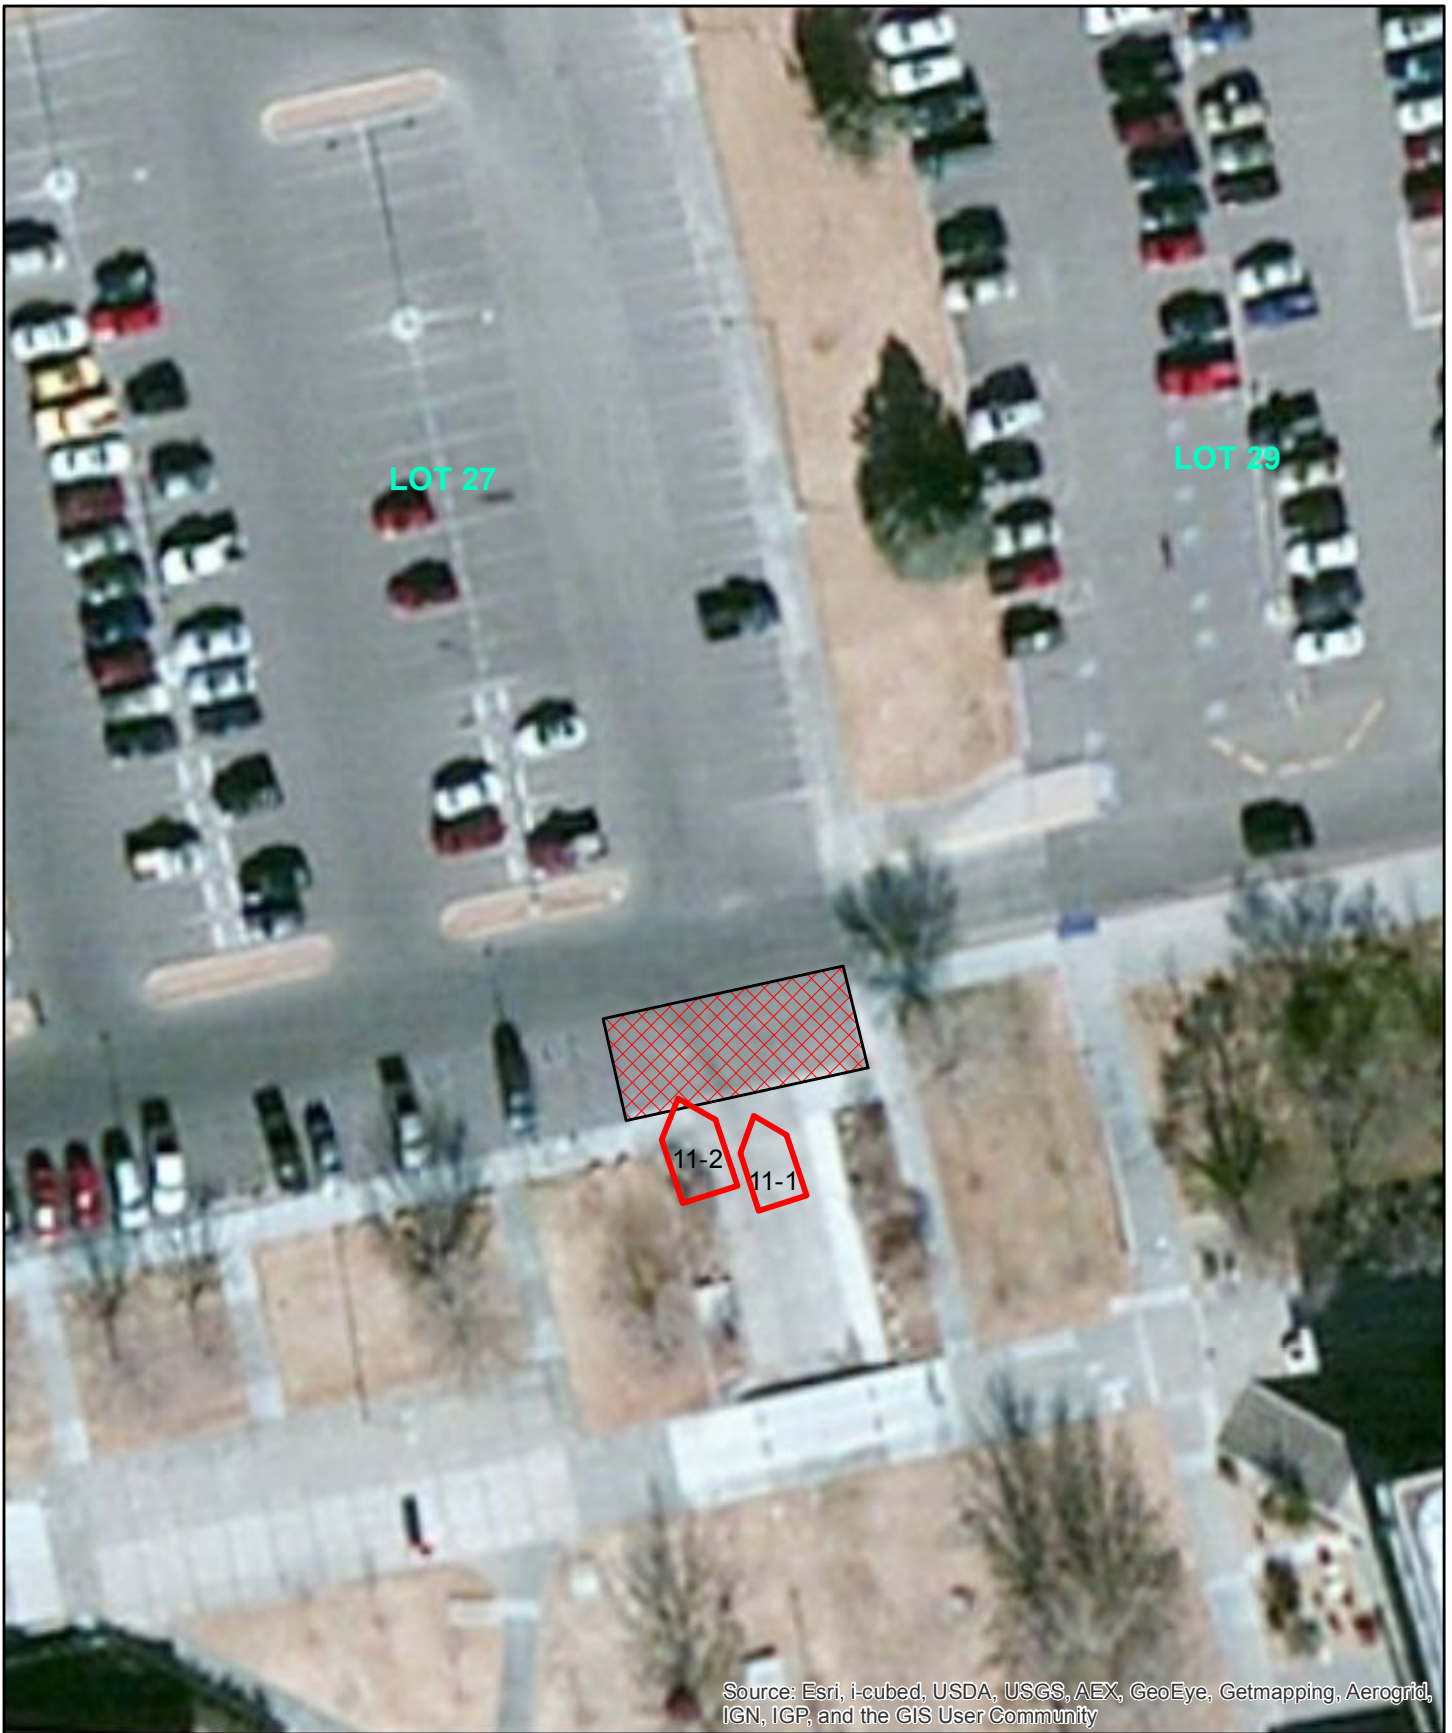
FIGURE 11-3

Ponding occurs just north of the entrance of the concrete culvert, as shown in Figure 11-1. Based on site observations, a 55x55 foot section of parking lot was replaced and has since experienced more deterioration due to onsite ponding. When the section was repaved, new pavement was placed over existing pavement without re-grading the affected area prior. Settlement of the existing pavement was not accounted for and low spots were created in the section. This can be seen in Figure 11-2. Figure 11-3 shows an aerial plan view of the affected area.

To relieve ponding on Lot 27, the existing 55x55 foot pavement section needs to be replaced. The replacement of the section will consist of removing the existing pavement, re-grading the base course and repaving. Due to the positive slope in the neighboring pavement sections, only minor regrading will need to occur to ensure low spots are not created.

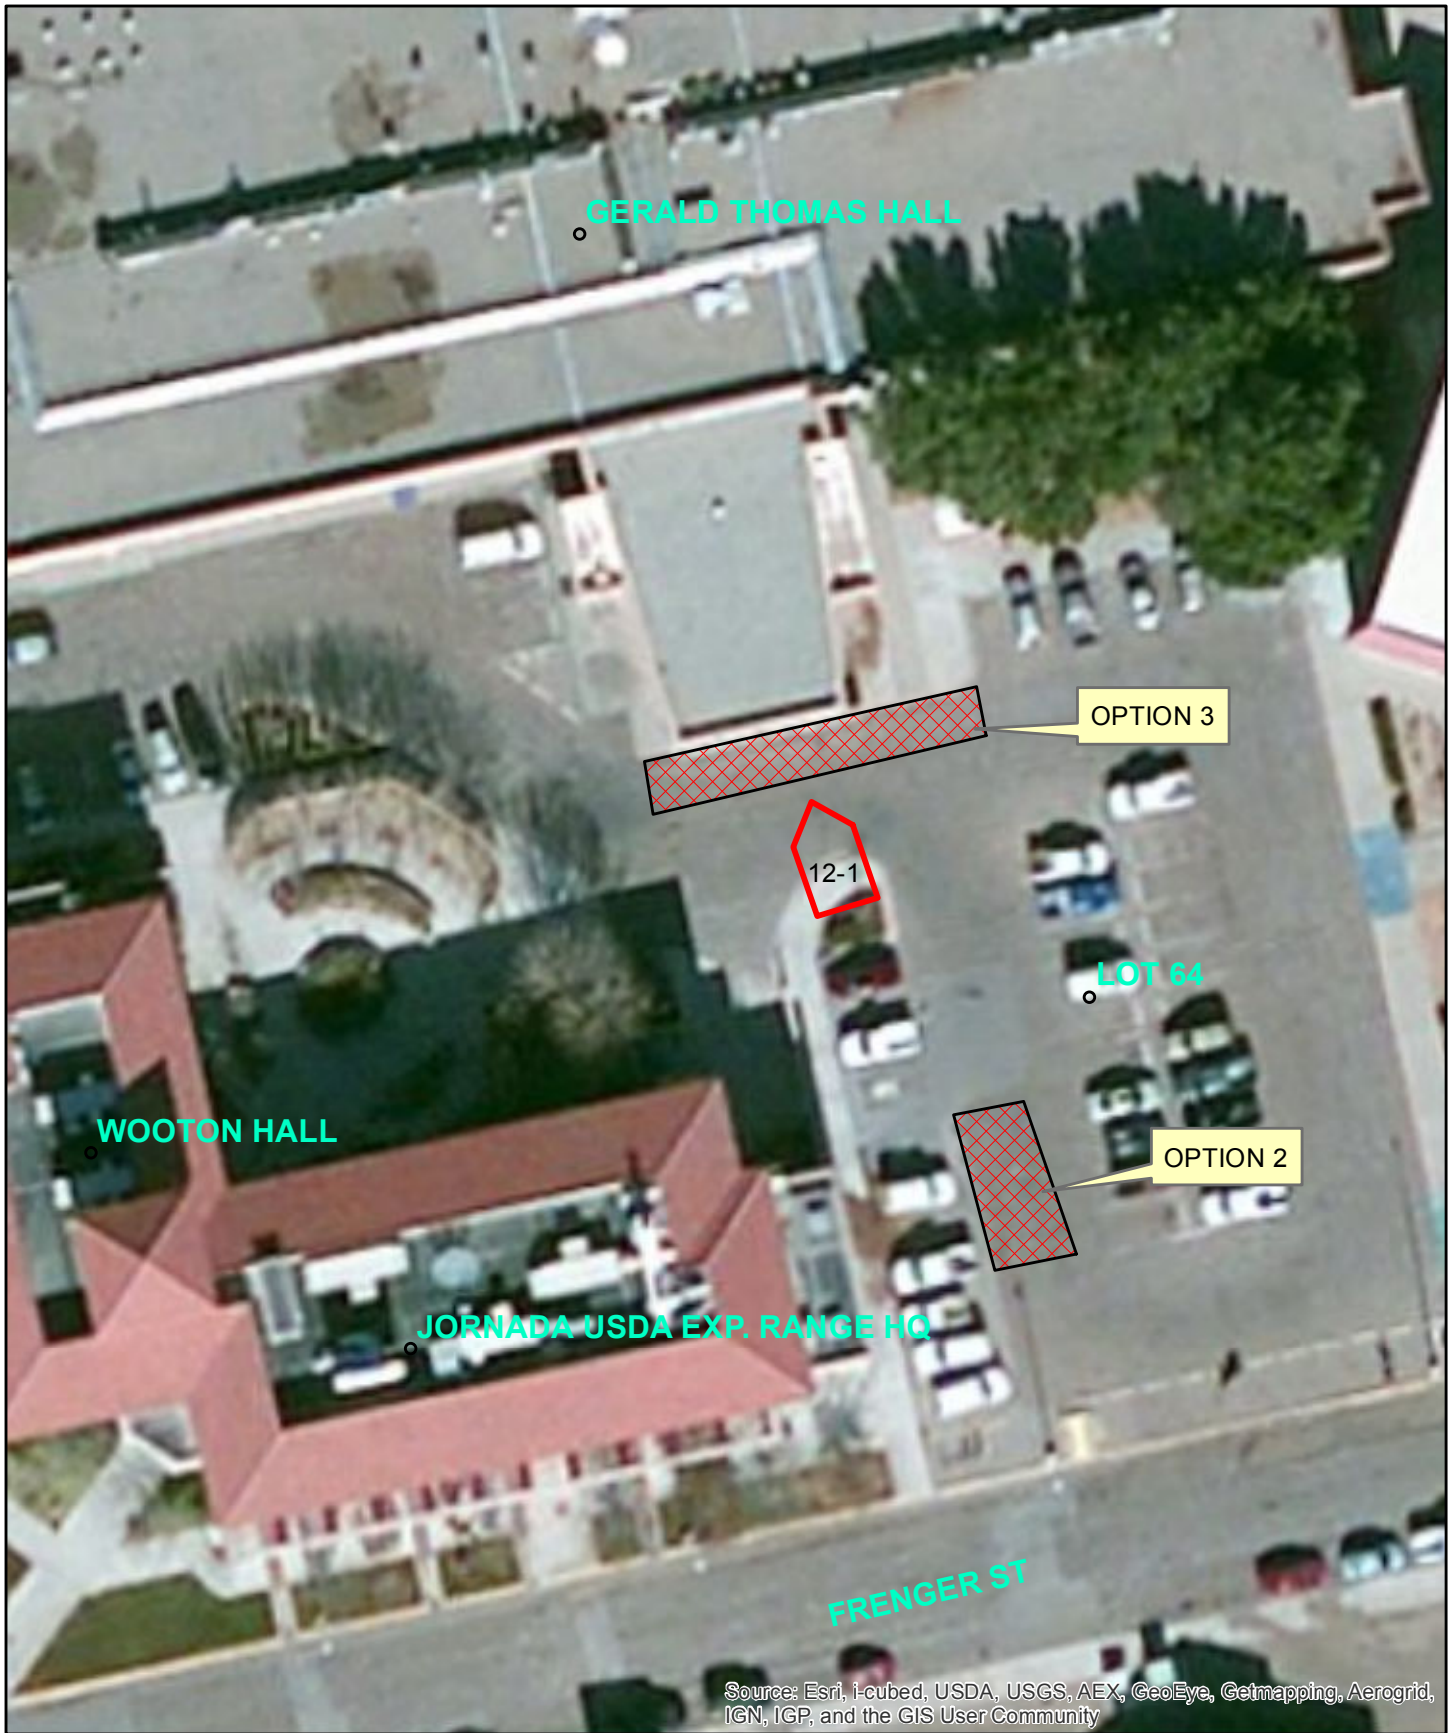
FIGURE 12-2

The entire lot is cracked and deteriorating with visible areas of where multiple repair patches have occurred. Based on our site visit, water ponds at two locations on the lot. The first ponding area is located near the accessible parking space adjacent to Wooton Hall. This ponding area is caused by a pavement repair patch which was placed at a higher elevation than the surrounding pavement, preventing runoff from draining towards Knox Street. The second ponding location is at the southern intersection of Gerald Thomas Hall and Lot 64. This can be seen in Figure 12-1. A wood/steel impact barrier was placed within the gutter to prevent vehicle impact from oncoming traffic. The wooden post placed in the gutter prevents runoff from flowing through unabated. In addition, PSC noticed that multiple layers of pavement have been placed throughout time to where the top of pavement is at a higher elevation than the gutter. To alleviate ponding in Lot 64, three construction options can be completed.

Option 2 consists of removing the existing pavement repair patch and re-grading the area so it matches up with existing pavement. This is a minor fix that will prevent water from ponding behind the accessible parking spots. The proposed pavement patch would measure 20’x9’ or 20-square yards of pavement. This can be done in conjunction with Option 3.

Option 3 consists of removing, re-grading and repaving a 52’x10’ section of pavement south of the vehicle impact barrier. The new pavement section would match existing elevation of the gutter and slope away from the gutter and wooden posts, providing an outlet for water trapped between the wooden posts. Runoff can then flow away from the gutter and runoff will continue to flow northwest towards Knox Street. Option 2 and 3 can be seen in Figure 12-2.

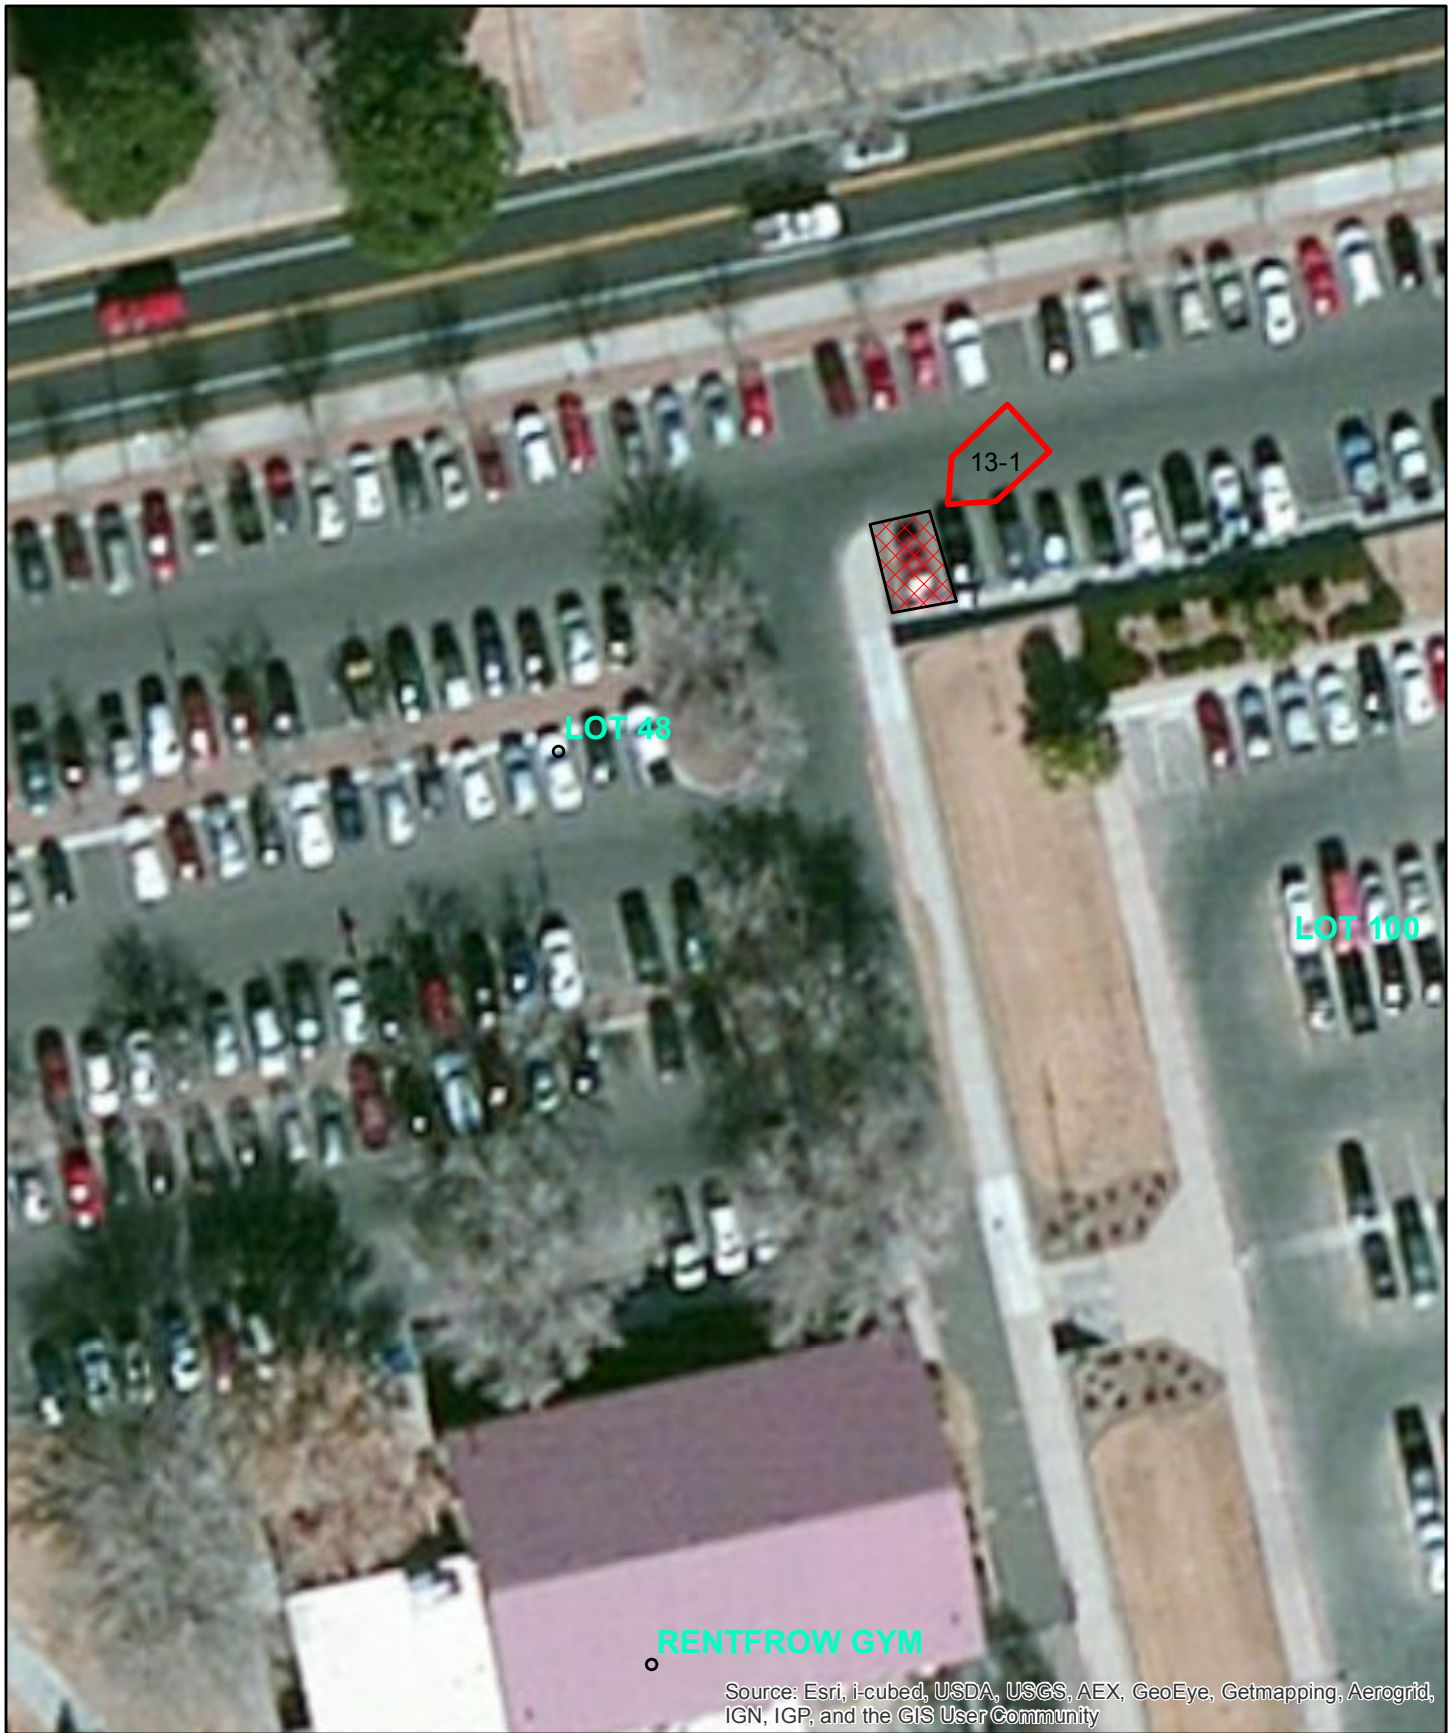
FIGURE 13-2

We were only able to identify ponding at one location of the lot near the intersection with Lot 100. As shown in Figure 13-1, settlement of the pavement and gutter is preventing water from draining north out of the parking stalls. Due to being inundated with water, we are unable to report on the condition of the pavement. The settlement of the curb is shown by adjacent settlement of the pedestrian sidewalk.

To alleviate the creation of the ponding area would require re-grading the subgrade beneath the pavement and curb and gutter. A 10'x18' section of pavement and 18-feet of curb and gutter (9-feet on each side of the corner section) would need to be removed and replaced. This can be seen in Figure 13-2.

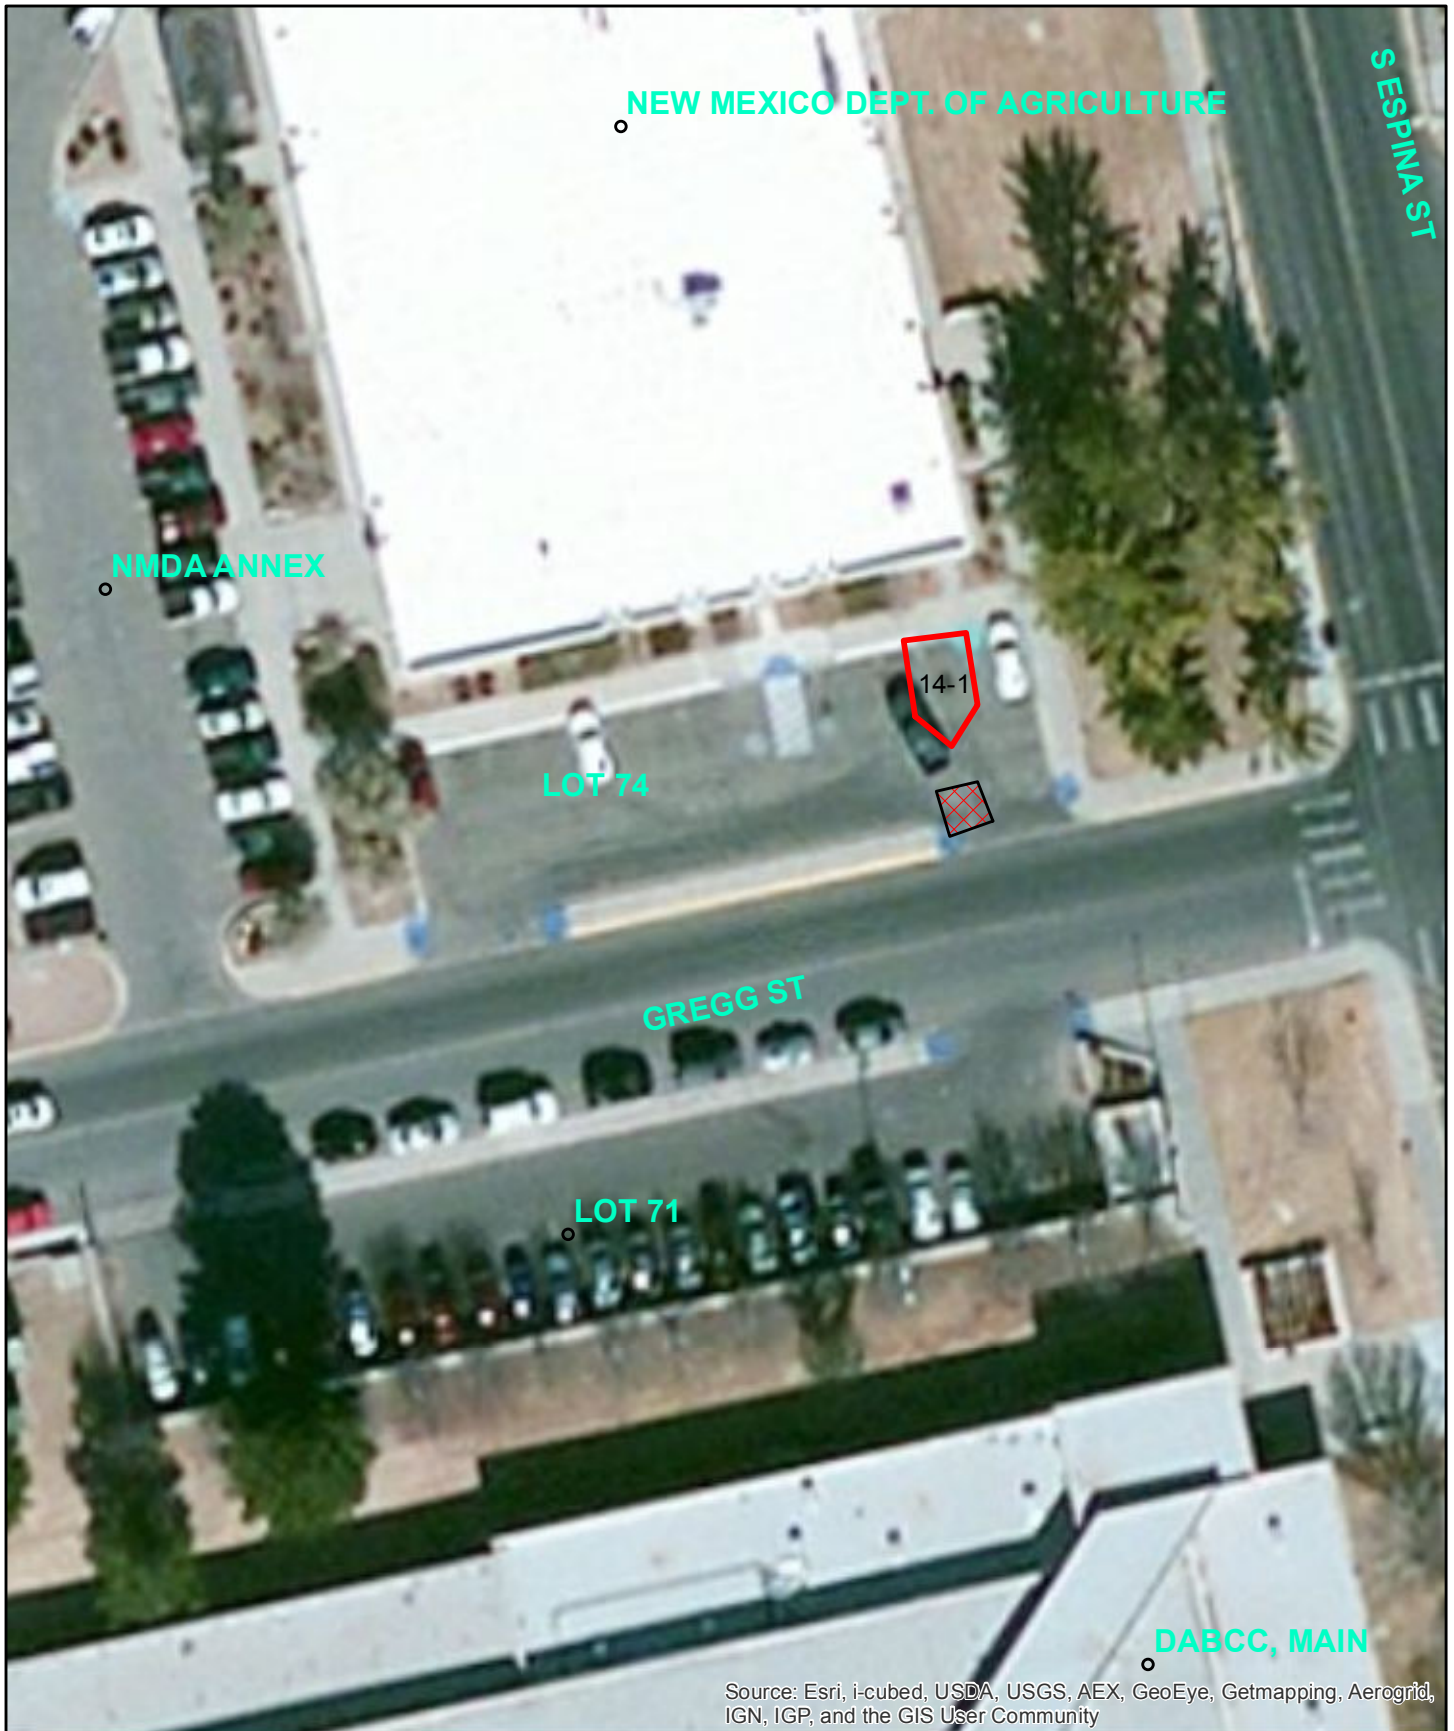
FIGURE 14-2

The existing pavement in the lot however looks old with many cracks and some settlement occurring in a few locations. This can be seen in Figure 14-1, where settlement has occurred in the pavement near the curb and gutter on the west side of the lot. To alleviate ponding in Lot 74, two construction options can be completed.

Option 2 consists of removing and replacing the 6'x6' pavement section, shown in Figure 14-2, and re-grading it to provide positive drainage slope. This provides an economic solution for the ponding in Lot 74, but due to the condition of the adjacent pavement, settlement may begin to occur in other locations. The opinion of probable cost for Options 1 and 2 are provided in Appendix A.
