Engineering Report

New Mexico State University
Auxiliary Services Drainage Concerns
Las Cruces, New Mexico

August 2013

PSC Project # 01891613

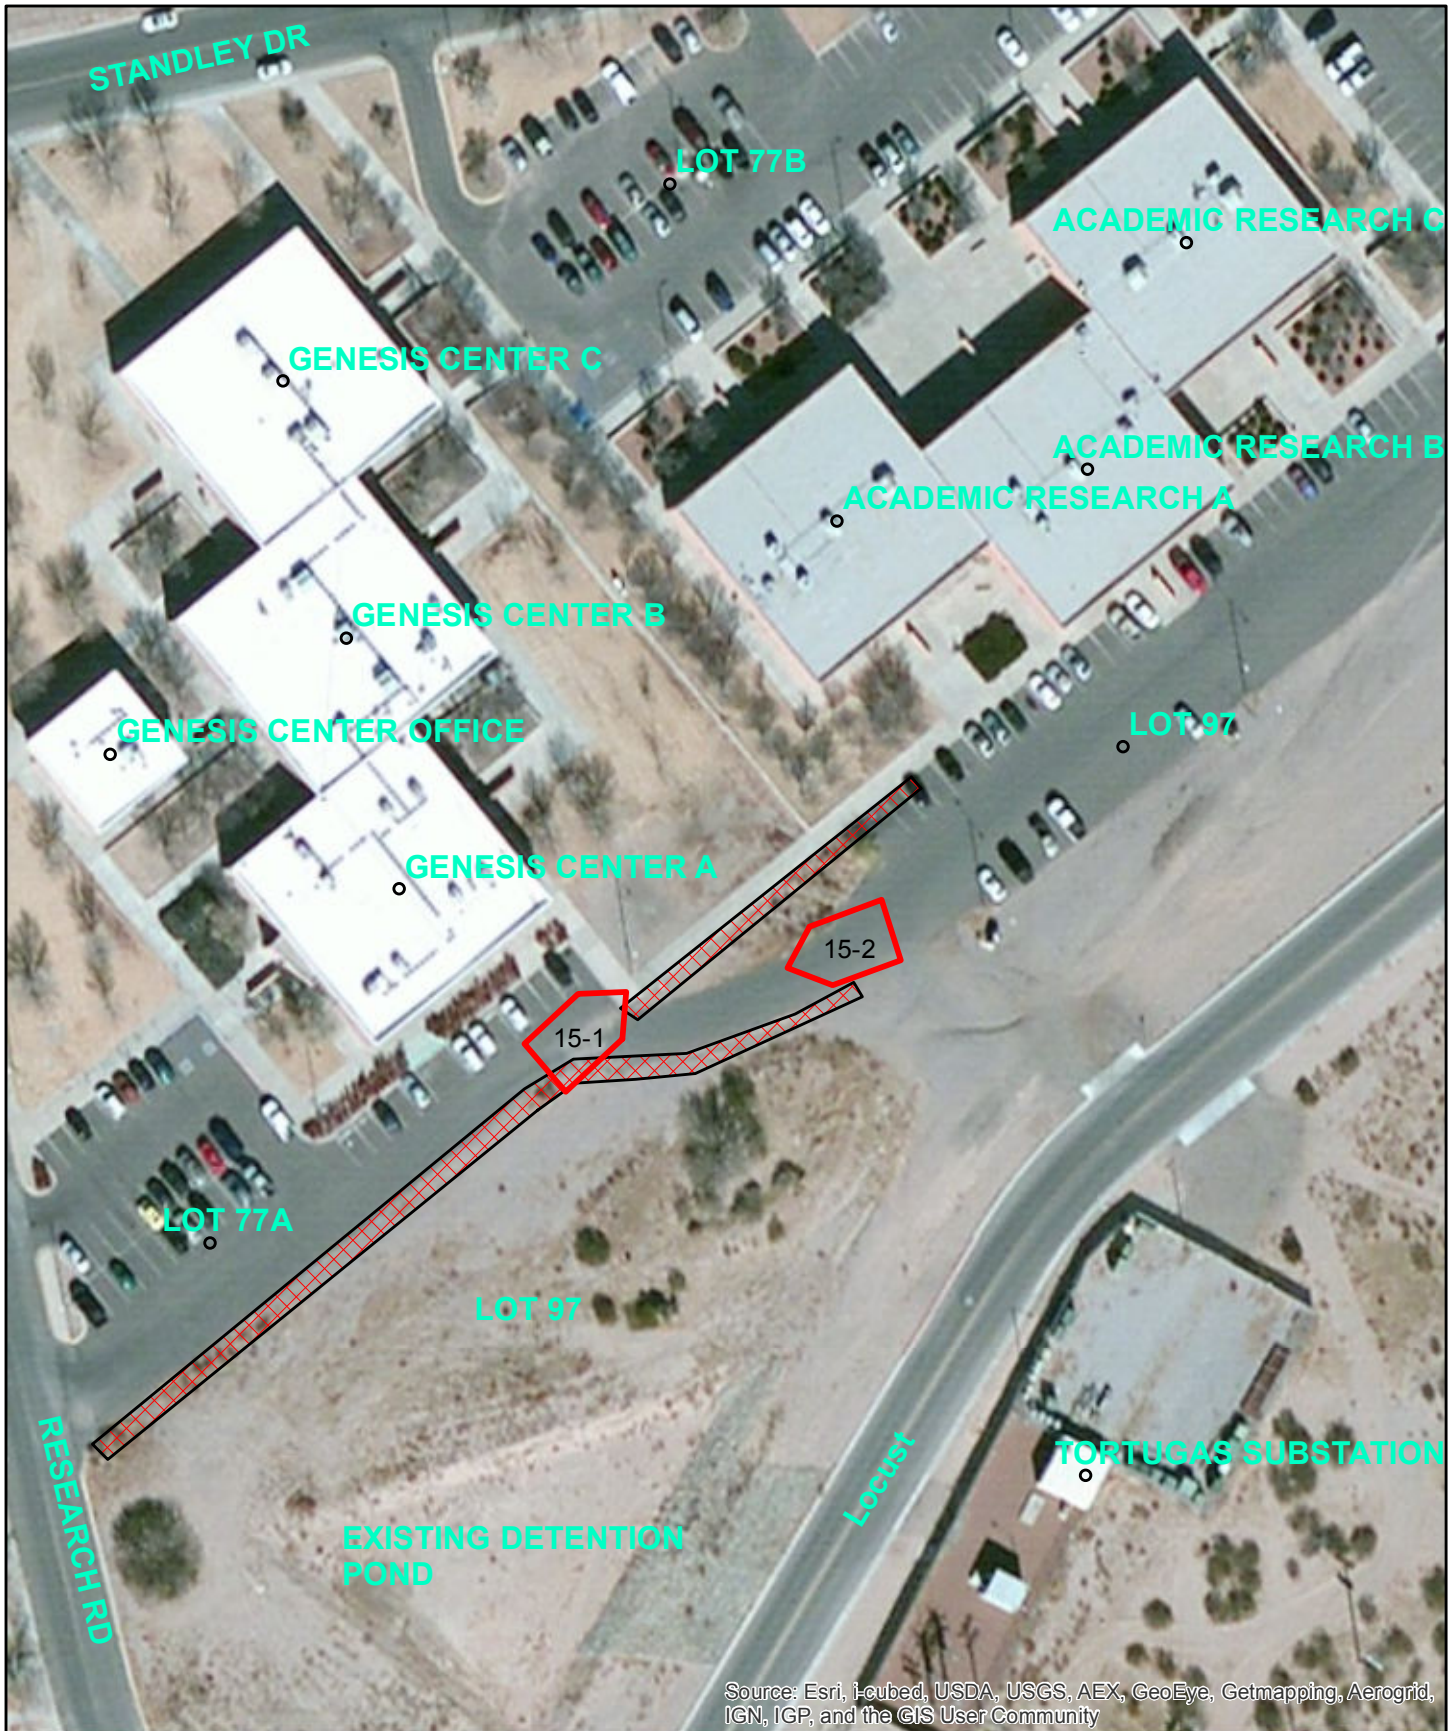
FIGURE 15-3

On average, Lot 97 is 2 to 4-feet higher than Lot 77A. Due to the elevation differences in the area, runoff from Lot 97 tends to cause drainage problems within Lot 77A. As seen in Figure 15-1, runoff from Lot 97 is deteriorating the edge of road pavement and concrete sidewalk located adjacent to the Academic Research building. In addition, sediment is being transported to Lot 77A, as seen in Figure 15-2. In order to prevent this from happening, two construction options can be implemented.

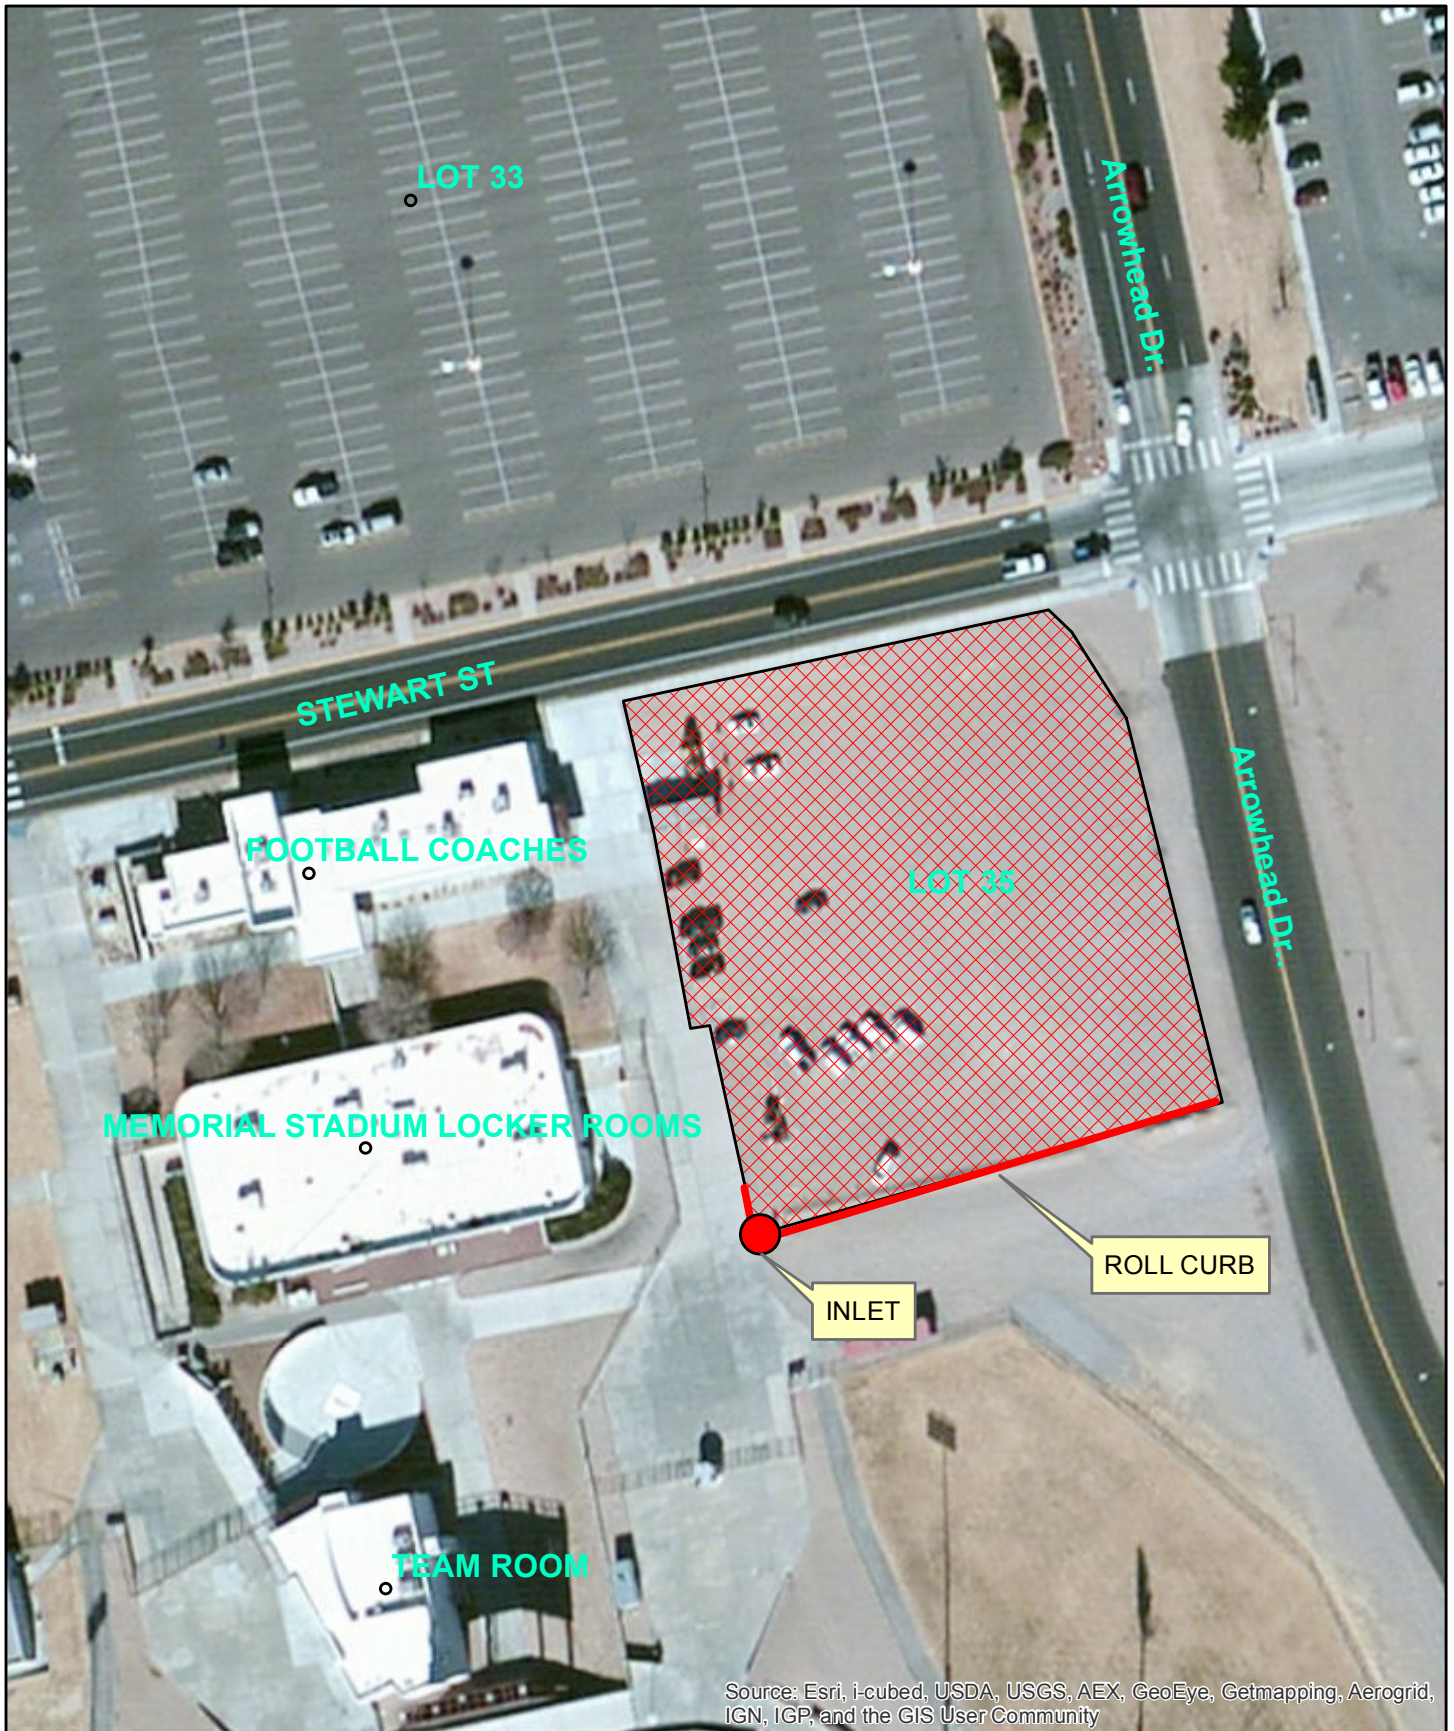
FIGURE 18-1

The main cause of Lot 35’s problems stem from two items as noticed per our site visit. The elevation difference between Lot 35 and the adjacent lots prevent gravity drainage other than towards the stadium. In addition, since the lot has no vegetative cover and consists mainly of dirt, any drainage structure placed within the lot will eventually be filled with sediment. The drainage area of the lot is approximately 56,250-square feet or 1.29-acres. Based on the City of Las Cruces Runoff Analysis, the area has a peak flow rate of 5.79-cfs and required storage volume of 486.11-cubic yards.

To alleviate erosion and drainage concerns within Lot 35, it is recommended to pave the lot, install a roll curb on the south perimeter, drainage inlets at certain points as seen on Figure 18-1 and drain to an underground storage system. The lot would require approximately 6,250-square yards of pavement. The proposed pavement section shall be 2-inches of HMAC, 6-inches of flexible base course, 6-inches of sub-grade. The roll curb if installed, on the south perimeter would transport runoff to inlet grates in the southwest corner of the lot. Runoff would then drain to an underground chamber storage system. Layout of the improvements is shown in Figure 18-1.

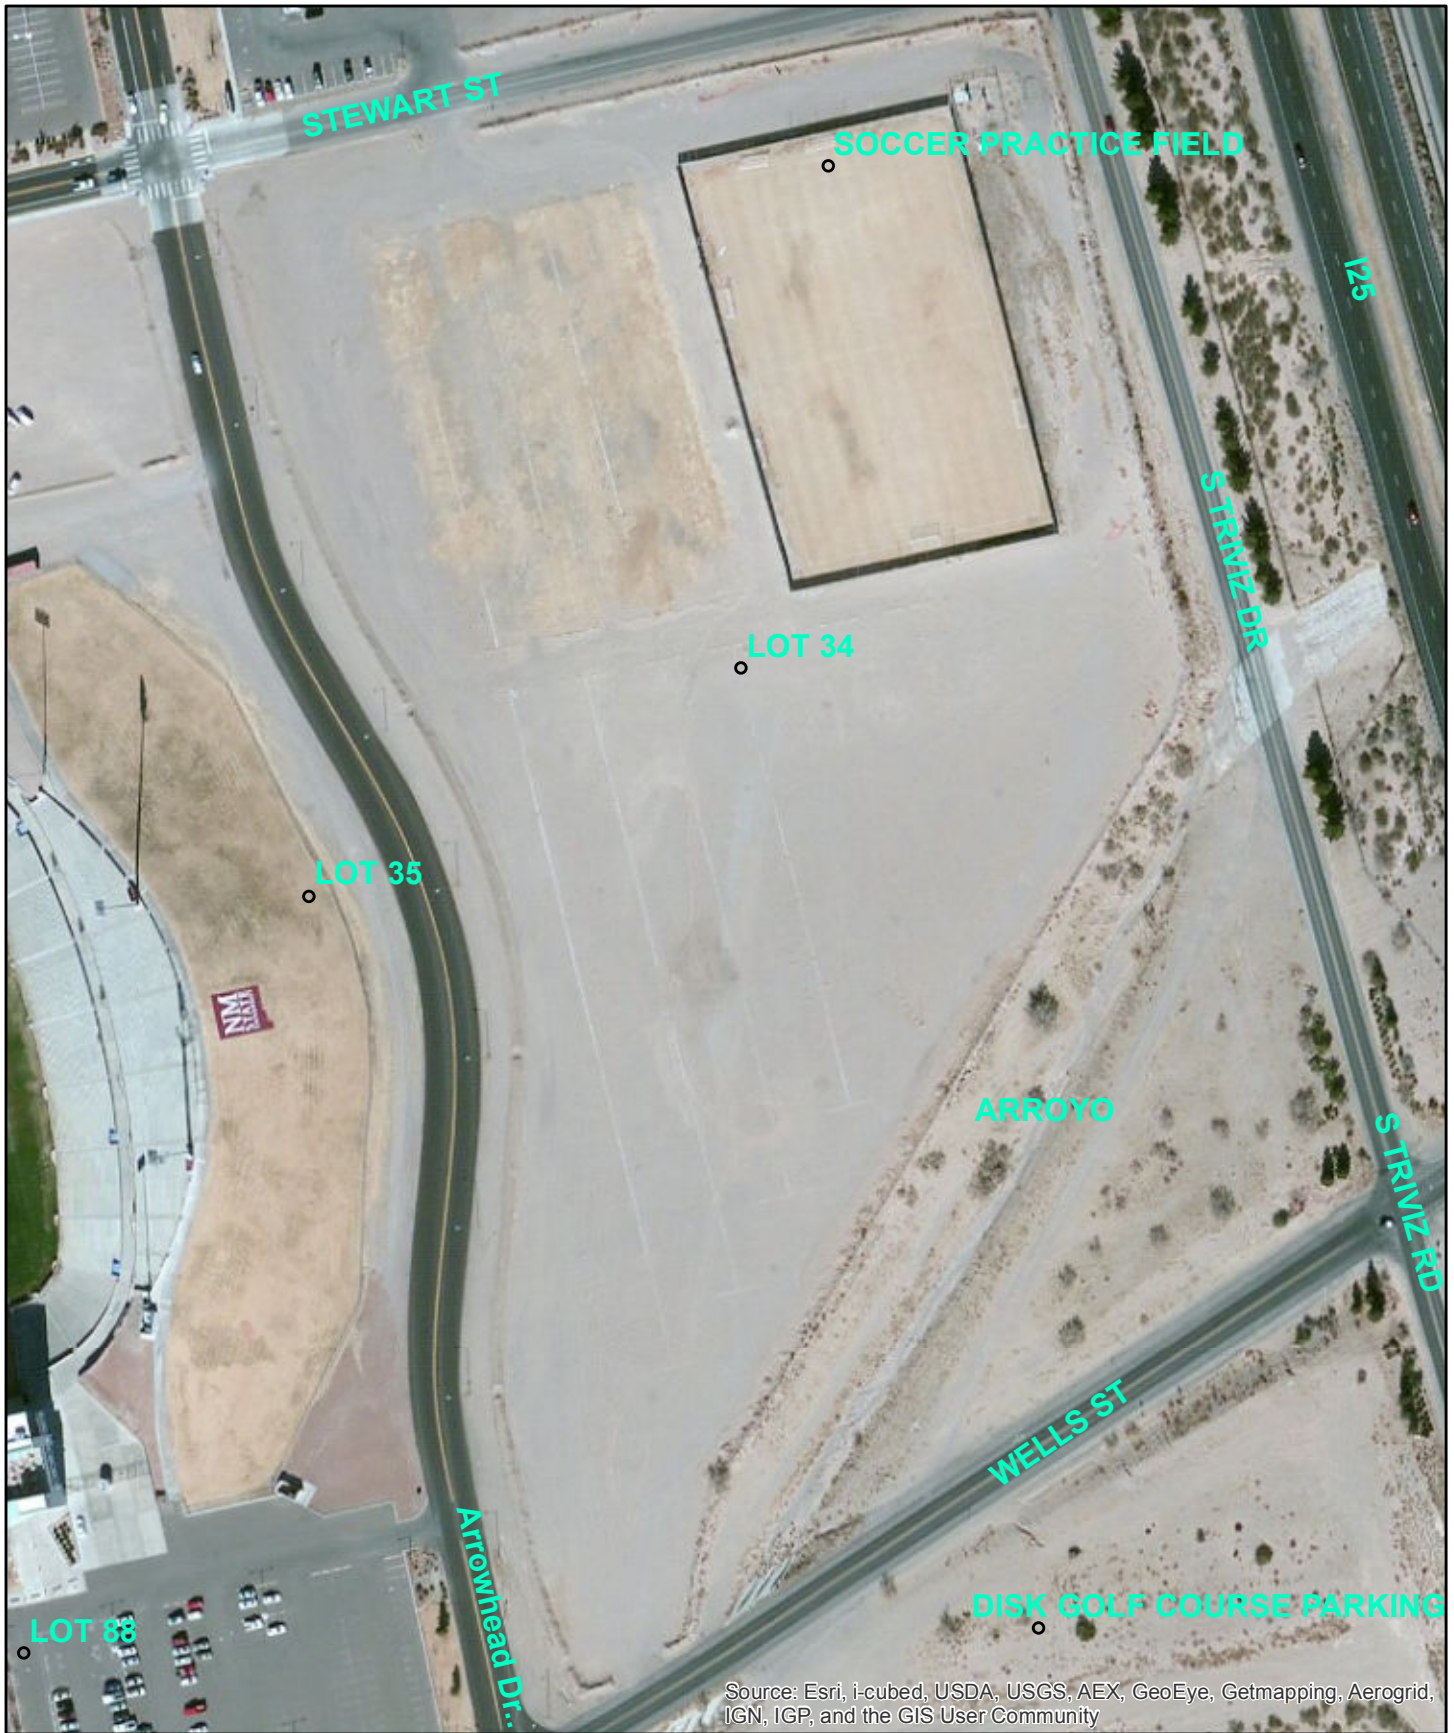
FIGURE 19-1

Lot 34 is located east of Aggie Memorial Stadium and west of I-25. The lot has a drainage arroyo in the southeast portion of the lot. During our site visit, the area had been graded for the campus rodeo. We were unable to identify any drainage concerns in the area. The drainage can be improved in Lot 34 if regular maintenance is performed. We do not recommend any significant changes to be made to the lot.

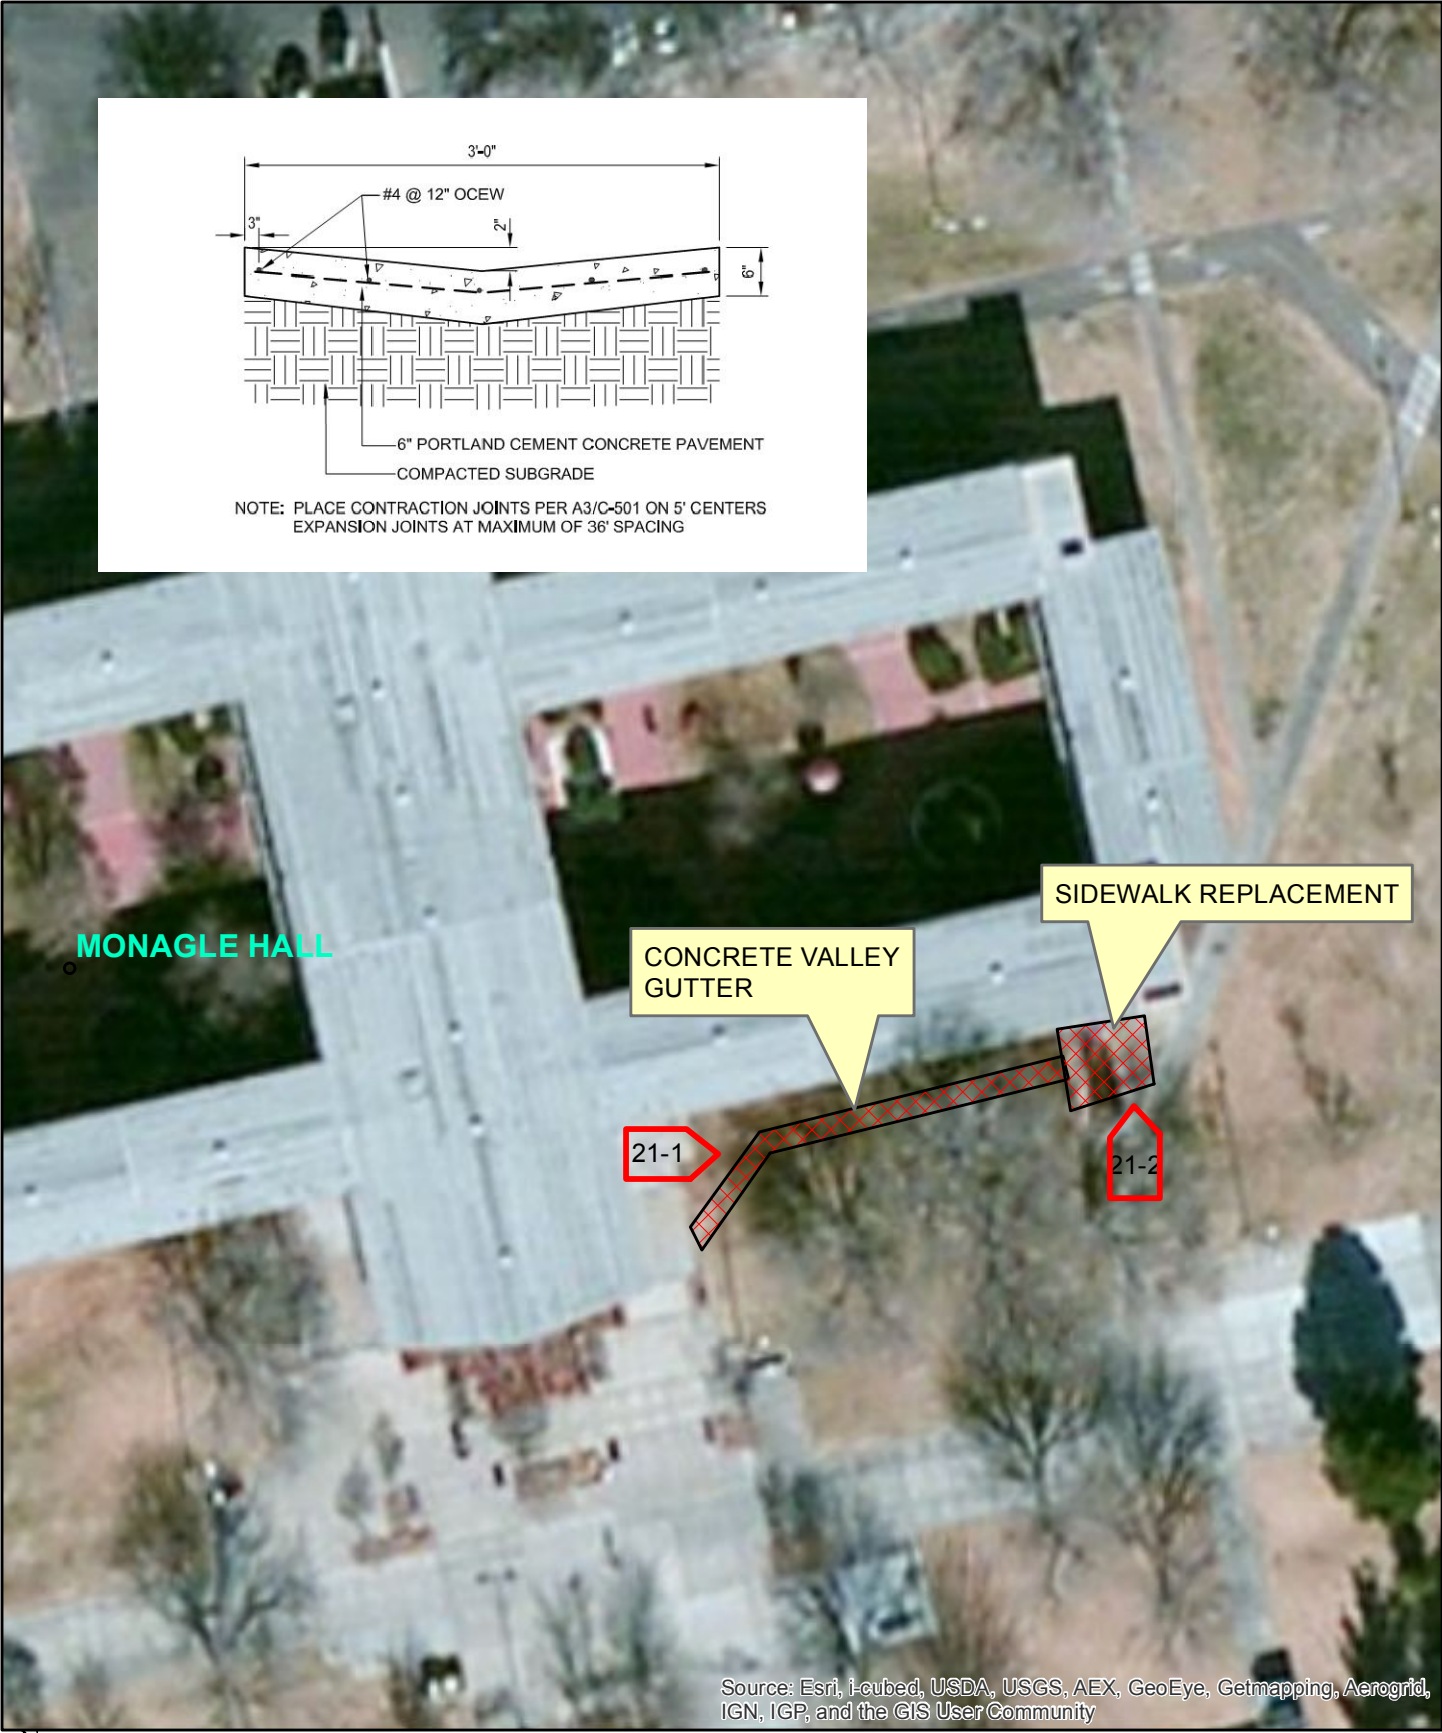
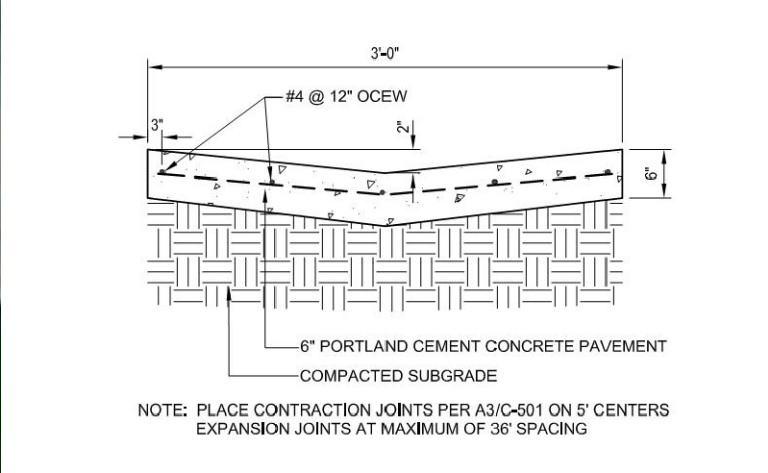
FIGURE 21-3

It can be seen in Figure 21-2, that concrete was recently replaced on the east end of the building and created a low spot where the landscape and sidewalk meet. Continuous ponding at this location has caused settlement of the concrete splash pads next to the building. Location and orientation of the pictures below can be seen on Figure 21-3.

To prevent ponding at this location would require the addition of a concrete valley gutter, and the removal and replacement of the sidewalk adjacent to the landscape area. The layout for the concrete valley gutter is shown in Figure 21-3. The valley gutter would run from the connection to the sidewalk 70-feet east make a 45-degree bend and continue 45-feet southwest to the existing sidewalk in front of the main entrance. The purpose of the 45-degree bend is to avoid disturbance of the existing sewer lift station. The gutter would be 3-feet wide with a depth of 4-inches. Where the proposed gutter outlets to the east, a 27'x7.5' section of sidewalk will need to be removed and replaced to match the slope of the existing valley gutter and the existing sidewalk to the east.
